SBCC Survey of Existing Buildings and Retrofit Plan

SANTA BARBARA CITY COLLEGE SEISMIC SURVEY

PRELIMINARY REPORT

May 31, 2023

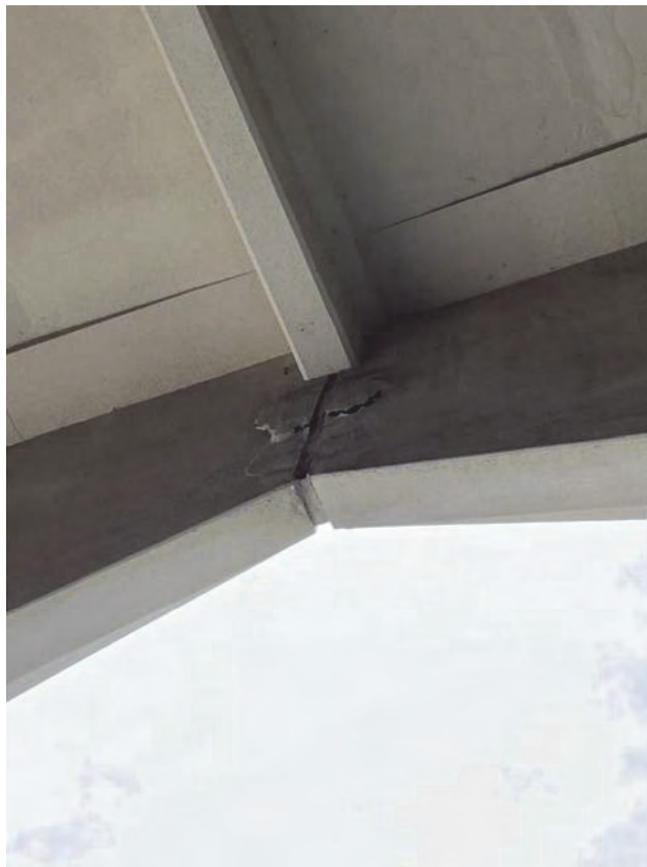
SUBJECT: 0024 – Student Services

Water Damage at Connection of Precast Concrete Exterior Columns

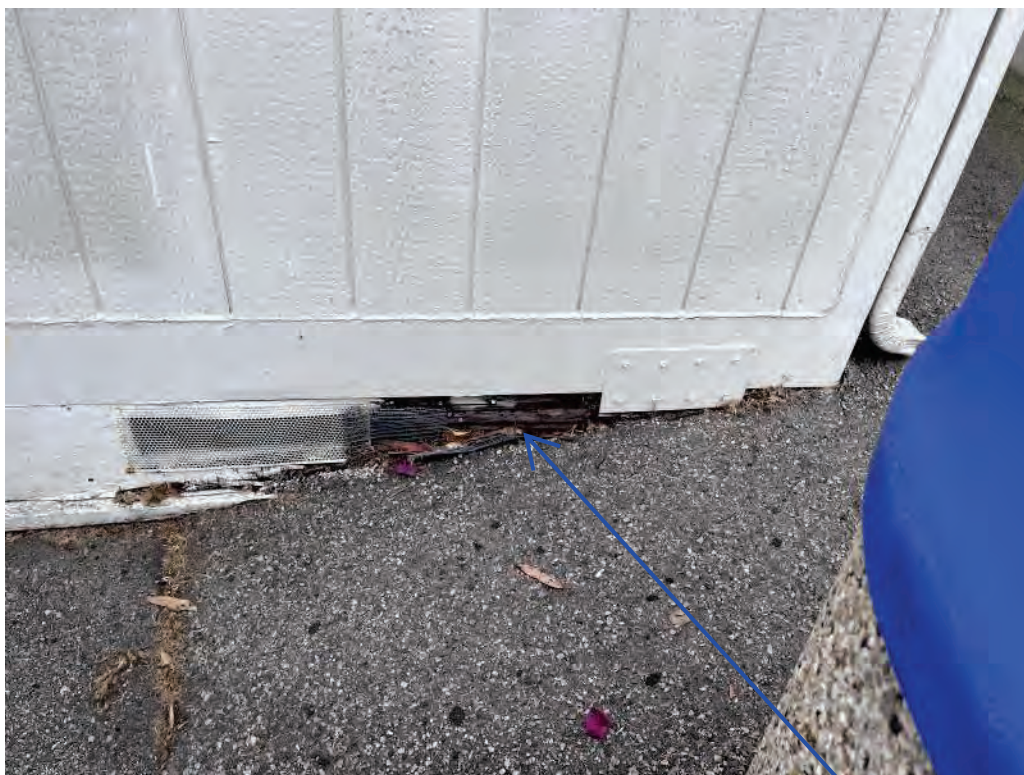
Pressure Treated Wood Sill and Rim

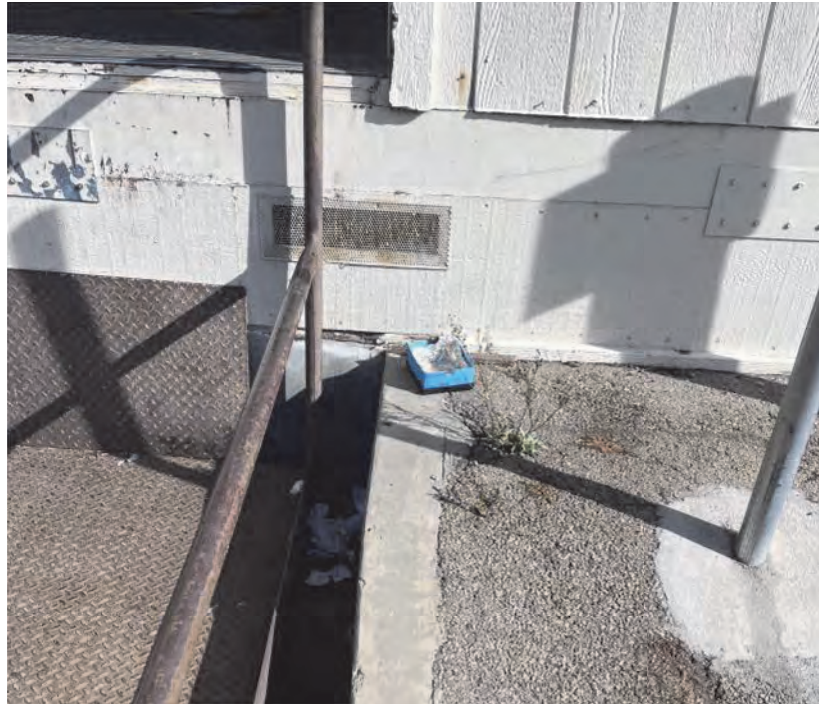
Deterioration of Wood Sill-On-Ground

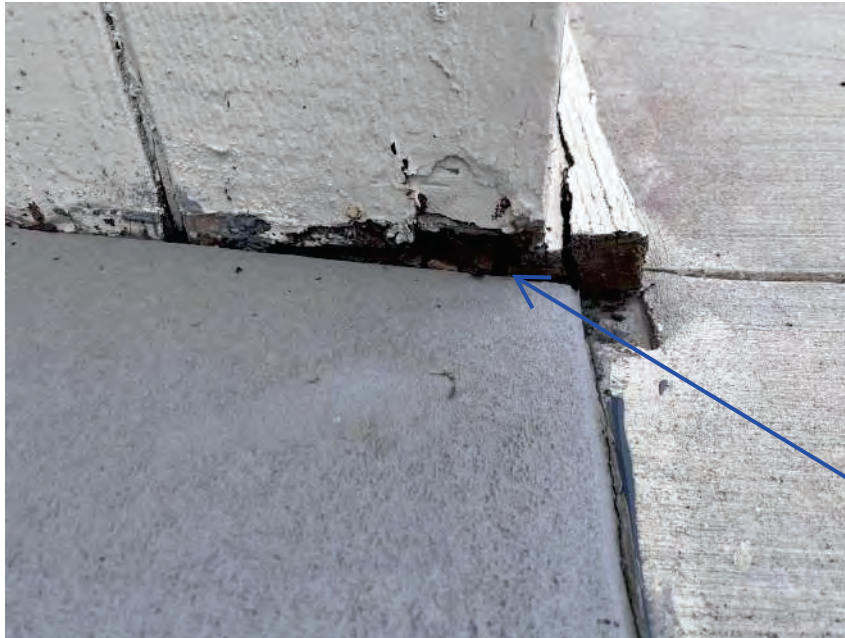
T&S/DRT: Crushing and deterioration of wood sill-on-ground

Pressure Treated Wood Sill-On-Ground

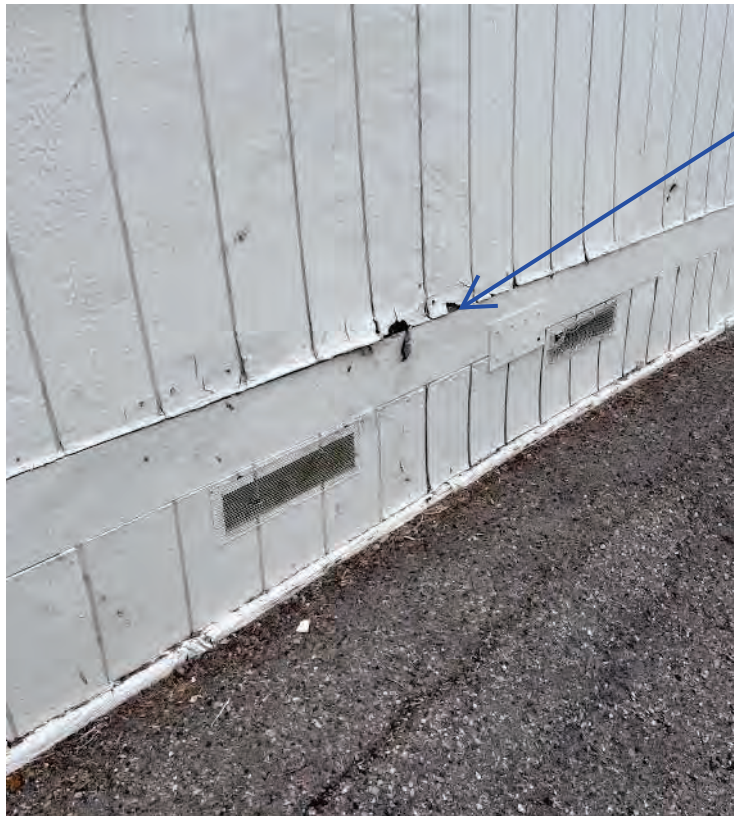
T&S/DRT: Crushing and warping of joint

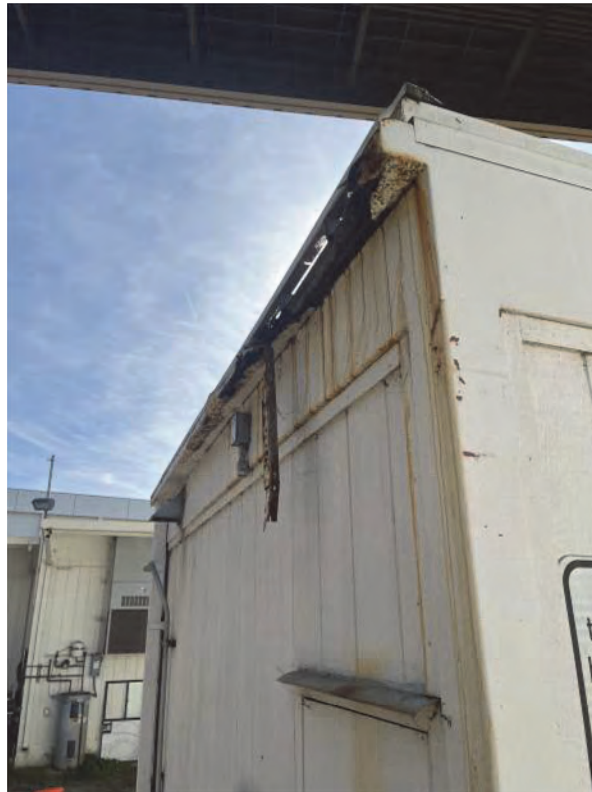
Significant Damage to Gutter

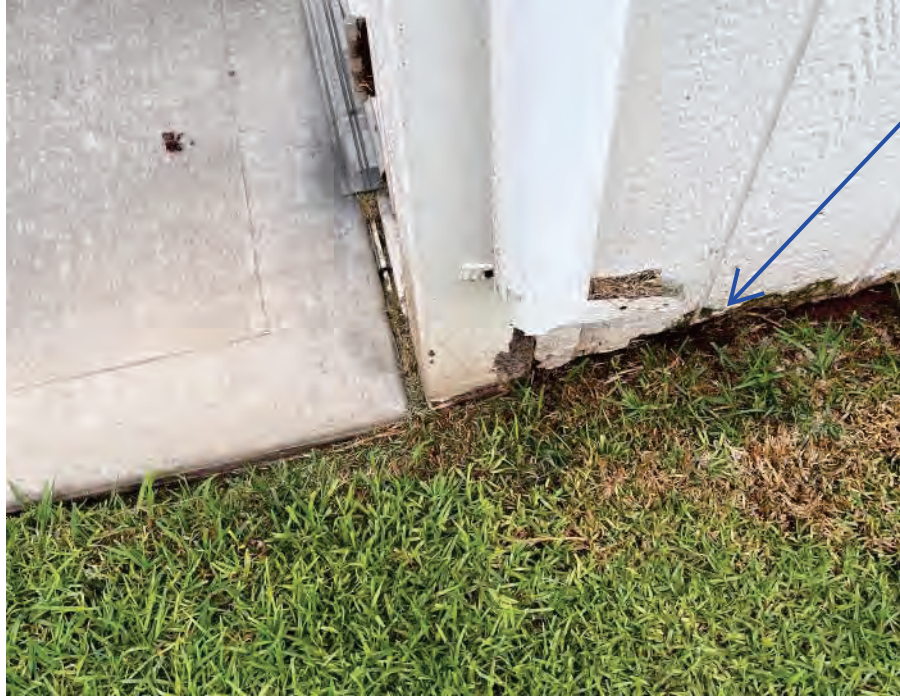
T&S/DRT: Rot and deterioration of wood sill-on-ground

Wood Sill-On-Ground

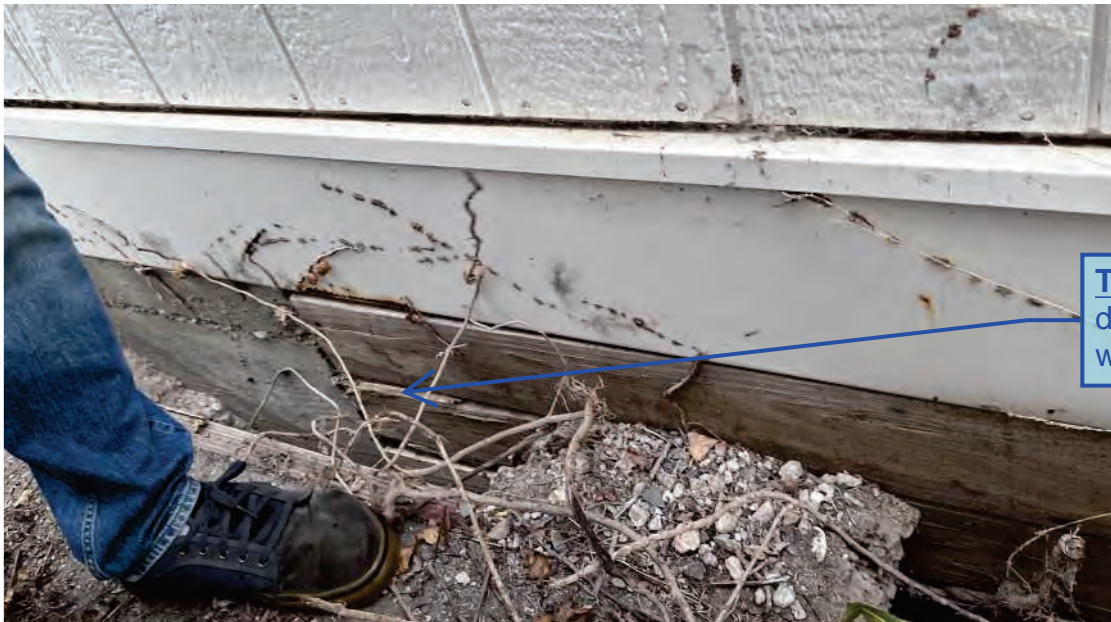
T&S/DRT: Rot and deterioration of wood blockout

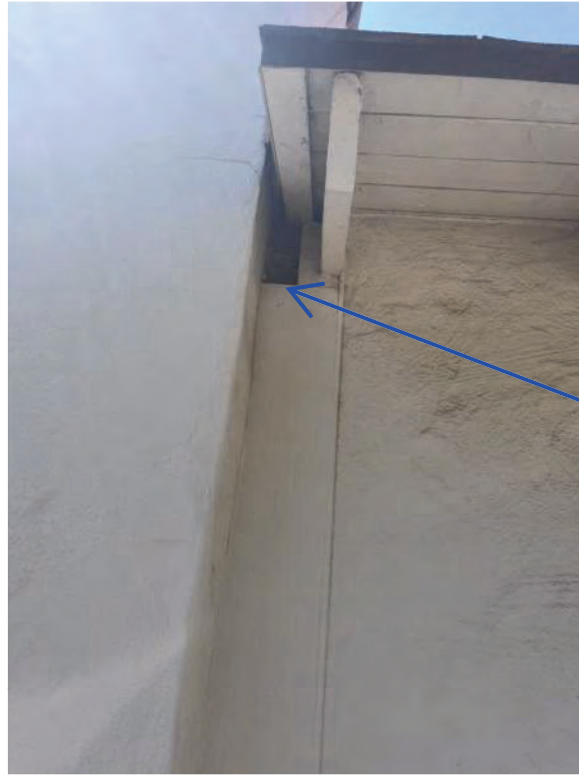
T&S/DRT: Limited clear distance to adjacent building and building end condition cause a potential for pounding

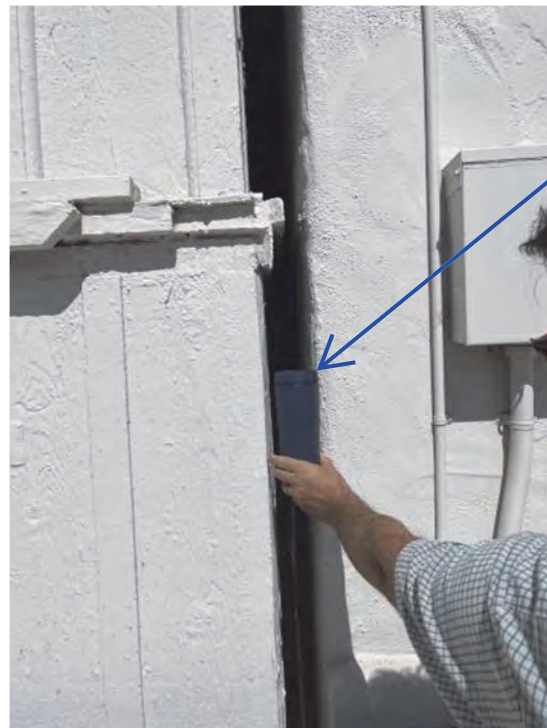
North-East Facing Wall

T&S/DRT: Limited clear distance to adjacent building and building end condition cause a potential for pounding

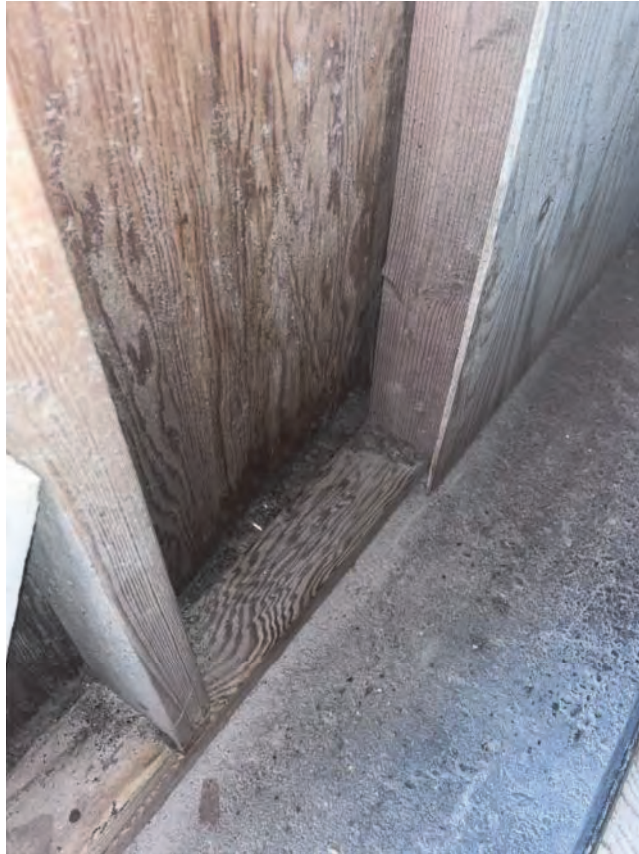
Building 37 - Damage to Sill Plate

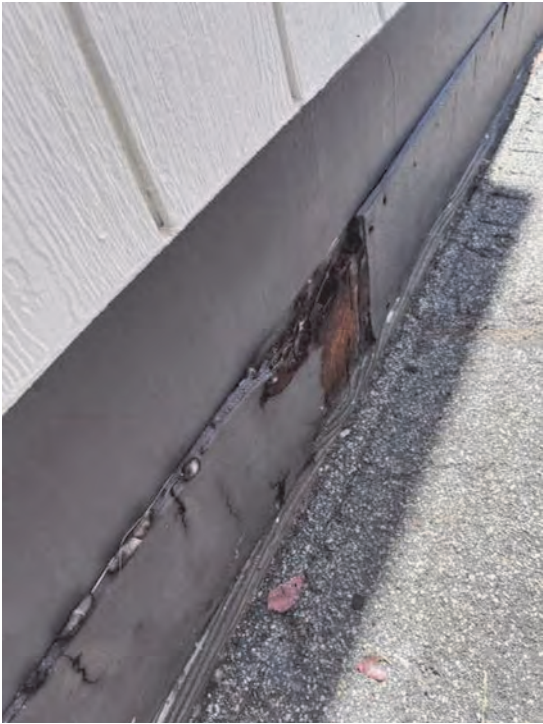
Damage to Plywood Skirting

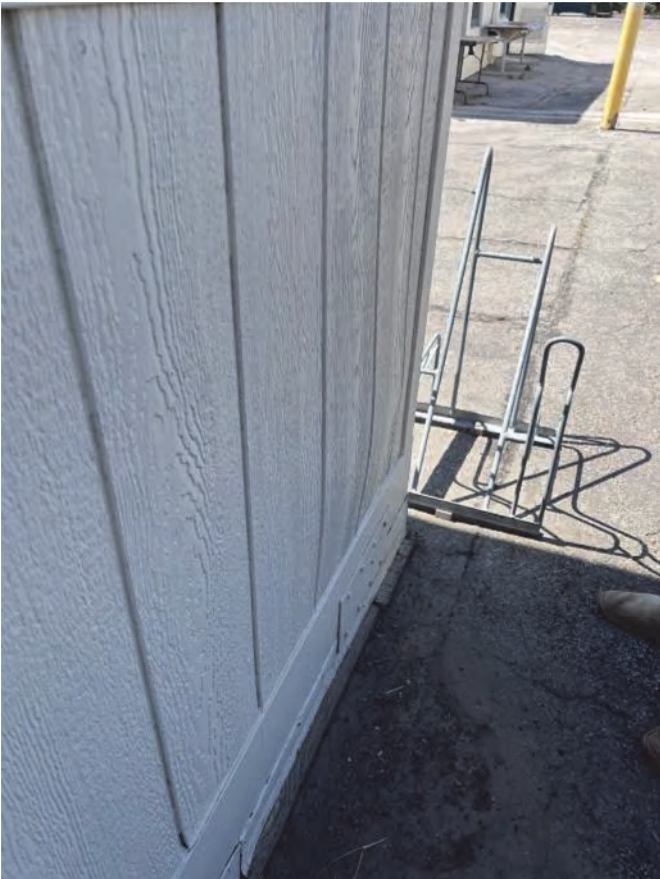
Damage to Metal Framing @ Foundation

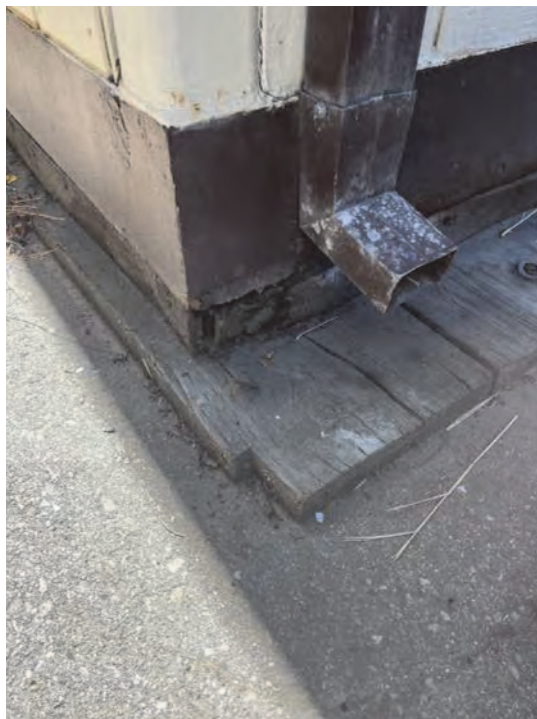
SUBJECT: 29 – Relocatable Classroom

Damage to Plywood Skirting

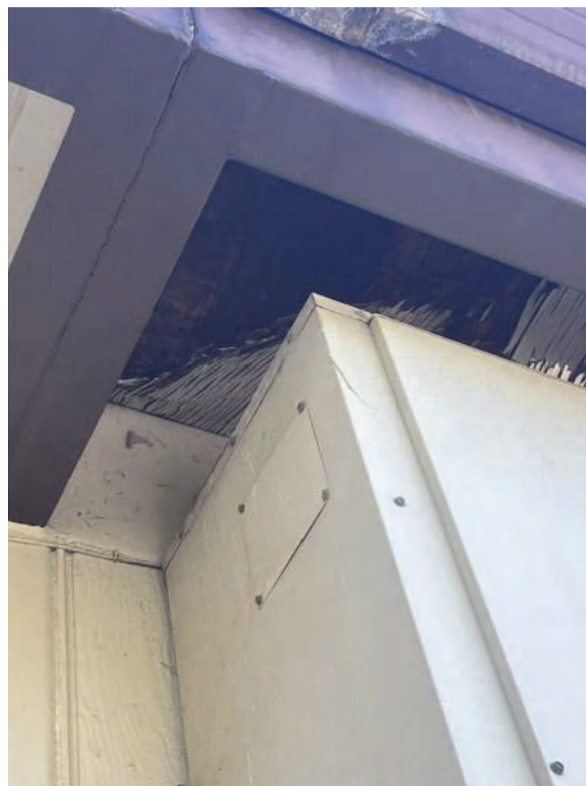
Damage to Plywood Roof Sheathing

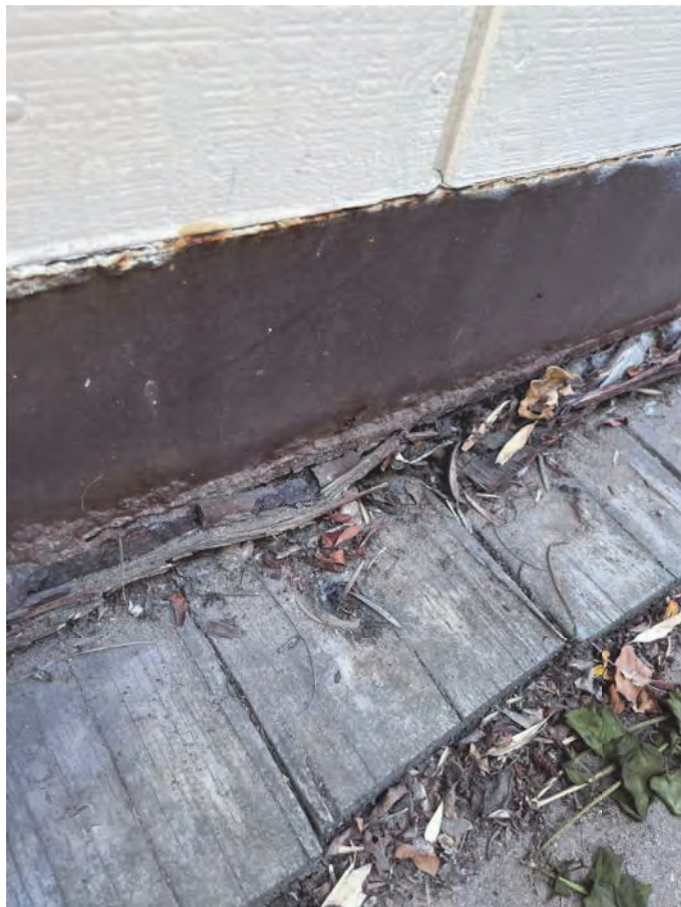
SUBJECT: 30 – Relocatable Classroom

Damage to Plywood Skirting/Wood Sill

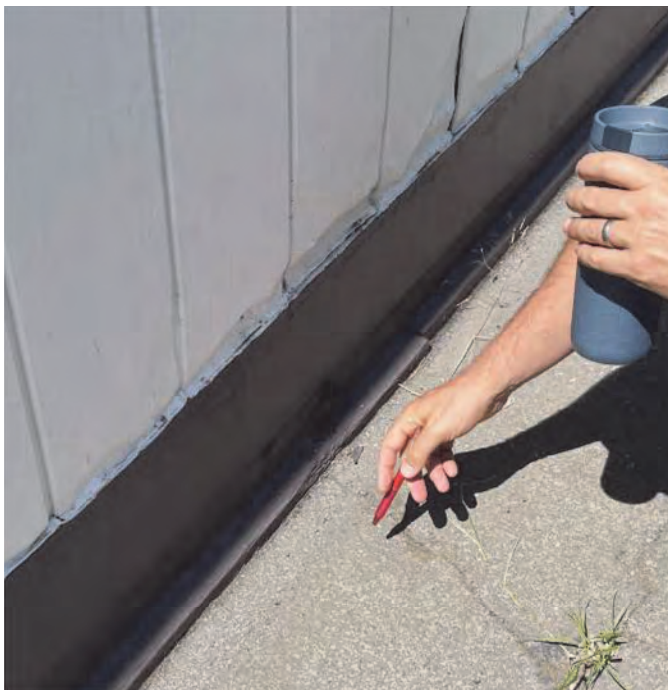
SUBJECT: 31 – Relocatable Classroom

Damage to Plywood Skirting

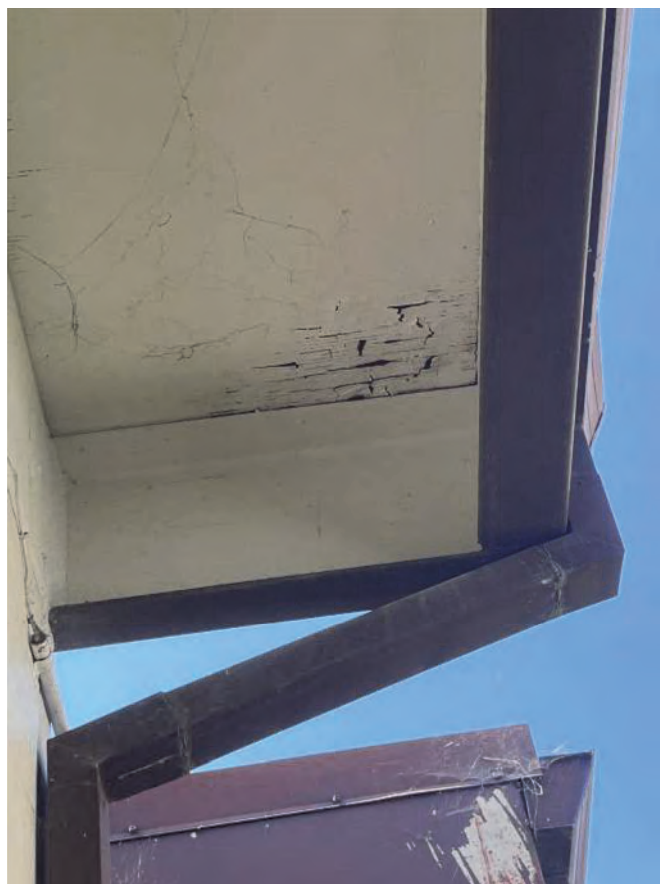
Damage to Plywood Roof Sheathing

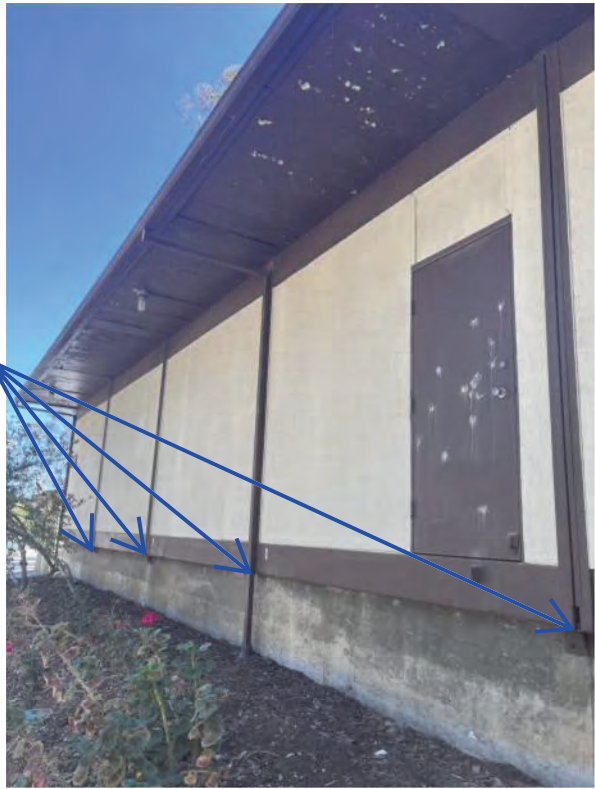
Inadequate Footing Anchorage

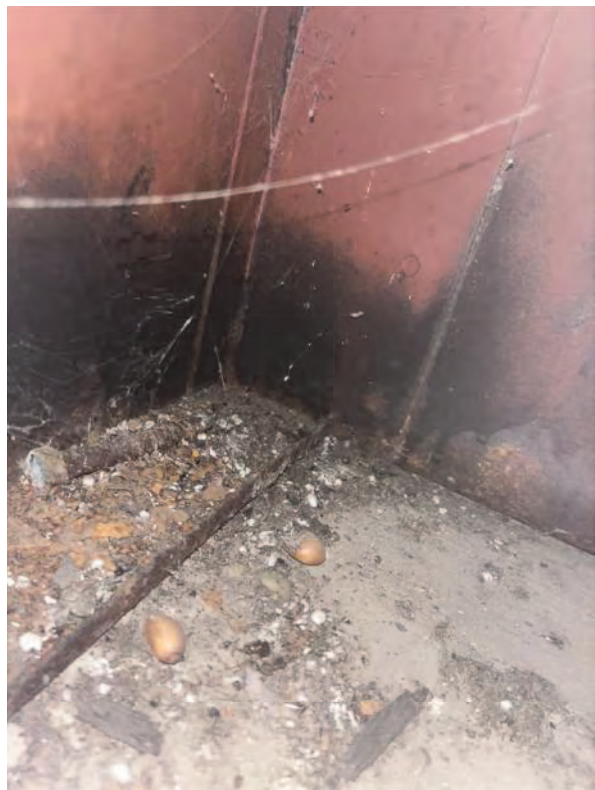
Slight Deterioration of Floor System on Footing

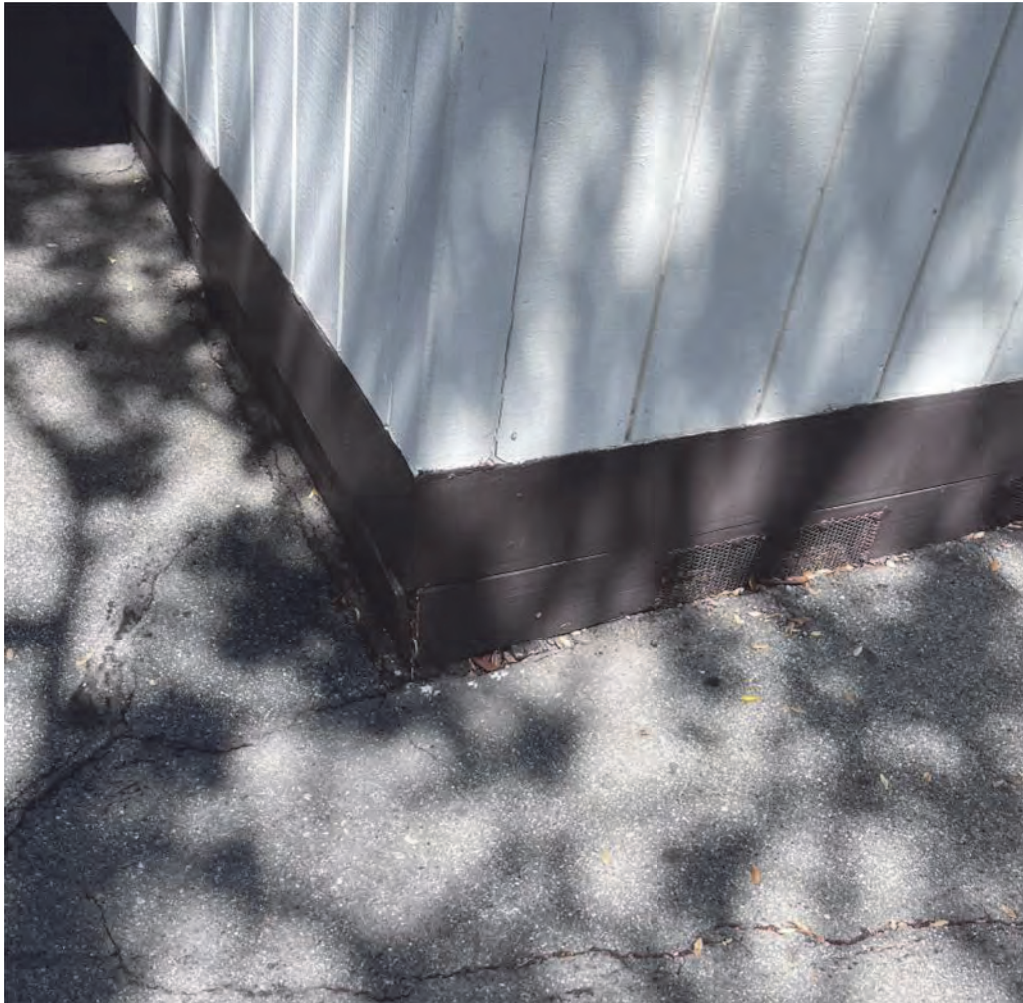
SUBJECT: 0032 – Relocatable 27

*Slight Deterioration of Wood Sill-On-Ground
and Cripple Wall Sheathing*

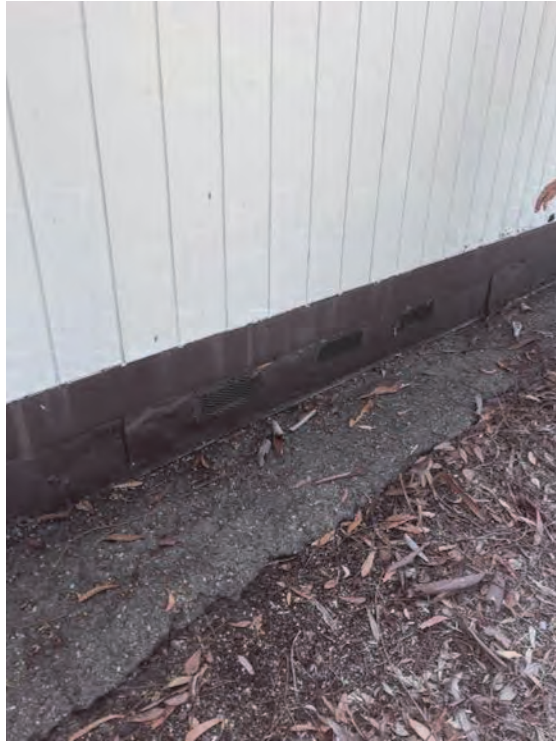
Slight Deterioration Cripple Wall Sheathing

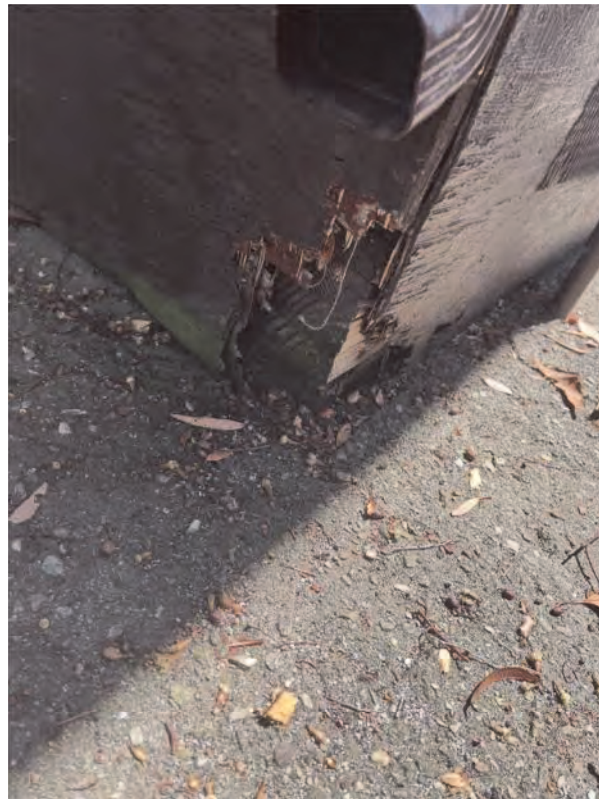
Slight Deterioration Cripple Wall Sheathing

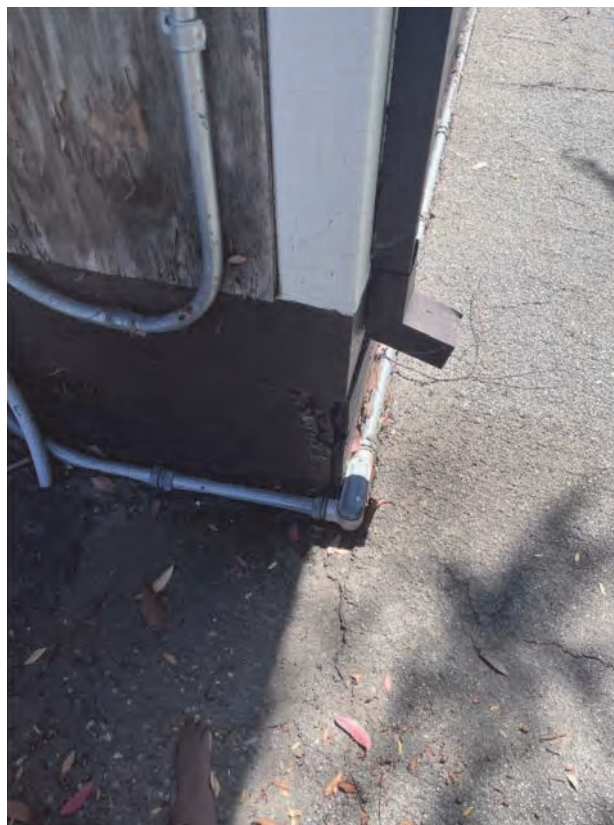
*Slight Deterioration to Cripple
Wall Sheathing*

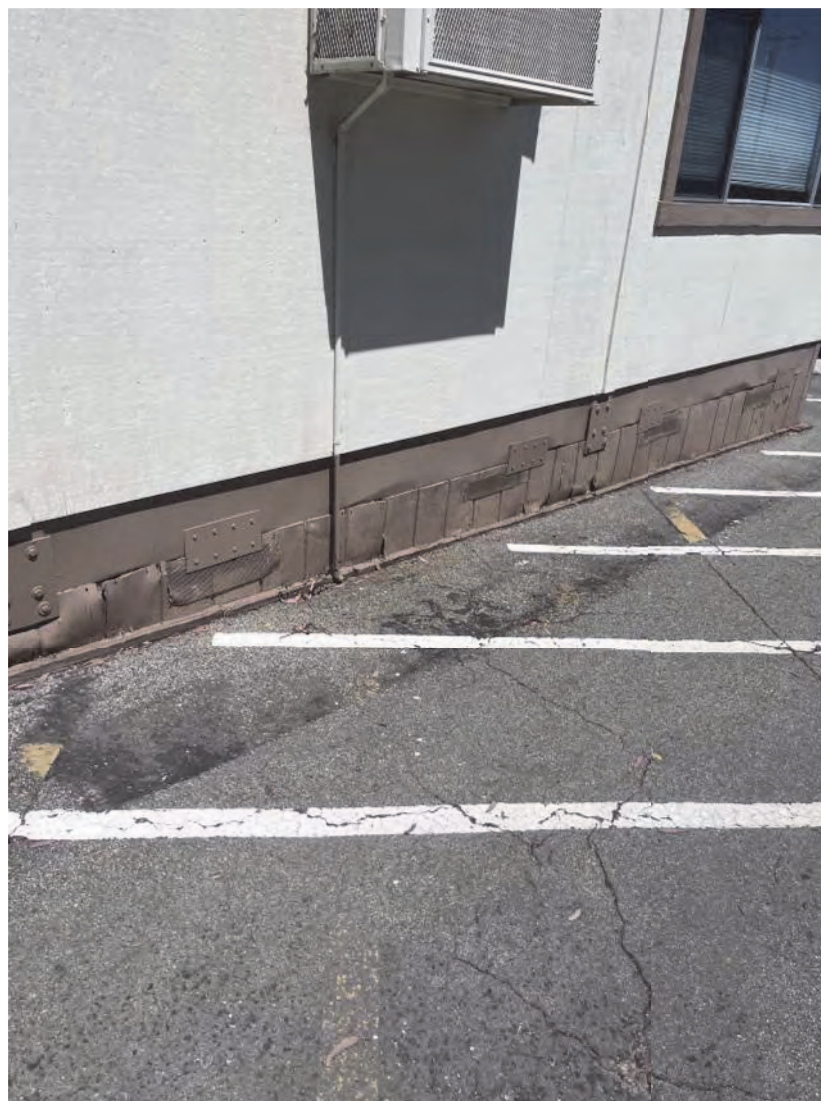
*Slight Deterioration of Cripple Wall
Sheathing*
