Santa Barbara City College

SBCC Campus & Building Assessments Report

April 2016

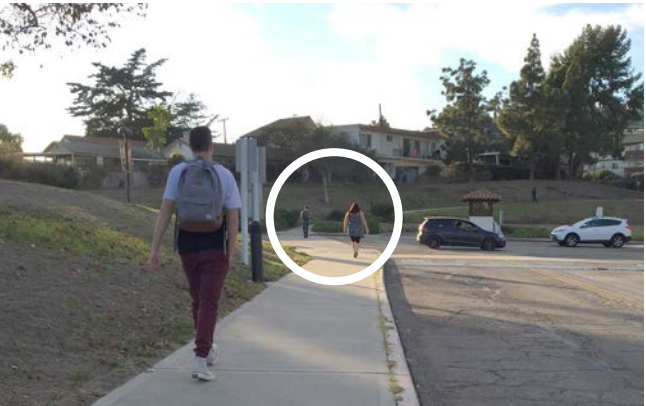
West Campus Entrance, desire line
 • Students walk dangerously in roadway.

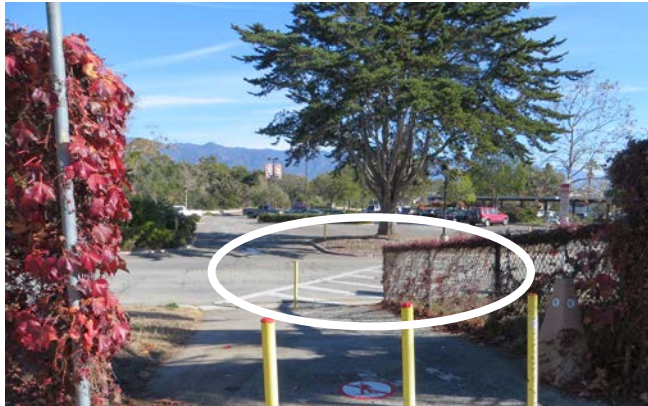
West Campus Entrance, sidewalk + crosswalk
 • Vehicles are not required to stop posing a hazard to pedestrians.

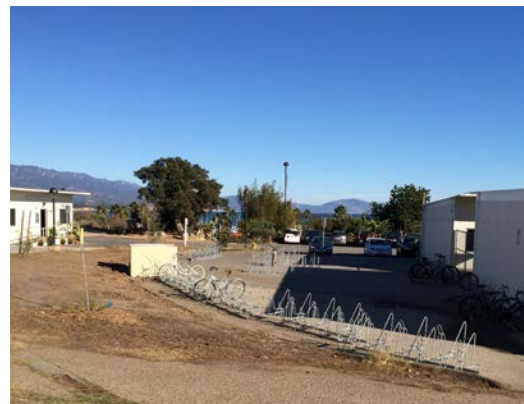
Tertiary pedestrian path, East Campus

- Tertiary paths are often in poor condition, and due to slope and materials, are noncompliant.

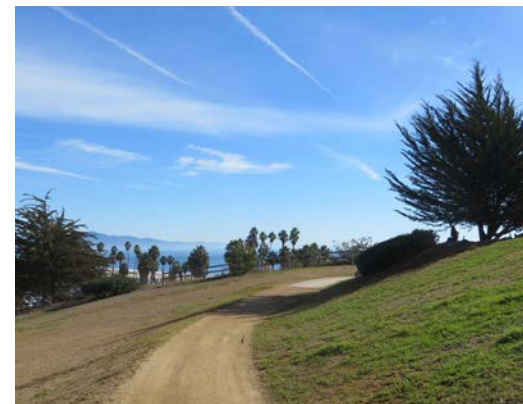
Garden path, Great Meadow

- Garden paths often lack proper drainage and are noncompliant.

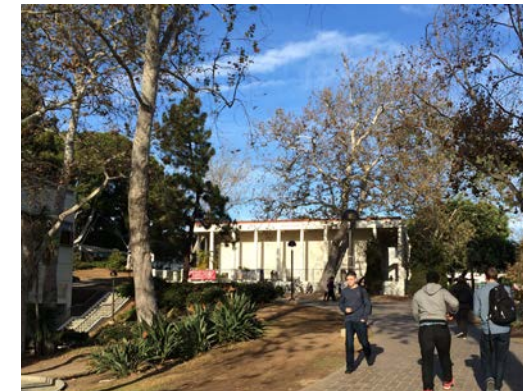
Primary pedestrian path, East Campus

- Paths along the main axis are often not wide enough, leading to adjacent landscape damage.

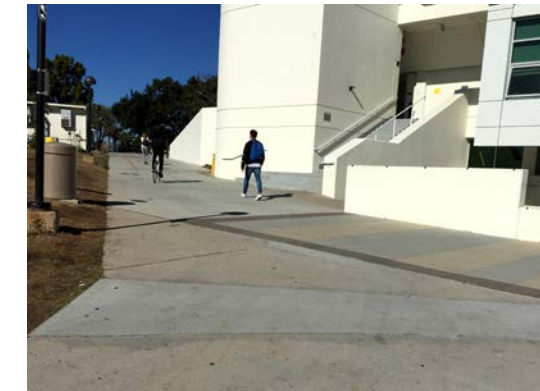
Secondary pedestrian path, East Campus

- Inconsistent paving material does not promote a clear hierarchy of pathways.

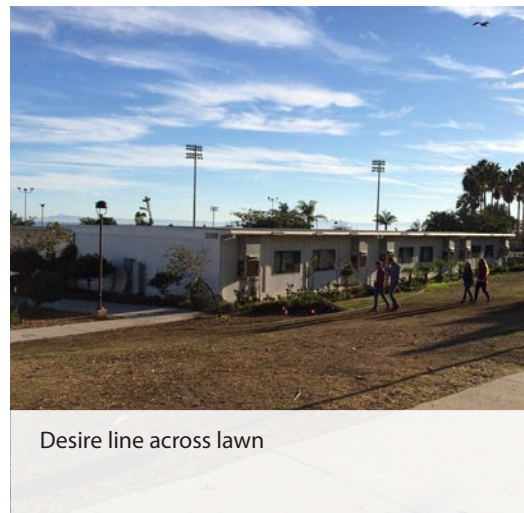
Desire line across lawn

- Students cut across the lawn in an area that lacks defined paths.

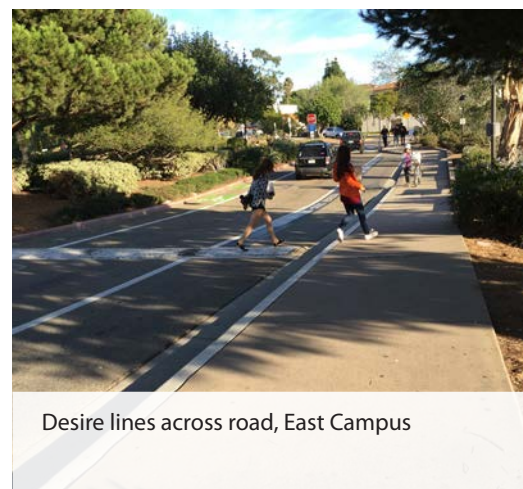
Desire lines across road, East Campus

- Students cross roads and parking lots when it provides the most direct route, causing safety hazards.

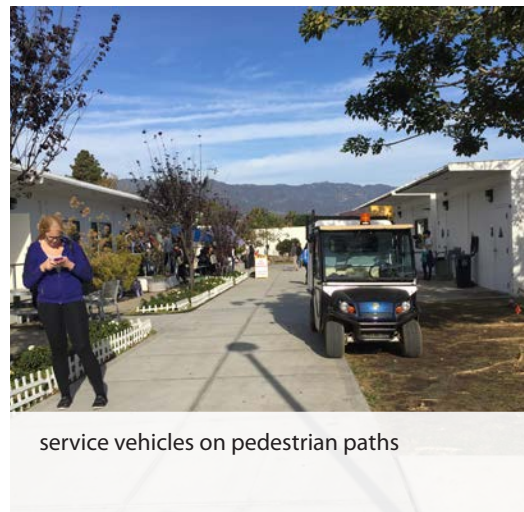
service vehicles on pedestrian paths

- Service vehicles use pedestrian paths, leading to adjacent landscape damage.

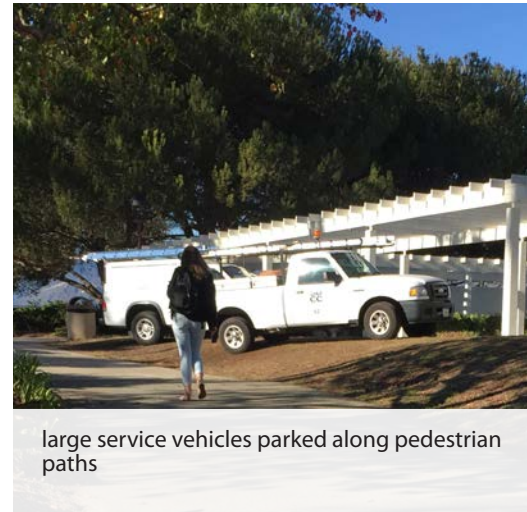
large service vehicles parked along pedestrian paths

- Large service vehicles cross pedestrian paths, causing potential paving and landscape damage and creating safety hazards.

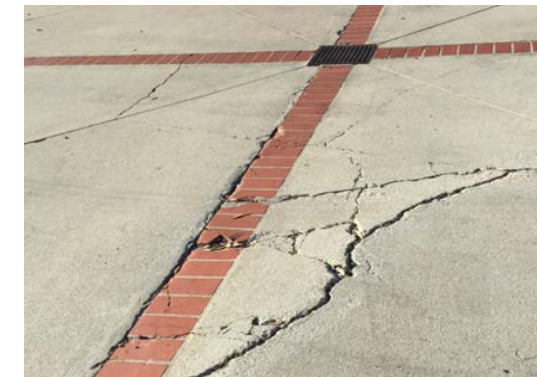
concrete with brick accents

- Some surfaces have moderate to severe cracking and uplifting.
- Concrete paving with brick accents is typically in fair to poor condition.

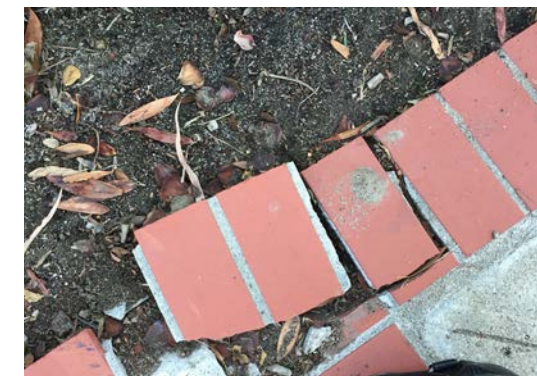
concrete with brick accents

- Failing paving edge with moderate to severe cracking and some loose and completely detached brick.
- Mortar joints have deteriorated along paving edge.

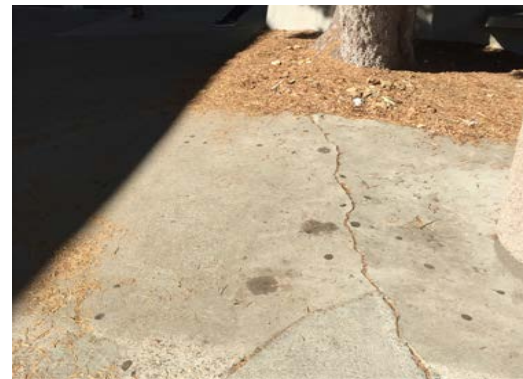
- In a few locations, trees are causing the concrete paving to crack and shift upward, creating a tripping hazard.

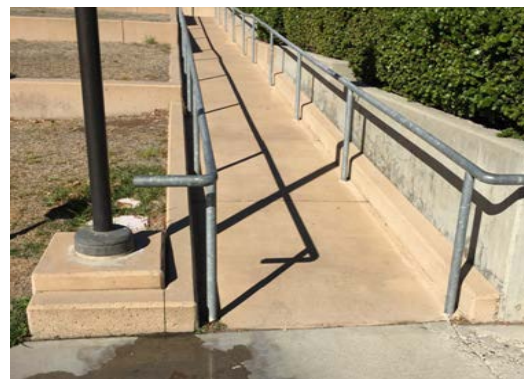
concrete with and without integral color

- Some surfaces are uneven and do not drain.
- Some expansion joints have minor to moderate cracking.

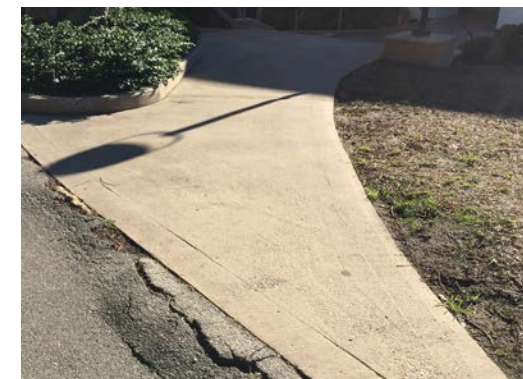
uneven surface and cracking at paving transition from asphalt to concrete

- Transitions from asphalt to other paving types are often uplifted and have moderate cracking, creating tripping hazards.

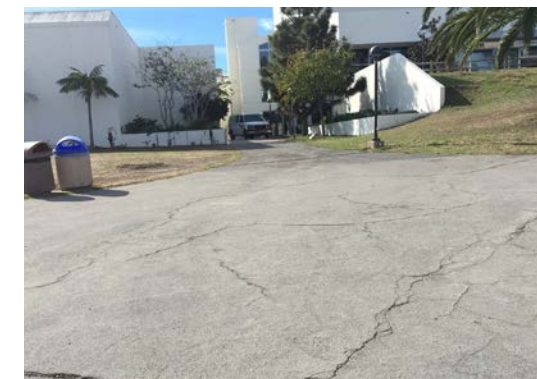
asphalt block cracking

- Many asphalt surfaces have minor to moderate block cracking, with some cracks larger than 1/4".

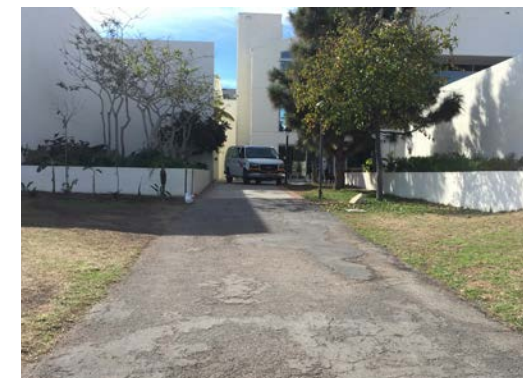
asphalt cracking and surface deterioration

- Some asphalt surfaces have moderate to severe cracking and deterioration.

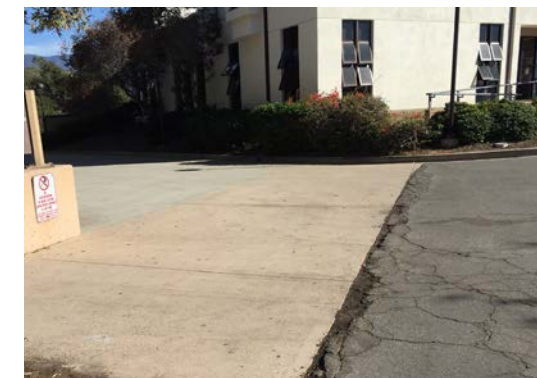
alligator cracking and deterioration at paving transition

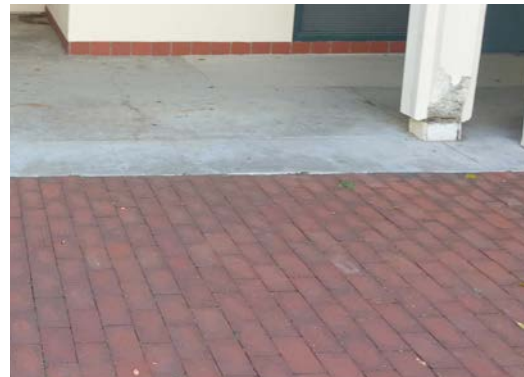
sand set brick

- Sand set brick requires additional maintenance for removal of weeds and debris.

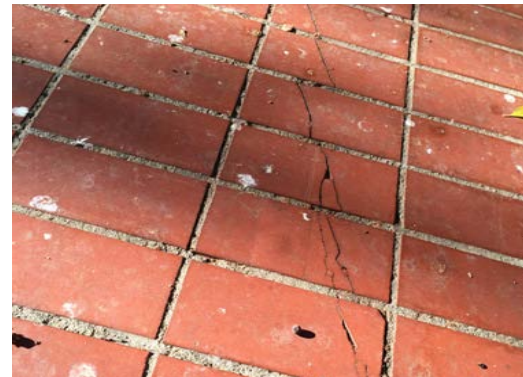
mortar set brick on concrete slab

- Aging mortar set brick has cracking and deterioration of grout joints.

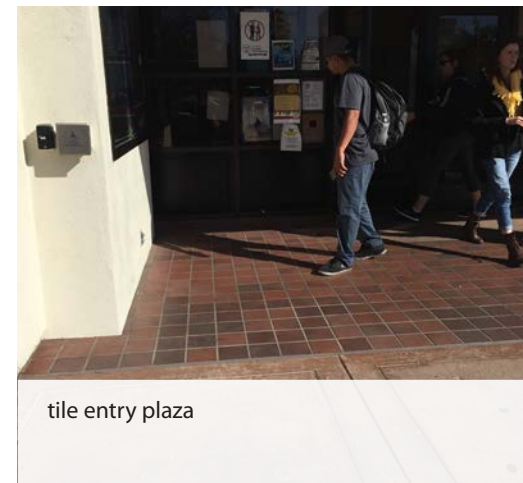
tile entry plaza

- Tile is used to pave the areas adjacent to doorways in building entry plazas.
- These entries are typically in fair condition.
- Tile typically does not comply with the coefficient of friction requirements for exterior installations and can get slippery.

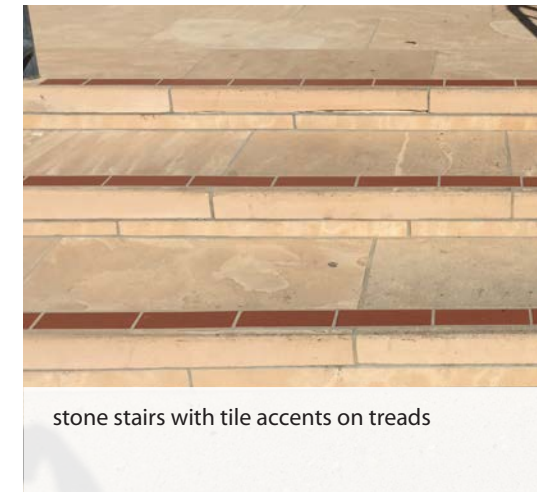
stone stairs with tile accents on treads

- Stone paving is used minimally. Santa Barbara sandstone is preferred type of stone on campus.
- Stair treads do not meet code. A grooved edge on treads is required.

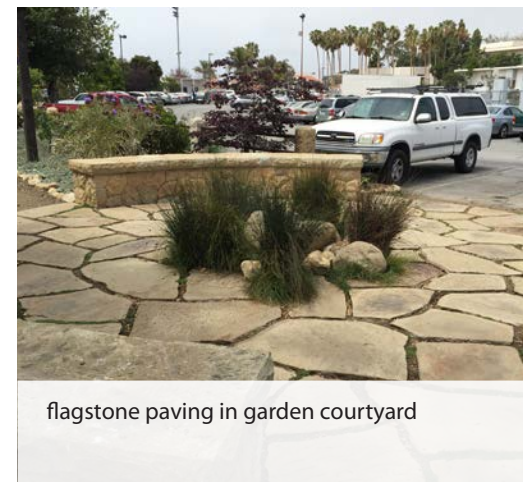
flagstone paving in garden courtyard

- Found at building entries, overlooks and gardens, the use of irregular stone pieces with wide joints in many places is more appropriate for a residential setting.
- Joints between stone pieces are typically wider than 1/4" and are non-compliant.

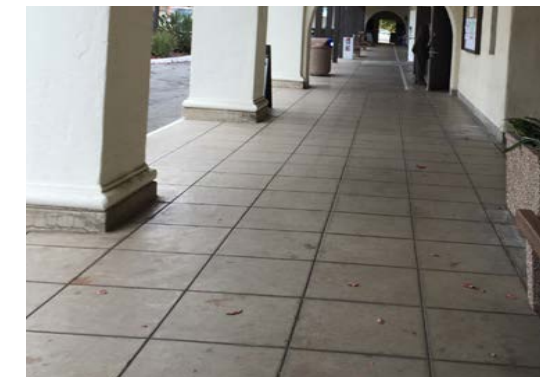
concrete arcade walk

- A small portion of the concrete paving in the arcaded walk has some minor cracking.
- Otherwise this paving is in good to fair condition.

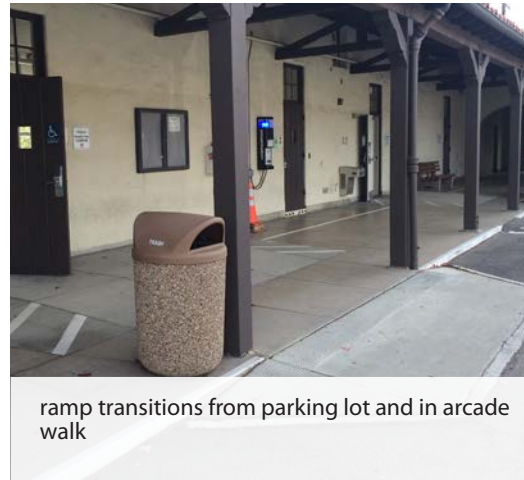
ramp transitions from parking lot and in arcade walk

- In most places, the arcade walk is only accessible by ramp, as it is 2-3" above adjacent parking lot paving.
- Some doors are also only accessible by ramp.

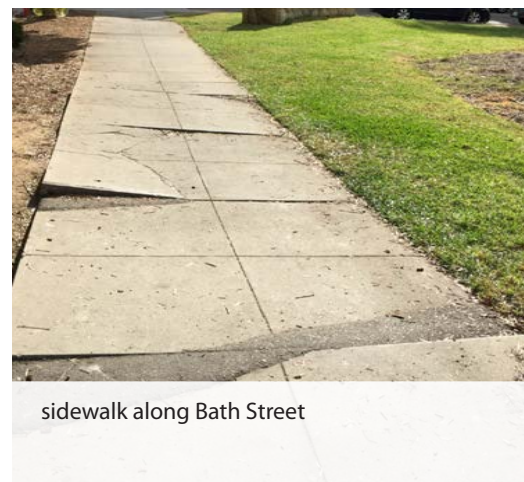
sidewalk along Bath Street

- The sidewalk has uplifting and poor patching, creating tripping hazards and accessibility issues.

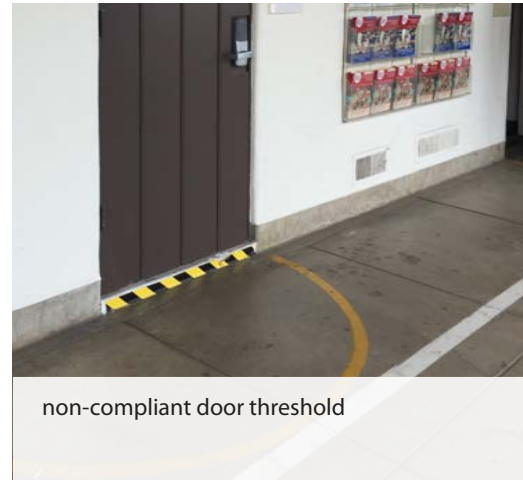
non-compliant door threshold

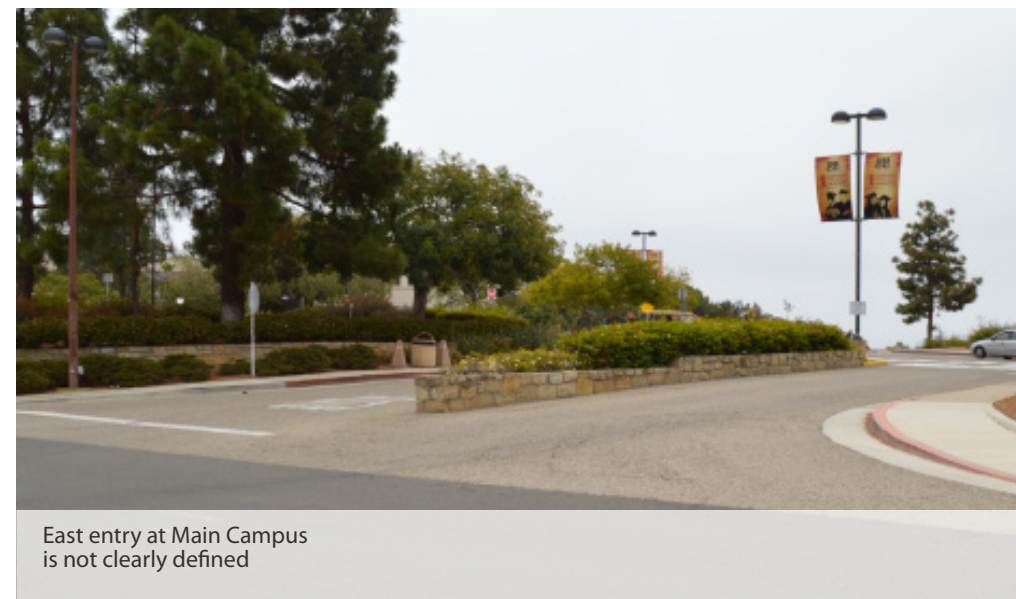
East entry at Main Campus is not clearly defined

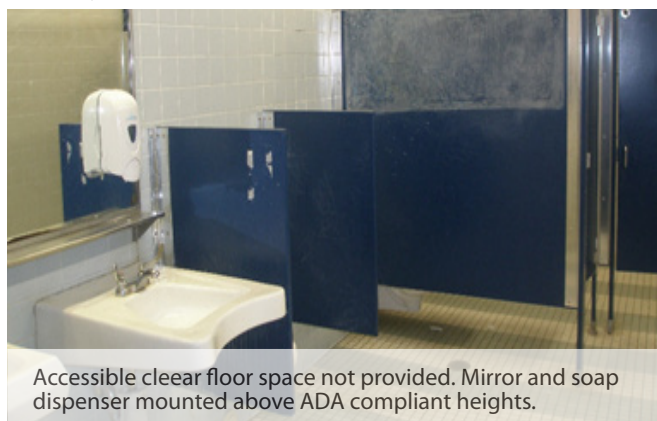
- The finishes are in fair condition, but are aging and in need of refurbishment. Multiple toilet partitions have been purposely defaced and should be replaced with products better suited to withstanding vandalism.
- Although the layout and configuration of the restrooms are relatively efficient, they were originally designed to meet 1988 ADA standards, and are unlikely to be in compliance with current codes. It is apparent that many components of the restroom no longer provide adequate accessible dimensional clearances.

Accessible clear floor space not provided. Mirror and soap dispenser mounted above ADA compliant heights.

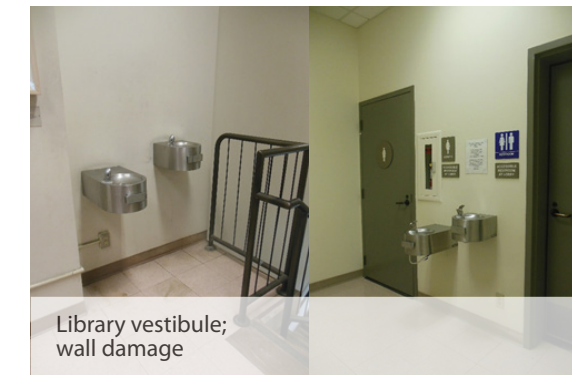
Library vestibule; wall damage

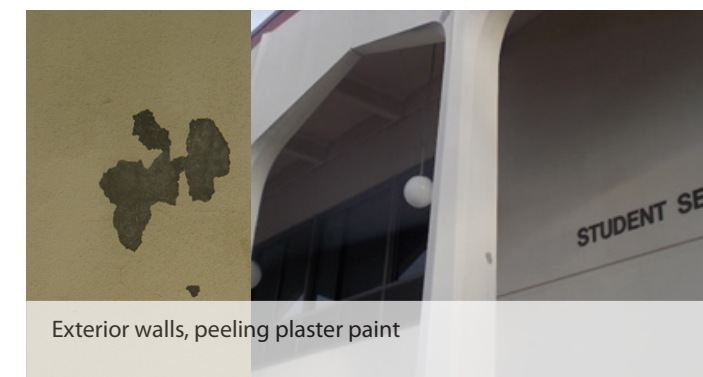
Exterior walls, peeling plaster paint
