SBCC Survey of Existing Buildings and Retrofit Plan

SANTA BARBARA CITY COLLEGE SEISMIC SURVEY

PRELIMINARY REPORT

May 31, 2023

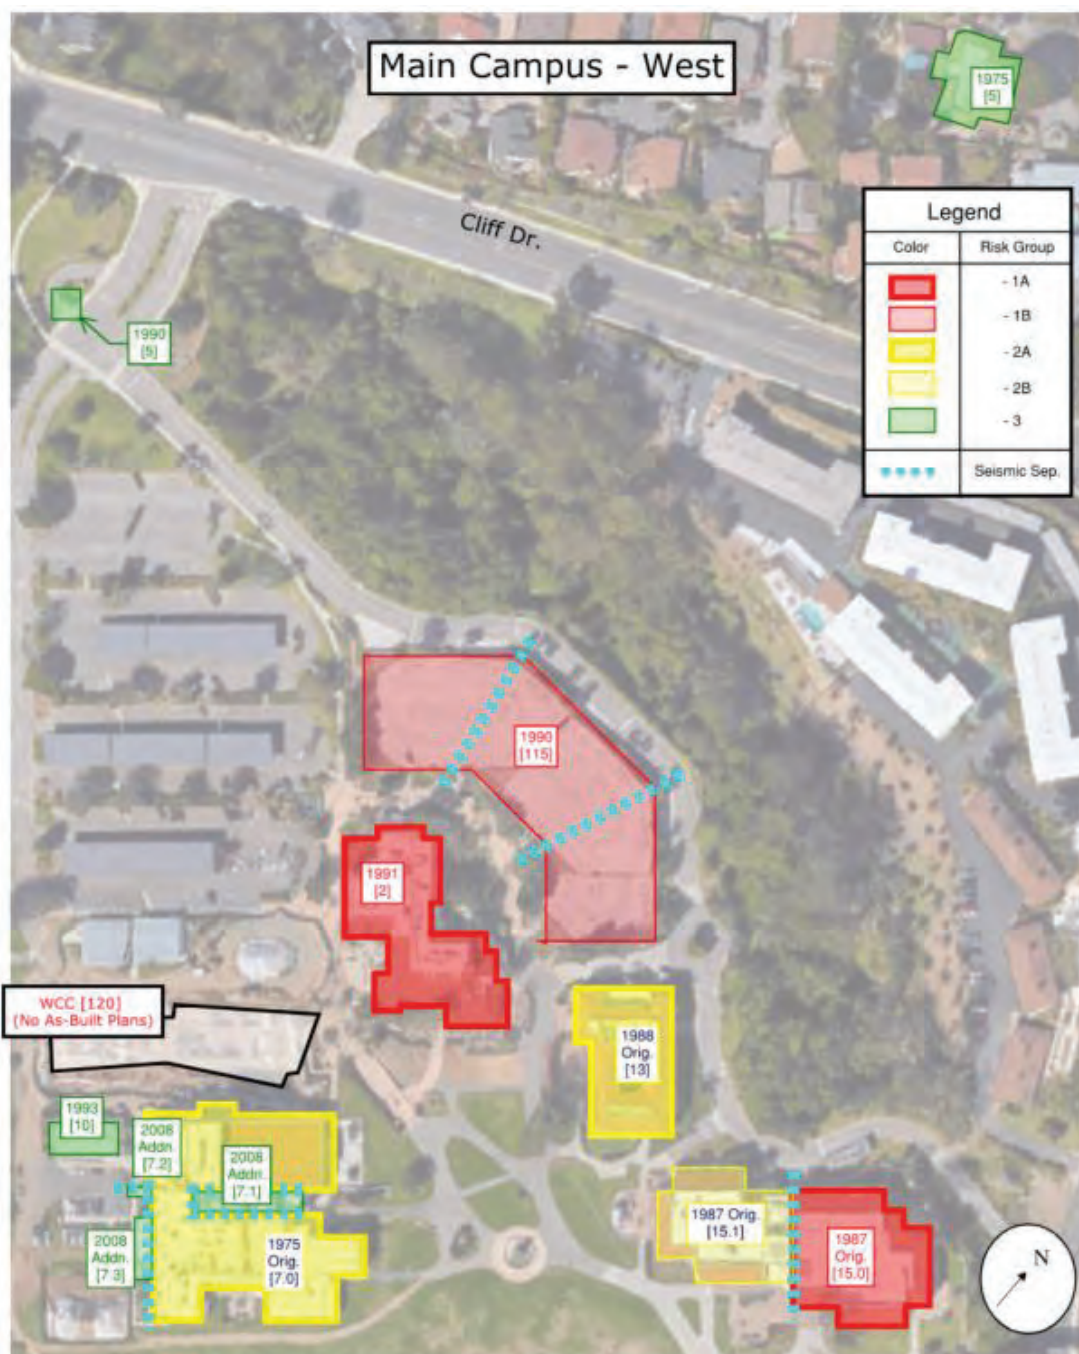
Seismic Risk Group	# of Structs.
1A	2
1B	1
2A	2
2B	1
3	4

Summary: The main campus-west had 12 independent structures surveyed. The most concerning structures include the parking structure (0115), the business/communications center (0002), and the library (0015.0) with the latter two of three having high occupancies. A combination of older construction, precast and formed concrete materials, and structural irregularities provide a high seismic risk. A more in-depth analysis is strongly recommended. The interdisciplinary center (0013), drama/music building (0007.0) and the learning center (0015.1) all have moderate seismic risk due to masonry/formed concrete materials and structural geometry. A more in-depth analysis should be conducted when possible.

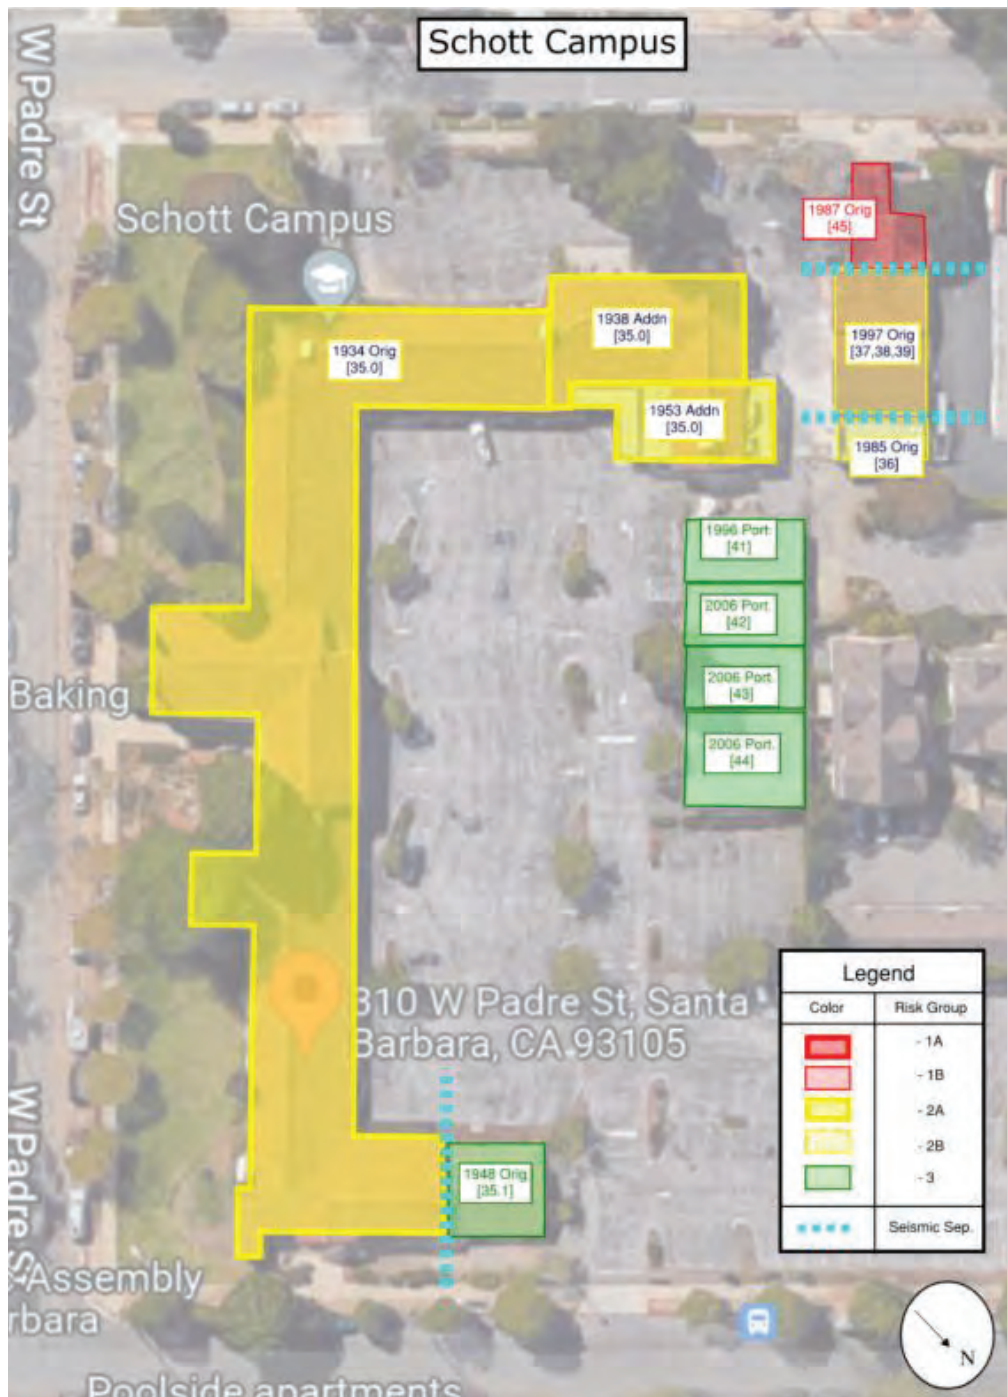
Schott Campus:

Seismic Risk Group	# of Structs.
1A	0
1B	1
2A	1
2B	2
3	5

Summary: The Schott campus had 9 independent structures surveyed. The most at-risk structure was the maintenance garage located on the southwest corner of the property. A combination of older construction, masonry materials, and structural irregularities provide a higher seismic risk. A more in-depth analysis is strongly recommended. The Schott center, kiln building, ceramics lab and grounds 5 all have moderate seismic risk due to structural irregularities and age, but are wood framed.

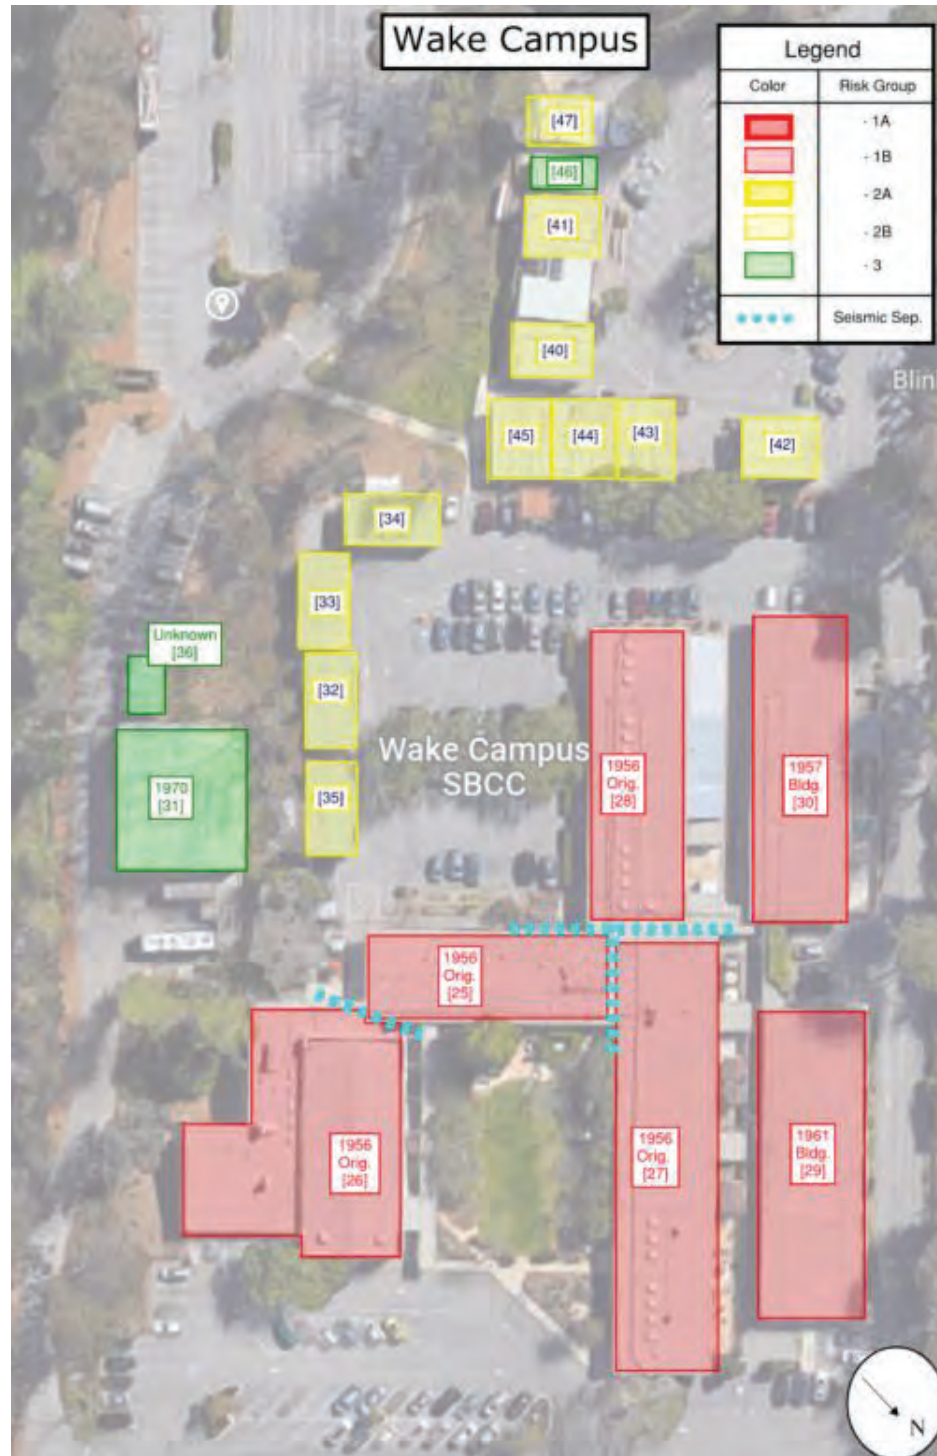
Wake Campus:

Seismic Risk Group	# of Structs.
1A	0
1B	6
2A	0
2B	11
3	3

Summary: The Wake campus had 20 independent structures surveyed. The most concerning structures include the administration, multipurpose, classrooms 1-6, classrooms 7-10, classrooms 11-14, and classrooms 15-18. A combination of older construction, masonry materials, and lack of shear connection from the roof to the walls provide a high seismic risk. A more in-depth analysis is strongly recommended. The remaining structures are modular in construction. Modular structures assigned to Group 2B should be assessed for permit issuance but does not necessarily pose a seismic risk.

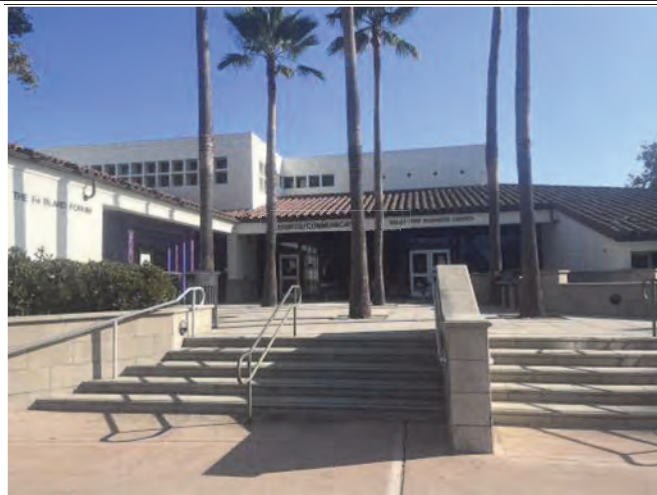
Address: 721 Cliff Dr.
Santa Barbara, CA Zip: 93109
 Other Identifiers: Main Campus West 0002 (from 2018 Fusion Report)
 Building Name: Business/Communications Center
 Use: Classrooms/Offices
 Latitude: 34.40407 Longitude: -119.70182
 Ss: 2.238 Sr: 0.803
 Screener(s): Sage Shingle/Dylan Thompson Date/Time: 09.16.2022/8:30am

COMMENTS:
 Three story steel framed structure with steel and metal deck roof, light gage steel walls, supported on a slab-on-grade foundation system. Tube steel braced frames over concrete shear walls seismic system. Concrete filled metal deck floor diaphragm and bare metal deck sheathing roof diaphragm. In-plane setbacks of the seismic system were discovered along gridlines 2 & 7 and out-of-plane setbacks were discovered along gridlines 3.2, 3.4, 7, H, G, B, and diagonal between B & B.1 (concrete deck used as force distribution). A re-entrant corner exists in the North-West corner of the structure.
 Site Conditions Observed:
 No observed signs of significant structural damage or deterioration.
 Additional sketches or comments on separate page

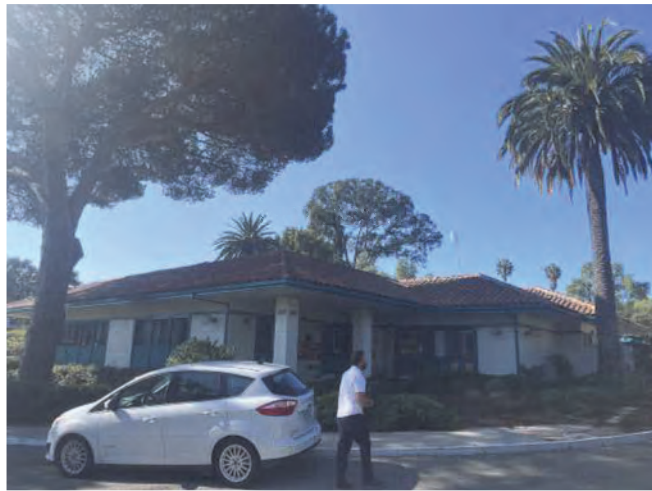
Address: 365 Loma Alta Dr.
Santa Barbara, CA Zip: 93109
 Other Identifiers: Main Campus West 0005 (from 2018 Fusion Report)
 Building Name: Orfalea Early Learning Center
 Use: Classrooms and offices
 Latitude: 34.40686 Longitude: -119.70290
 Ss: 2.234 Sr: 0.802
 Screener(s): Sage Shingle/Dylan Thompson Date/Time: 09.16.2022/10:00am

COMMENTS:
 Single-story structure with wood-framed roof and walls supported on a slab-on-grade foundation system. Wood shearwall seismic system, with plaster for shear resistance. 1x diagonal sheathing for roof diaphragm. Small re-entrant corners exist on each corner of the building (less than 20ft).
 Site Conditions Observed:
 No observed signs of significant structural damage or deterioration.

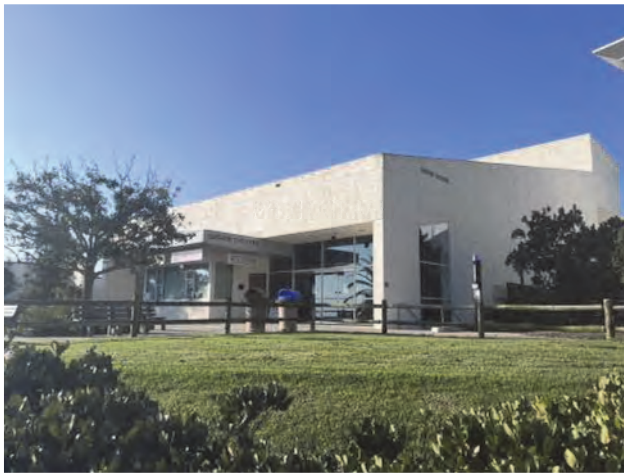
Address: 721 Cliff Dr.
Santa Barbara, CA Zip: 93109
 Other Identifiers: Main Campus West 0007 (from 2018 Fusion Report)
 Building Name: Drama/Music
 Use: Offices, Classrooms, and Auditorium
 Latitude: 34.40307 Longitude: -119.70143
 Ss: 2.239 Sr: 0.804
 Screener(s): Sage Shingle/Dylan Thompson Date/Time: 09.16.2022/9:30am

COMMENTS:
 Three-story above basement structure with steel framed roof and reinforced CMU walls supported on a slab-on-grade foundation system. Reinforced CMU wall seismic system. Reinforced concrete slab for floor diaphragm and concrete filled metal deck for roof diaphragm. A re-entrant corner exists in the courtyard between grids 6 & 9.
 Site Conditions Observed:
 No observed signs of significant structural damage or deterioration.
 Additional sketches or comments on separate page

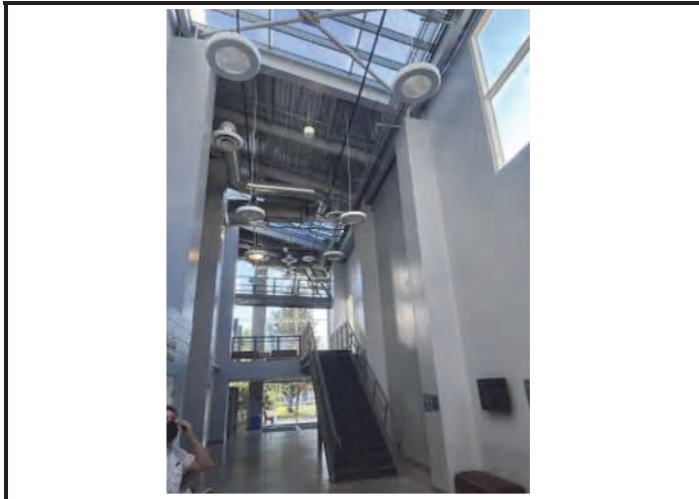
Address: 721 Cliff Dr.
Santa Barbara, CA Zip: 93109
 Other Identifiers: Main Campus West 0007.1 (from 2018 Fusion Report)
 Building Name: Drama/Music Lower Lobby Addition
 Use: Dress Room and Lobby Roof
 Latitude: 34.40307 Longitude: -119.70143
 Ss: 2.239 Sr: 0.804
 Screener(s): Sage Shingle/Dylan Thompson Date/Time: 09.16.2022/9:30am

COMMENTS:
 Single-story structure infill between grids 6 & 8 with steel wide flange framed roof and walls supported on a grade-beam foundation system. Steel wide flange moment frame seismic system typical with 3-sided, 2 floor braced frame elevator shaft. Seismic separation joints were present on all sides shared with the existing building. Light gage metal decking for roof diaphragm.
 Site Conditions Observed:
 No observed signs of significant structural damage or deterioration.
 Additional sketches or comments on separate page

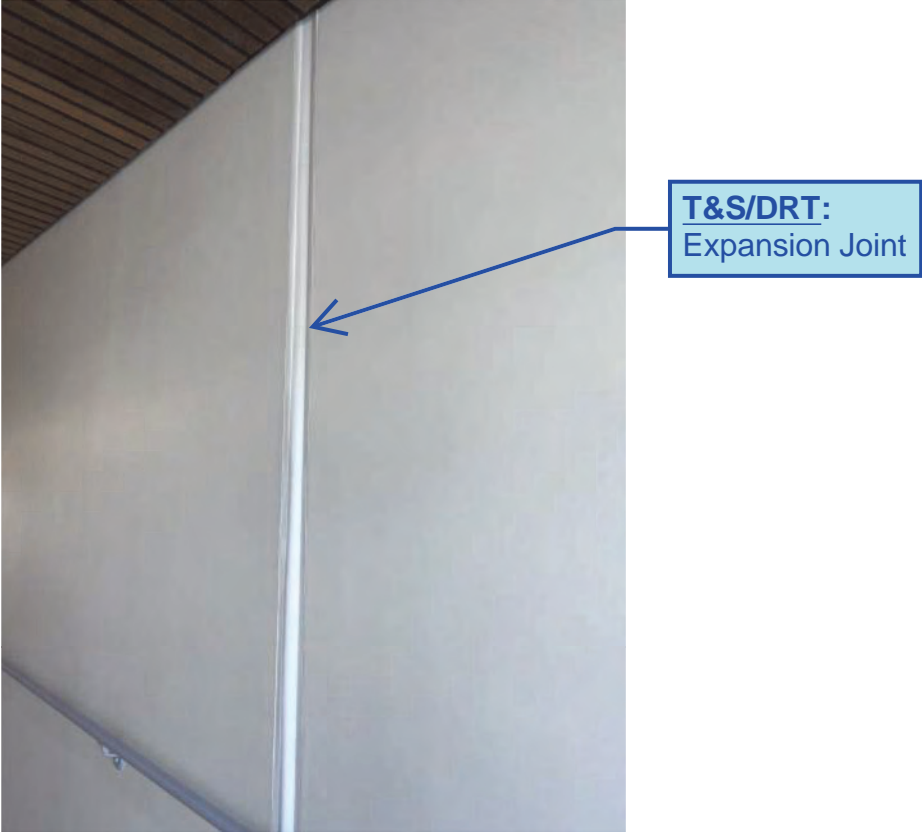
Seismic Separation @ 0007

COMMENTS:
 Single-story structure with steel tube framed roof and light gage steel stud walls supported on a grade-beam & slab-on-grade foundation system. Steel tube cantilever column seismic system. Seismic separation joints were present on all sides shared with the existing building. Light gage metal decking for roof diaphragm.
 Site Conditions Observed:
 No observed signs of significant structural damage or deterioration.
 Additional sketches or comments on separate page

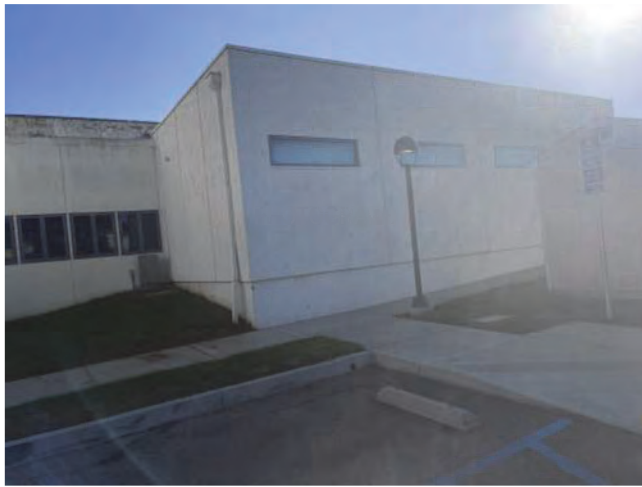
COMMENTS:
 Single-story structure with steel wide flange framed roof and light gage steel stud walls supported on a slab-on-grade foundation system. Light gage steel shearwall seismic system, with plywood for shear resistance. A seismic separation joint was present on the side shared with the existing building. Light gage metal decking for roof diaphragm.
 Site Conditions Observed:
 No observed signs of significant structural damage or deterioration.
 Additional sketches or comments on separate page

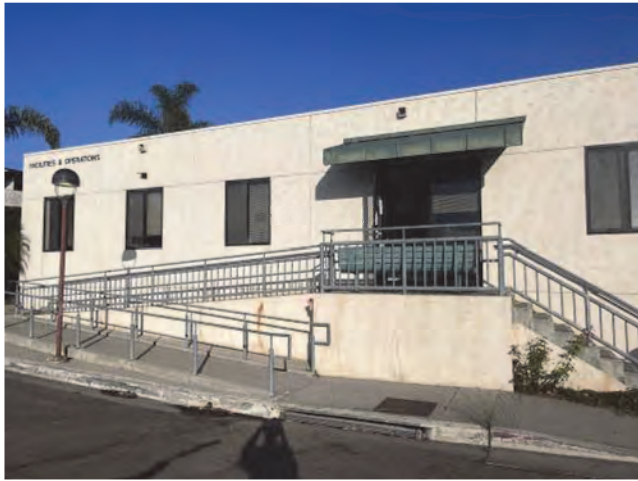
COMMENTS:
 Single-story structure with wood-framed roof and walls supported on a slab-on-grade foundation system. Wood shearwall seismic system, with plywood for shear resistance. Plywood sheathing for roof diaphragm.
 Site Conditions Observed:
 No observed signs of significant structural damage or deterioration.

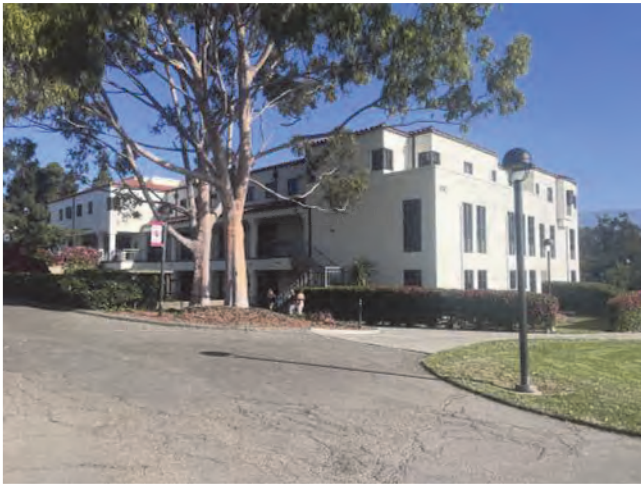
COMMENTS:
 Three-story structure with reinforced CMU walls at the first and second floor, steel framed structure above with light gage steel walls, and supported on a slab-on-grade foundation system. Wide Flange steel moment frame over reinforced masonry shear walls for the seismic system. Concrete filled metal deck floor diaphragm and bare metal deck roof diaphragm.
 Site Conditions Observed:
 No observed signs of significant structural damage or deterioration.
 Additional sketches or comments on separate page

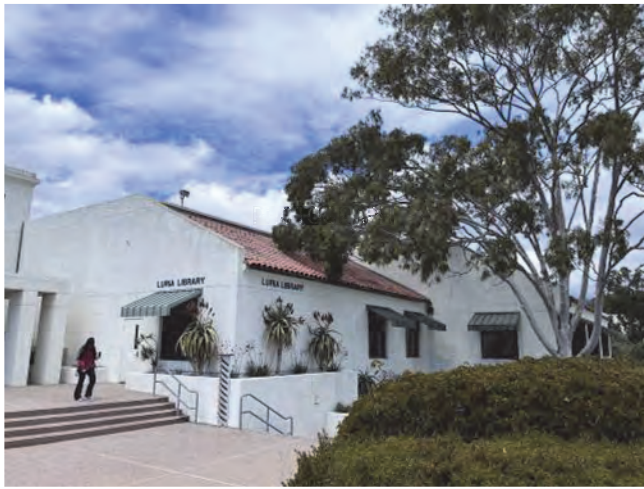
COMMENTS:
 Two-story structure with steel wide flanged framed roof, concrete waffle slab floor and steel stud framed walls supported on a slab-on-grade foundation system. Steel moment frame above reinforced concrete foundation wall seismic system. Light gage metal deck sheathing for roof diaphragm, reinforced concrete slab for floor diaphragm. Seismic separation was present between the library and learning resource center. Along gridline 9 & B, a moment frame on the upper floor is outboard of concrete walls below, causing a severe out-of-plane setback. Along gridline C, a moment frame does not stack over a concrete wall below causing an in-plane setback. Re-entrant corners exists on north-east, north-west and south-west corners of the structure.

Site Conditions Observed:
 No observed signs of significant structural damage or deterioration.
 Additional sketches or comments on separate page

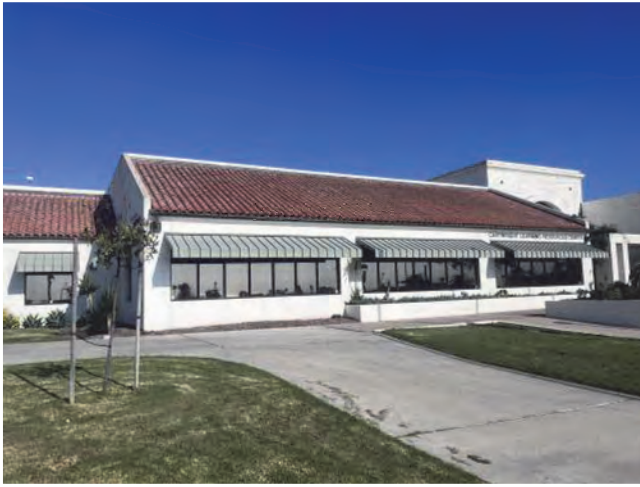
COMMENTS:
 Single-story structure with steel wide flanged roof and steel stud framed walls supported on a slab-on-grade foundation system. Steel moment frame seismic system. Light gage metal deck sheathing for roof diaphragm. Seismic separation was present between the library and learning resource center. Re-entrant corners exists on south-west and south-east corners of the structure.

Site Conditions Observed:
 No observed signs of significant structural damage or deterioration.

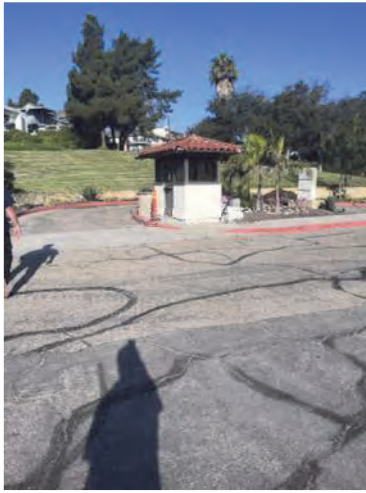
COMMENTS:
 Single-story structure with wood-framed roof and walls supported on a slab-on-grade foundation system. Wood shearwall seismic system, with plywood for shear resistance. Plywood sheathing for roof diaphragm.
 Site Conditions Observed:
 No observed signs of significant structural damage or deterioration.

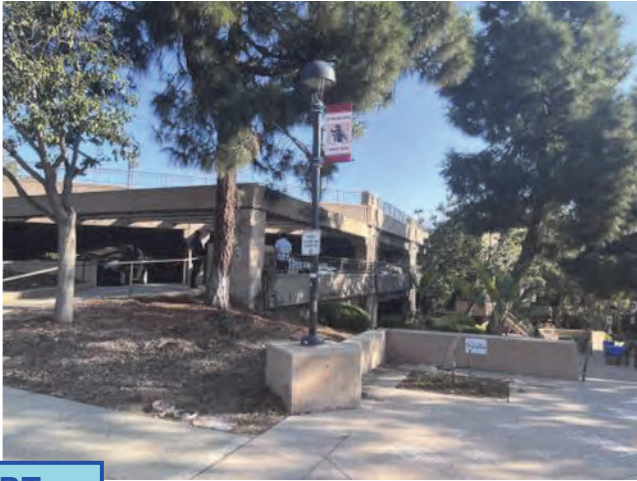
COMMENTS:
 Four-story structure with pre-cast concrete framed floor and roof supported on a slab-on-grade foundation system. Reinforced cast-in-place concrete shearwall seismic system. Reinforced concrete topping slab for diaphragm.
 Site Conditions Observed:
 No observed signs of significant structural damage or deterioration.
 *Inadequate precast concrete beam ties to walls/interior beams
 Additional sketches or comments on separate page

Comments: Inadequate ties from interior precast concrete beams to concrete walls/exterior precast concrete beams is justification for moderate vertical irregularity.

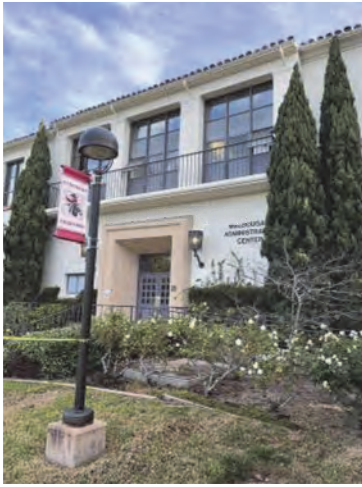
COMMENTS:
 Two-story structure with reinforced concrete slab over reinforced concrete joists for roof and floor and cast-in-place concrete walls/columns supported on a slab-on-grade foundation system. Reinforced concrete shearwall seismic system. Reinforced concrete deck over steel/concrete joists for roof and floor diaphragm. Along the west wall line of the corridor over arcade that runs north south, a concrete shear wall does not stack over a wall below and an in-plane offset is present. The roof of the auto shop located at the south west wing of the structure does not line up with the roof or second floor level, and as such a split level irregularity occurs. Re-entrant corners exist on the north-east and north-west corners of the structure.

Site Conditions Observed:
 No observed signs of significant structural damage or deterioration.
 Additional sketches or comments on separate page

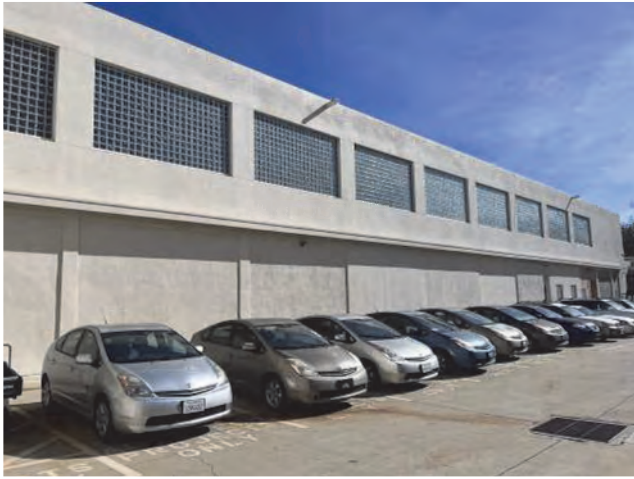
Site Conditions Observed:
 No observed signs of significant structural damage or deterioration.

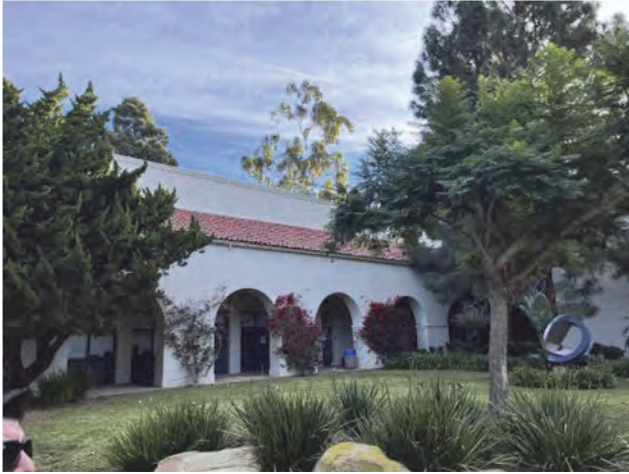
COMMENTS:
 Two-story structure with reinforced concrete slab over reinforced concrete joists for roof and cast-in-place concrete walls/columns supported on a slab-on-grade foundation system. Reinforced concrete shearwall seismic system. Reinforced concrete deck for roof and floor diaphragm. Concrete shear walls along gridline C at the upper floor are inboard of concrete shear walls below, causing an out-of-plane setback. The lack of seismic strength at the upper floor along gridline B, and the lack of seismic strength at the lower floor along gridline D both cause a torsional irregularity. The seismic separation to the main administration building is only 2" (less than 2" per story or 4" total) and the building sits at the end of a block of structures, so pounding is still a concern.

Site Conditions Observed:
 No observed signs of significant structural damage or deterioration.
 Additional sketches or comments on separate page

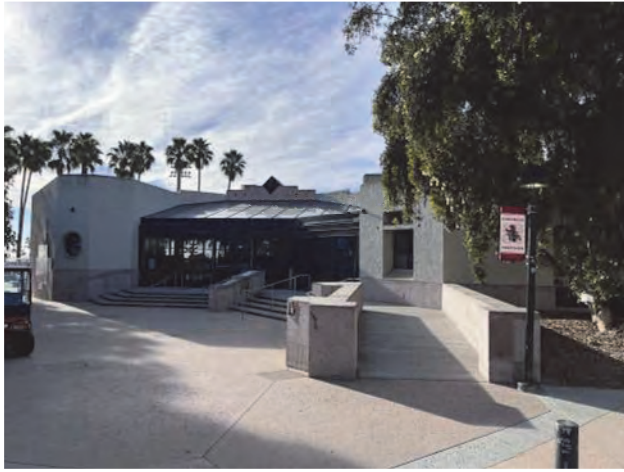
COMMENTS:
 Two-story structure with steel-framed roof and floor and light gage steel or reinforced masonry walls supported on a slab-on-grade foundation system. Tube steel braced frame over reinforced masonry shearwall seismic system. Concrete filled metal deck for roof and floor diaphragm. Along gridline 'W 480'-0", a brace frame at the upper floor does not stack over a masonry shear wall below causing an out-of-plane setback. Re-entrant corners exists at the entrance and south face of the building. Brace frames at the upper floor are non-orthogonal to each other (some facing N-S while others are N 45° E) causing a non-parallel systems irregularity.
 Site Conditions Observed:
 No observed signs of significant structural damage or deterioration.
 Additional sketches or comments on separate page

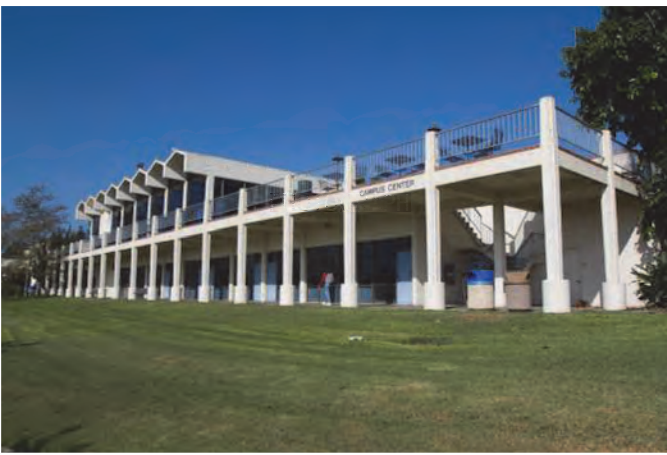
COMMENTS:
 Two-story structure with cast-in-place concrete floor, pre-cast concrete roof and cast-in-place concrete walls supported on a slab-on-grade foundation system. Reinforced concrete shearwall seismic system. Reinforced concrete topping slab for roof diaphragm and reinforced concrete deck for floor diaphragm. A concrete shear wall at the upper floor located along gridline 2 is inboard of the concrete shear walls at the level below, causing an out-of-plane setback. There are re-entrant corners at the east and west corners of the upper structure.

Site Conditions Observed:
 No observed signs of significant structural damage or deterioration.
 Additional sketches or comments on separate page

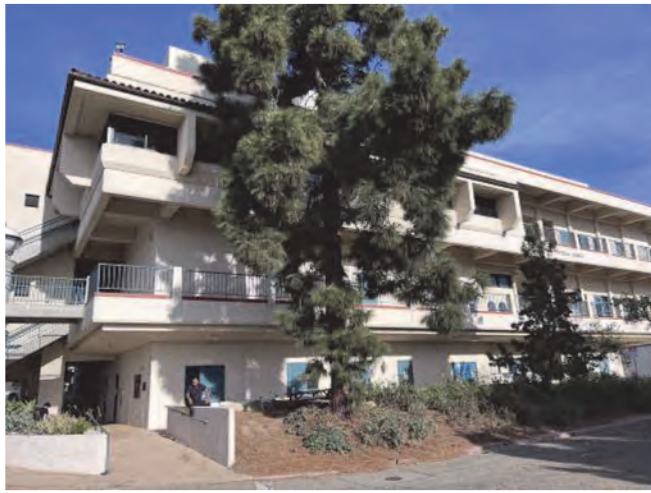
COMMENTS:
 Three-story structure with concrete encased steel-framed floor and roof and steel columns supported on a slab-on-grade foundation system. Tube steel braced frame over reinforced fully grouted masonry shearwall seismic system. Reinforced concrete slab for floor and roof diaphragm. A comprehensive seismic retrofit occurred in 2000, along with an exterior stair addition.
 Site Conditions Observed:
 No observed signs of significant structural damage or deterioration.
 Additional sketches or comments on separate page

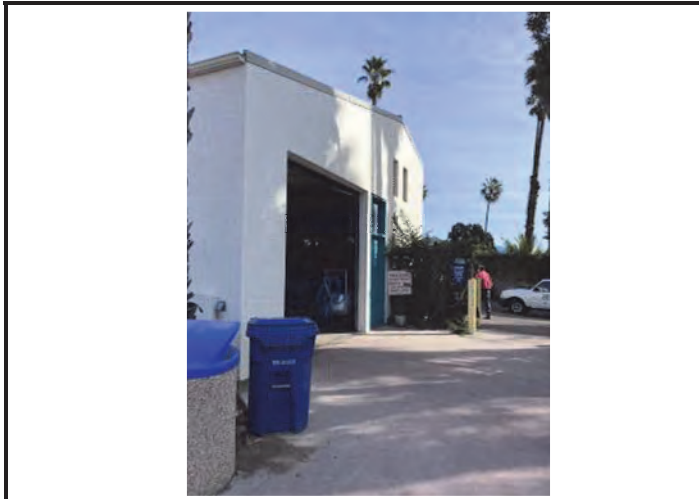
COMMENTS:
 Single-story structure with wood-framed roof and walls supported on a slab-on-grade foundation system. Wood shearwall seismic system. Plywood sheathing for roof diaphragm. Smaller re-entrant corners exist on the north-east and south-east corners of the structure (less than 20ft).
 Site Conditions Observed:
 No observed signs of significant structural damage or deterioration.
 Additional sketches or comments on separate page

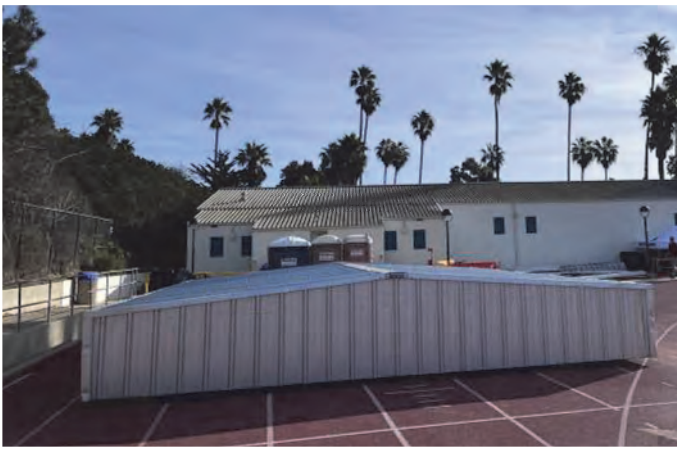
COMMENTS:
 Single-story structure with wood-framed roof and masonry walls supported on a slab-on-grade foundation system. Reinforced masonry shearwall seismic system. Plywood sheathing for roof diaphragm. Smaller re-entrant corners exist on the north-west and south-west corners of the structure (less than 20ft).
 Site Conditions Observed:
 No observed signs of significant structural damage or deterioration.
 Additional sketches or comments on separate page

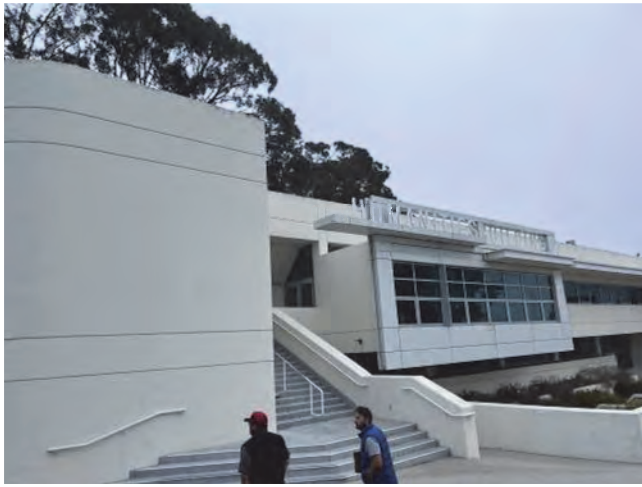
COMMENTS:
 Three-story structure with steel-framed roof and light gage steel walls supported on a slab-on-grade foundation system. Reinforced concrete shearwall seismic system. Reinforced concrete deck for roof and floor diaphragm. Along gridline C between gridlines 5 & 7 and 8 & 9, a concrete shear wall at the upper level does not stack with a wall below causing an in-plane offset irregularity. Along gridline 15, a concrete shearwall at the upper level is inboard of the concrete shearwalls at the lower level causing an out-of-plane setback.

Site Conditions Observed:
 No observed signs of significant structural damage or deterioration.

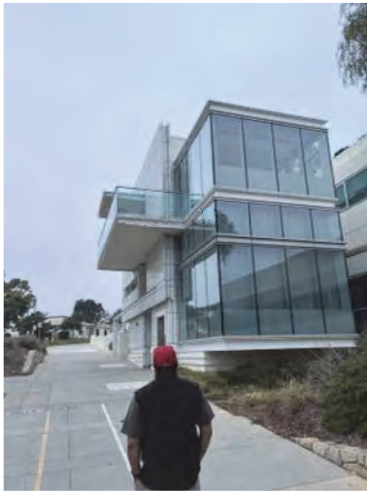
COMMENTS:
 Three-story structure with steel-framed roof and reinforced concrete walls supported on slab-on-grade foundation system. Reinforced concrete shearwall seismic system. Reinforced concrete deck for roof diaphragm.
 Site Conditions Observed:
 No observed signs of significant structural damage or deterioration.

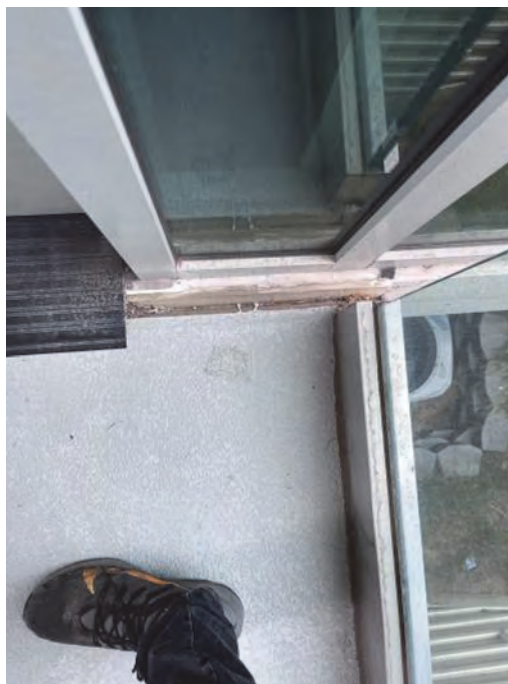
Seismic Separation @ Stair

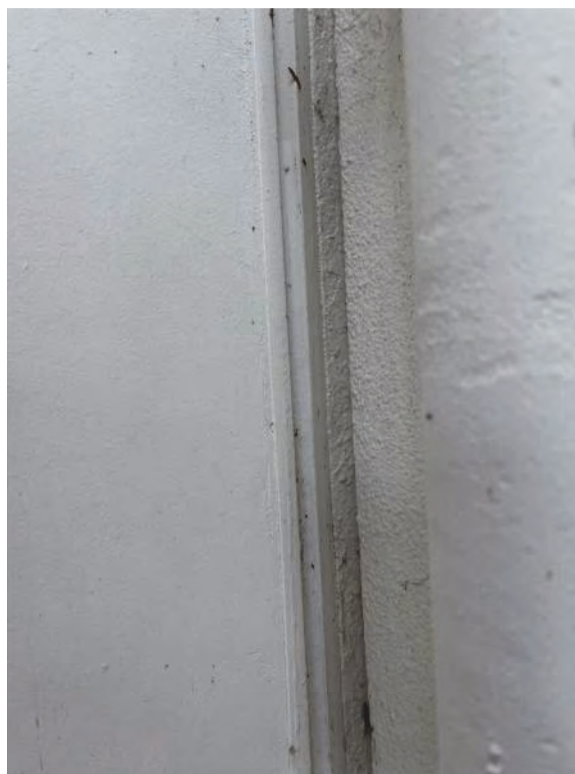
Seismic Separation @ Storage

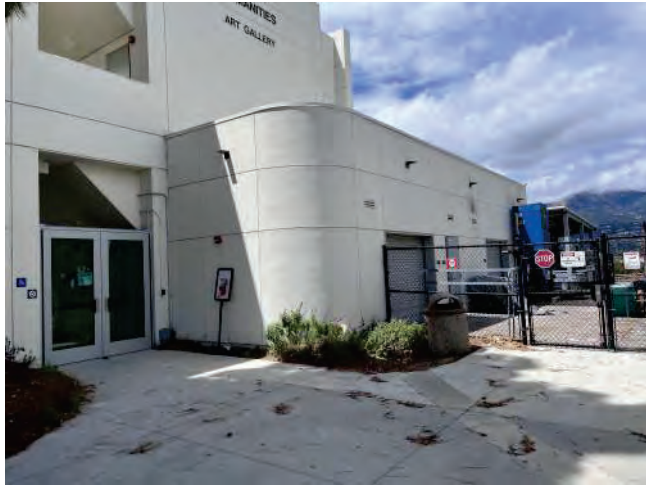
COMMENTS:
 Single-story structure with light gage steel-framed roof and walls supported on slab-on-grade foundation system. Sure-board sheathed light gage metal stud shearwall seismic system. Light gage steel corrugated deck for roof diaphragm.
 Site Conditions Observed:
 No observed signs of significant structural damage or deterioration.

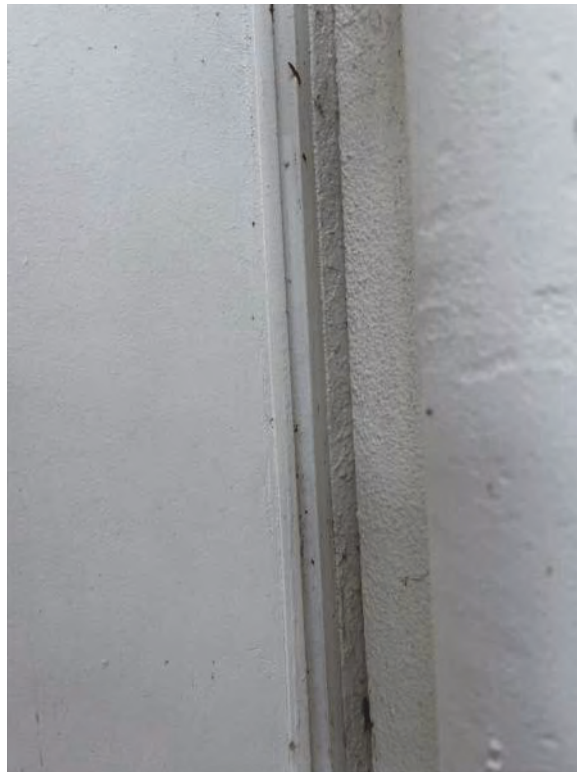
Seismic Separation @ Storage

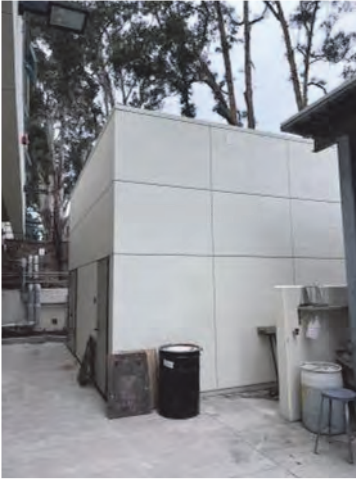
COMMENTS:
 Single-story structure with light gage steel-framed roof and walls supported on slab-on-grade foundation system. Sure-board sheathed light gage metal stud shearwall seismic system. Light gage steel corrugated deck for roof diaphragm.
 Site Conditions Observed:
 No observed signs of significant structural damage or deterioration.

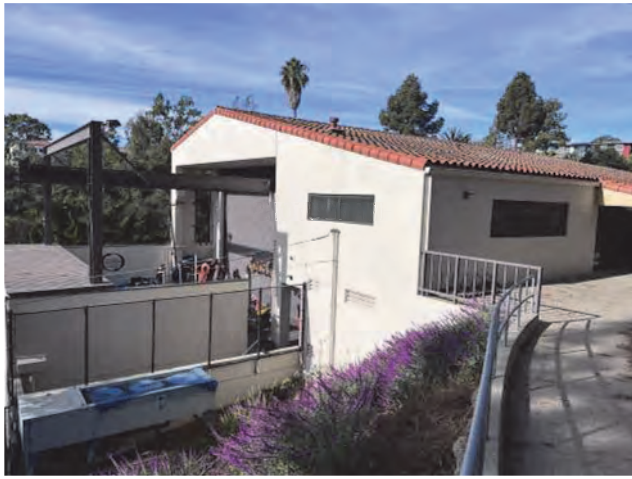
Two-story above basement structure with cast-in-place concrete pan floor and reinforced masonry walls supported on a slab-on-grade foundation system. Reinforced masonry shearwall seismic system. Plywood sheathing over wood/steel joists for roof diaphragm.

Site Conditions Observed:
 No observed signs of significant structural damage or deterioration.

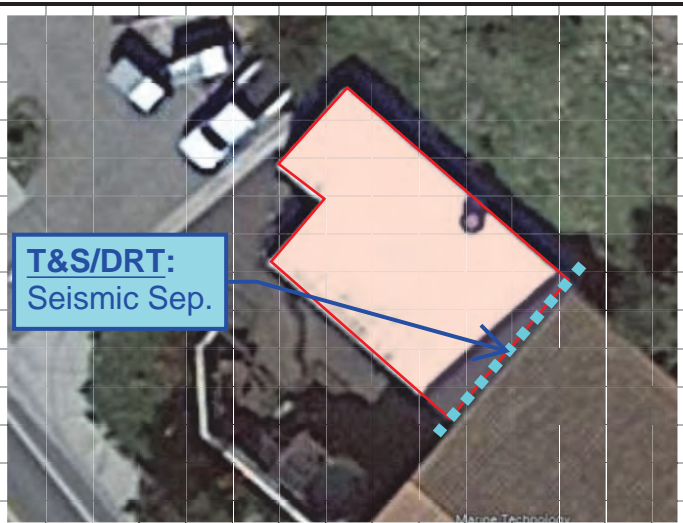
COMMENTS:
 Single-story structure with steel roof framing and reinforced masonry walls supported on a slab-on-grade foundation system. Reinforced masonry shearwall and steel braced frame seismic system. Corrugated metal sheathing for roof diaphragm. A small re-entrant corner exists on the north-west corner of the structure (less than 20ft).
 Site Conditions Observed:
 No observed signs of significant structural damage or deterioration.
 Additional sketches or comments on separate page

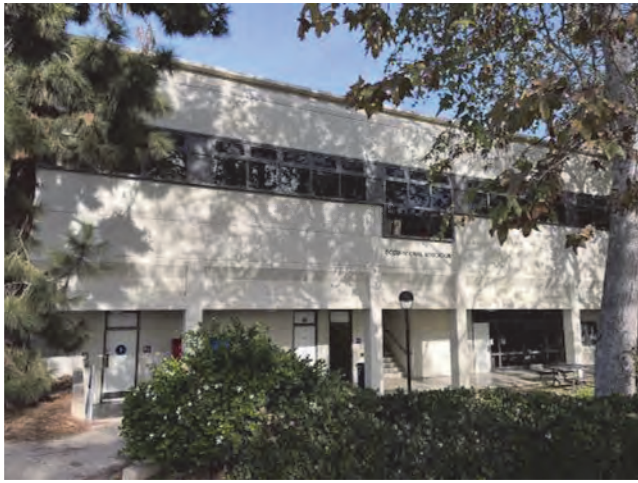
COMMENTS:
Two-story structure with cast-in-place reinforced concrete slab over reinforced concrete joists floor and cast-in-place concrete walls supported on a slab-on-grade foundation system. Reinforced concrete shearwall seismic system. Reinforced concrete pan deck over steel joists for roof diaphragm. A 33ft shearwall along gridline 'F' on the upper floor is slightly inboard and offset from concrete shear walls below causing a minor out-of-plane setback and minor in-plane offset.

Site Conditions Observed:
No observed signs of significant structural damage or deterioration.
 Additional sketches or comments on separate page

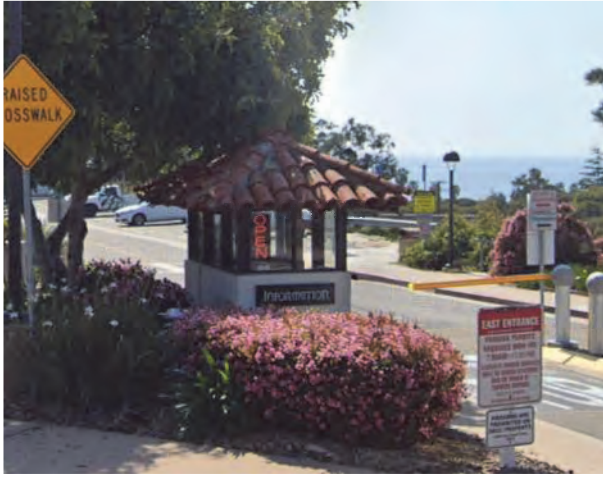
COMMENTS:
Single-story structure with wood-framed roof and walls supported on a slab-on-grade foundation system. Wood shearwall seismic system, with plywood for shear resistance. Plywood sheathing for roof diaphragm.
Site Conditions Observed:
No observed signs of significant structural damage or deterioration.

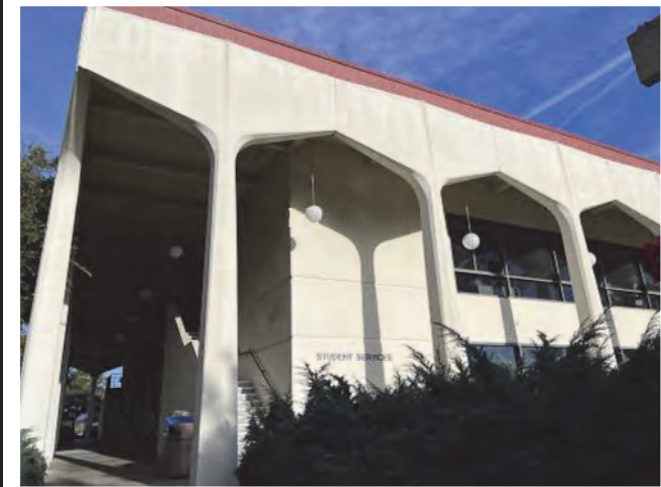
COMMENTS:
Two-story above basement structure with reinforced cast-in-place concrete slab over concrete joist for floor and cast-in-place concrete walls supported on a slab-on-grade foundation system. Reinforced concrete shearwall seismic system. Concrete slab over pre-cast and/or pre-stressed concrete joists/beams for roof diaphragm. A re-entrant corner exists at the second floor level, where a seismically separated mezzanine has been added. The roof level has a diaphragm opening where raised concrete cones exist, which also provides a concern for a severe diaphragm discontinuity irregularity.
Site Conditions Observed:
Visible water damage at the connection of precast concrete exterior columns.
 Additional sketches or comments on separate page

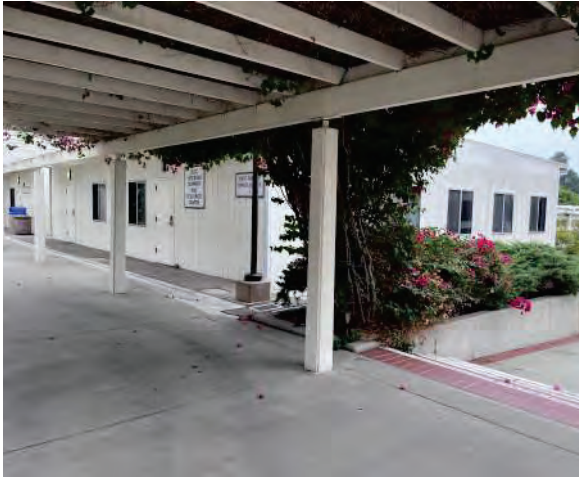
COMMENTS:
 Single-story structure with light gage steel framed roof, floor, and walls supported on pressure treated lumber plates. Light gage steel with plywood shearwall seismic system. Standing seam steel sheathing for roof diaphragm.
 Site Conditions Observed:
 No observed signs of significant structural damage or deterioration.

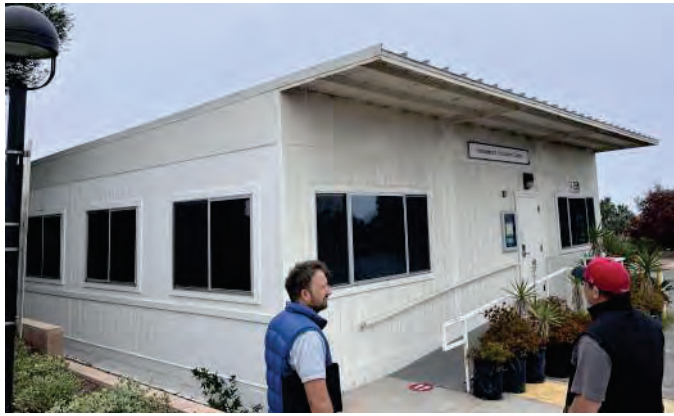
Pressure Treated Wood Sill and Rim

T&S/DRT:
Significant rot damage to rim and sill plate.

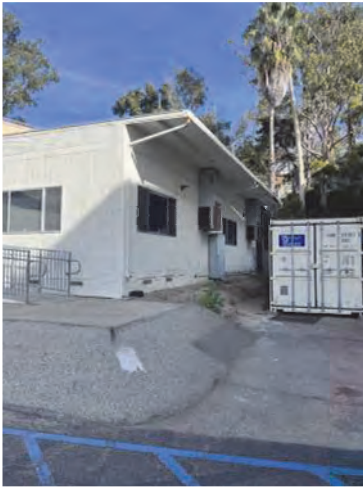
COMMENTS:
 Single-story structure with light gage steel framed roof and walls supported on pressure treated wood on grade foundation system. Plywood sheathed light gage steel shearwall seismic system. Light gage corrugated steel sheathing for roof diaphragm.
 Site Conditions Observed:
 Deterioration of the wood sill-on-ground was observed.
 Additional sketches or comments on separate page

Deterioration of Wood Sill-On-Ground

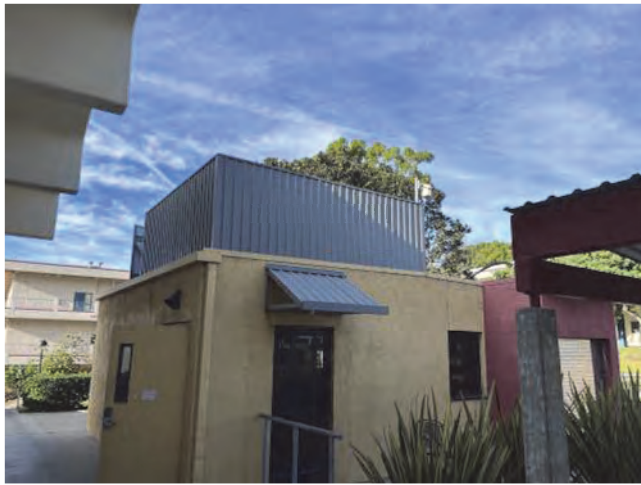
Wall Framing to Floor Framing Joint

Site Conditions Observed:
 Wood sill-on-ground was observed to be crushing and deteriorating. Additionally, crushing and warping at the joint of wall to floor framing was observed.

T&S/DRT: Crushing and warping of joint

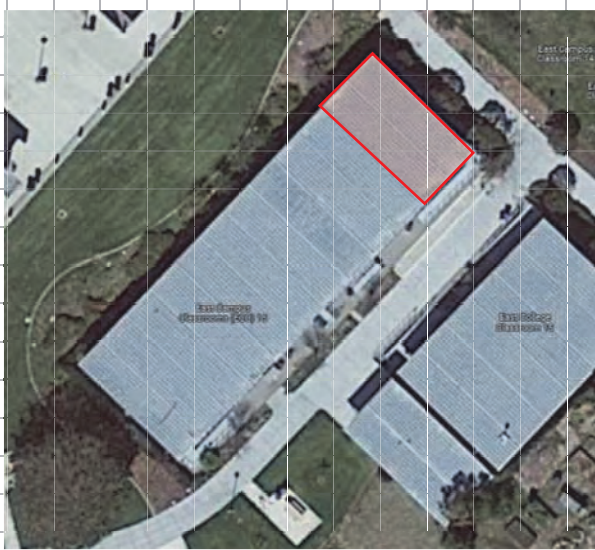
COMMENTS:
 Single-story structure with light gage steel framed roof, floor, and walls supported on pressure treated lumber plates. Light gage steel with plywood shearwall seismic system. Standing seam steel sheathing for roof diaphragm.
 Site Conditions Observed:
 Significant damage to the gutter on the rear side of the structure was observed. More specifically, the gutter was missing and rust/water damage was present along the entire fascia of the roof.
 Additional sketches or comments on separate page

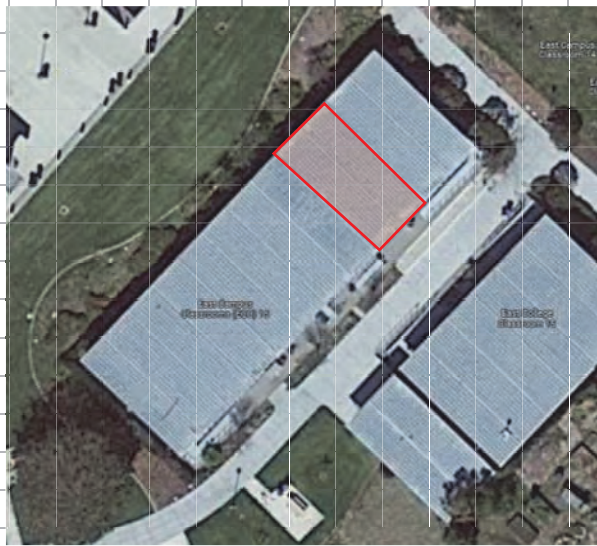
COMMENTS:
 Single-story structure with light gage steel framed roof, floor, and walls supported on pressure treated lumber plates. Light gage steel with plywood shearwall seismic system. Standing seam steel sheathing for roof diaphragm.
 Site Conditions Observed:
 Significant damage to the gutter on the rear side of the structure was observed. More specifically, the gutter was missing and rust/water damage was present along the entire fascia of the roof.
 Additional sketches or comments on separate page

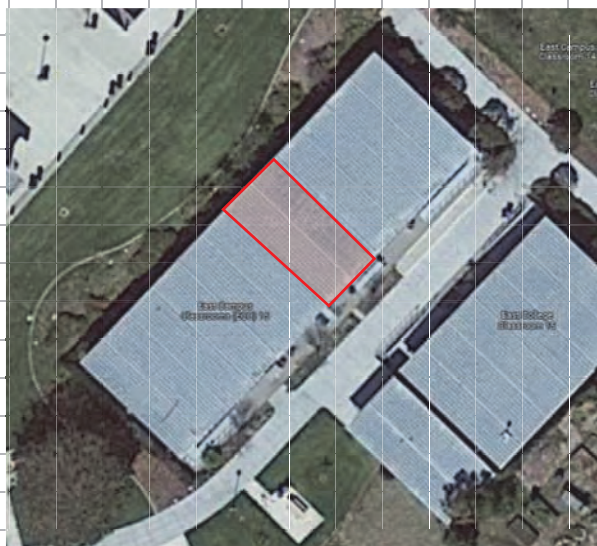
COMMENTS:
 Single-story structure with light gage steel framed roof, floor, and walls supported on pressure treated lumber plates. Light gage steel with plywood shearwall seismic system. Standing seam steel sheathing for roof diaphragm.
 Site Conditions Observed:
 Significant damage to the gutter on the rear side of the structure was observed. More specifically, the gutter was missing and rust/water damage was present along the entire fascia of the roof.
 Additional sketches or comments on separate page
