SBCC Survey of Existing Buildings and Retrofit Plan

SANTA BARBARA CITY COLLEGE SEISMIC SURVEY

PRELIMINARY REPORT

May 31, 2023

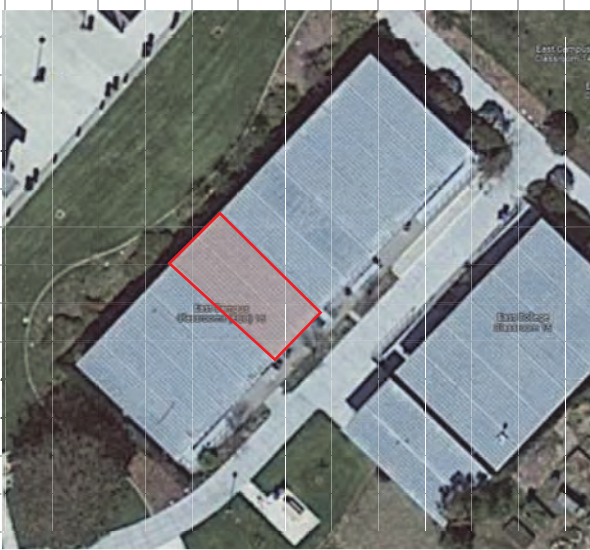
COMMENTS:
 Single-story structure with light gage steel framed roof, floor, and walls supported on pressure treated lumber plates. Light gage steel with plywood shearwall seismic system. Standing seam steel sheathing for roof diaphragm.
 Site Conditions Observed:
 Significant damage to the gutter on the rear side of the structure was observed. More specifically, the gutter was missing and rust/water damage was present along the entire fascia of the roof.
 Additional sketches or comments on separate page

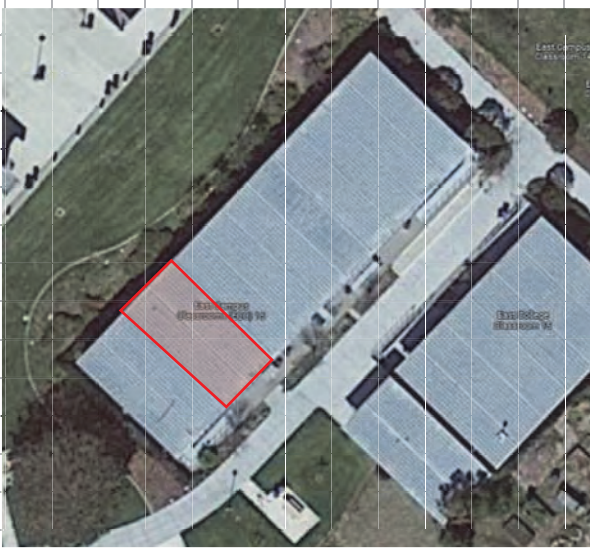
COMMENTS:
 Single-story structure with light gage steel framed roof, floor, and walls supported on pressure treated lumber plates. Light gage steel with plywood shearwall seismic system. Standing seam steel sheathing for roof diaphragm.
 Site Conditions Observed:
 Significant damage to the gutter on the rear side of the structure was observed. More specifically, the gutter was missing and rust/water damage was present along the entire fascia of the roof.
 Additional sketches or comments on separate page

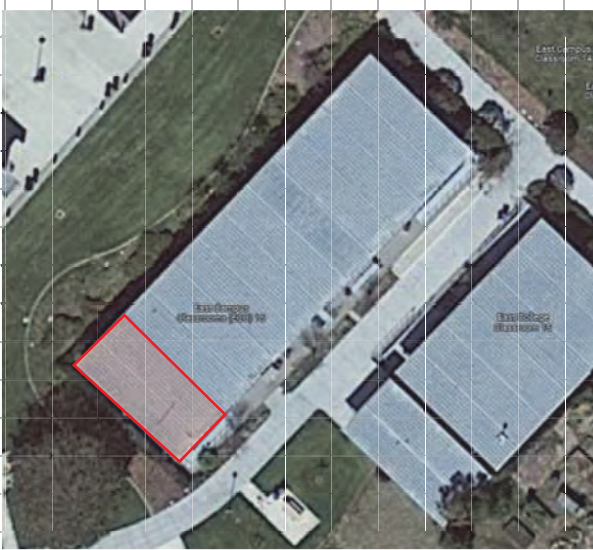
COMMENTS:
 Single-story structure with light gage steel framed roof, floor, and walls supported on pressure treated lumber plates. Light gage steel with plywood shearwall seismic system. Standing seam steel sheathing for roof diaphragm.
 Site Conditions Observed:
 Significant damage to the gutter on the rear side of the structure was observed. More specifically, the gutter was missing and rust/water damage was present along the entire fascia of the roof.
 Additional sketches or comments on separate page

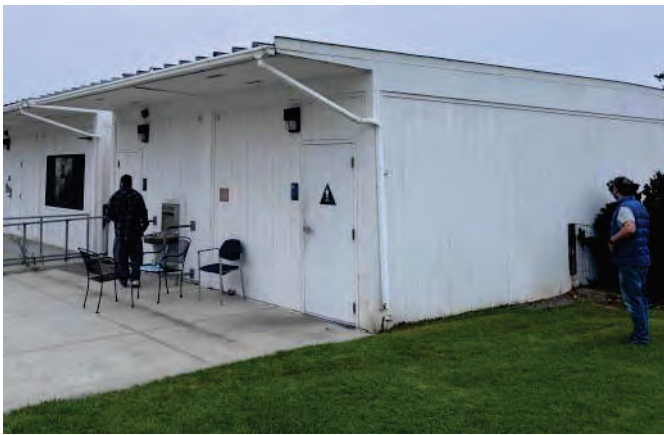
COMMENTS:
Single-story structure with light gage steel framed roof, floor, and walls supported on pressure treated lumber plates. Light gage steel with plywood shearwall seismic system. Standing seam steel sheathing for roof diaphragm.
Site Conditions Observed:
Significant damage to the gutter on the rear side of the structure was observed. Rust/water damage was present along the entire fascia of the roof.

Significant Damage to Gutter

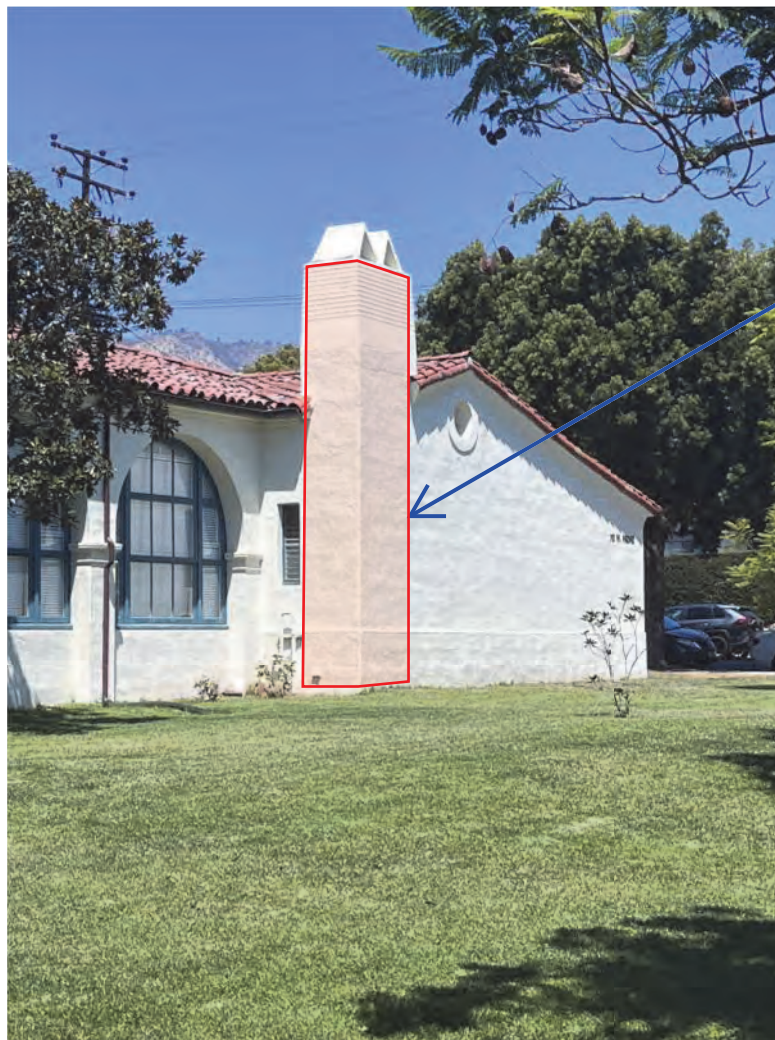
SUBJECT: 35.0 - Schott Center

Site Conditions Observed:
Unbraced masonry chimney occurs at the south-east corner of the building.

T&S/DRT: Unbraced masonry chimney

East Corner of Structure

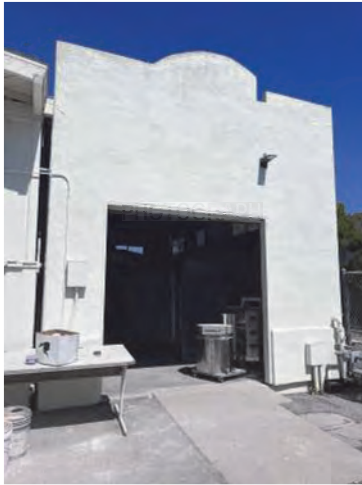
T&S/DRT: Limited clear distance to adjacent building and building end condition cause a potential for pounding

Clearance to Adjacent Structure

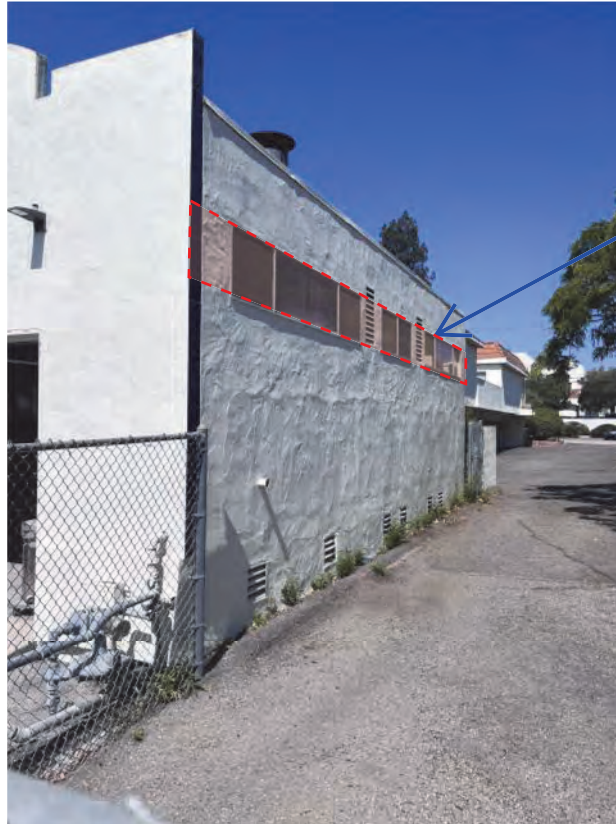
SUBJECT: 36 - Kiln Building

T&S/DRT: limited shear resistance in this wall with clerestory windows causing moderate vertical irregularity

North-East Facing Wall

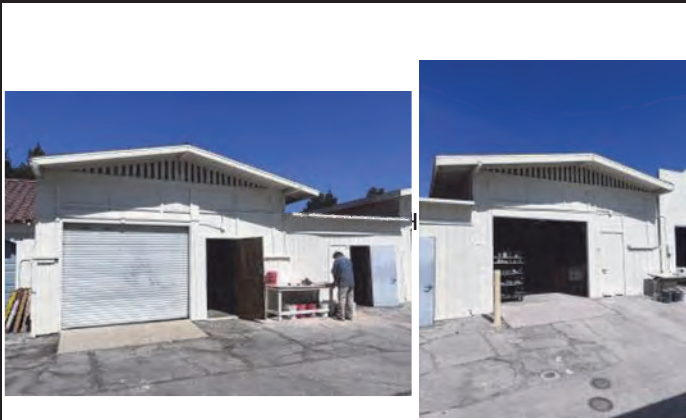
T&S/DRT: Limited clear distance to adjacent building and building end condition cause a potential for pounding

South-East Facing Wall

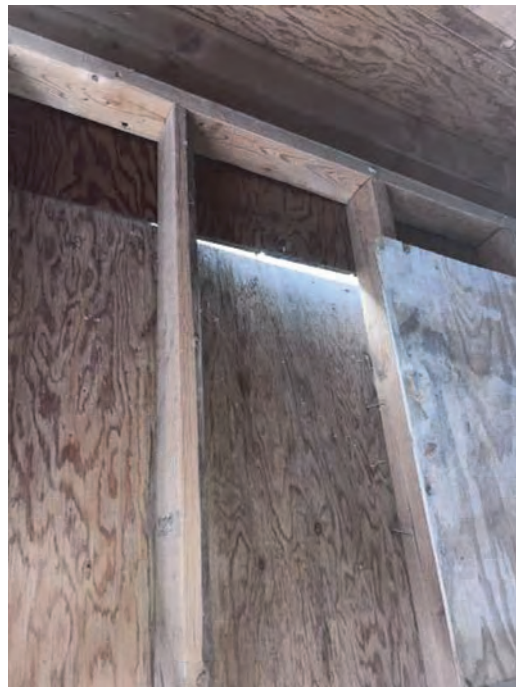
Building 37 - Damage to Sill Plate

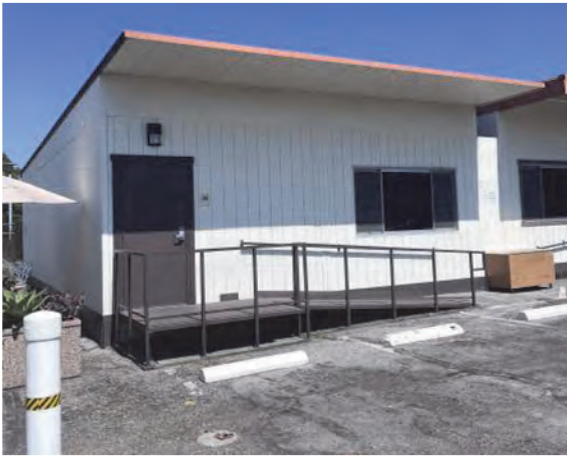
Building 37 - Damage to Exterior Wall Sheathing

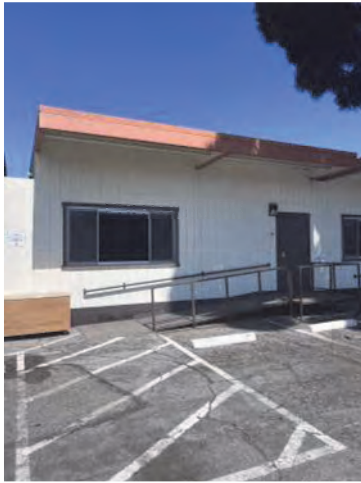
COMMENTS:
 Single-story modular structure, with light-gage metal framed roofs and walls supported on pressure treated lumber plates on grade. Metal stud shearwall seismic system, with plywood for shear resistance. Interlocking standing seam panels roof diaphragm. DSA approval was found on as-built plans.
 Site Conditions Observed:
 Significant deterioration of the plywood perimeter skirting. The metal framing just above the wood sill shows signs of "squishing" from vertical loading.
 Additional sketches or comments on separate page

Damage to Metal Framing @ Foundation

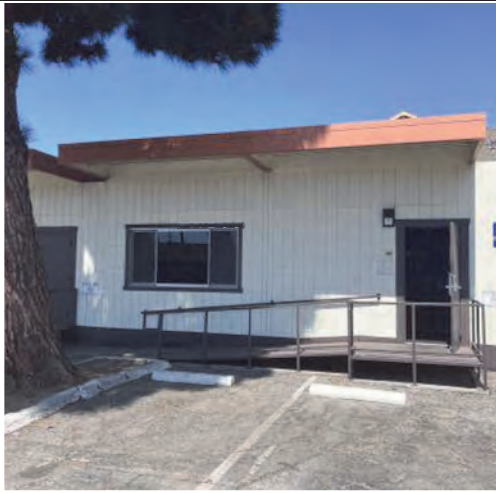
COMMENTS:
 Single-story modular structure, with light-gage metal framed roofs and walls supported on pressure treated lumber plates on grade. Metal stud shearwall seismic system, with plywood for shear resistance. Plywood for roof diaphragm. DSA approval was found on as-built plans.
 Site Conditions Observed:
 Significant deterioration of the plywood perimeter skirting. Significant deterioration of plywood roof sheathing at rear roof overhang.
 Additional sketches or comments on separate page

Damage to Plywood Roof Sheathing

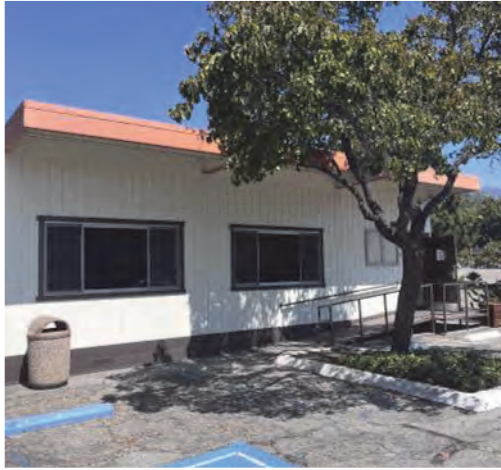
Damage to Plywood Skirting/Wood Sill

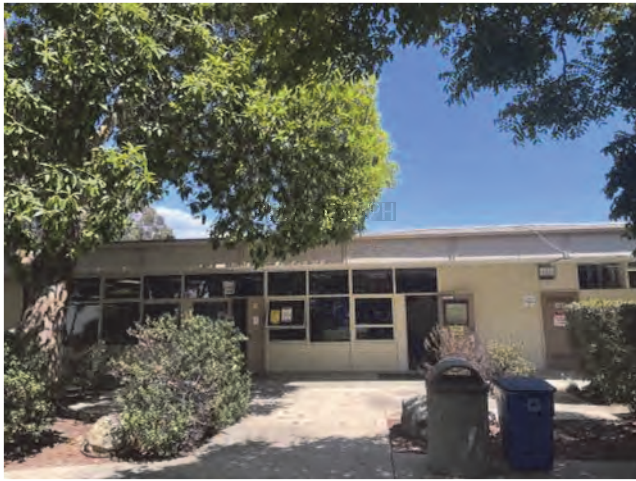
COMMENTS:
 Single-story structure with wood framed roofs and reinforced masonry walls supported on a conventional concrete foundation system with slab-on-grade construction. Reinforced masonry shearwall seismic system. Plywood for roof diaphragm.
 Site Conditions Observed:
 Limited shear transfers from the roof to the masonry walls was observed. The limited clearance to the adjacent structure, along with being the end building, cause the potential for pounding.

Clearance to Adjacent Structure

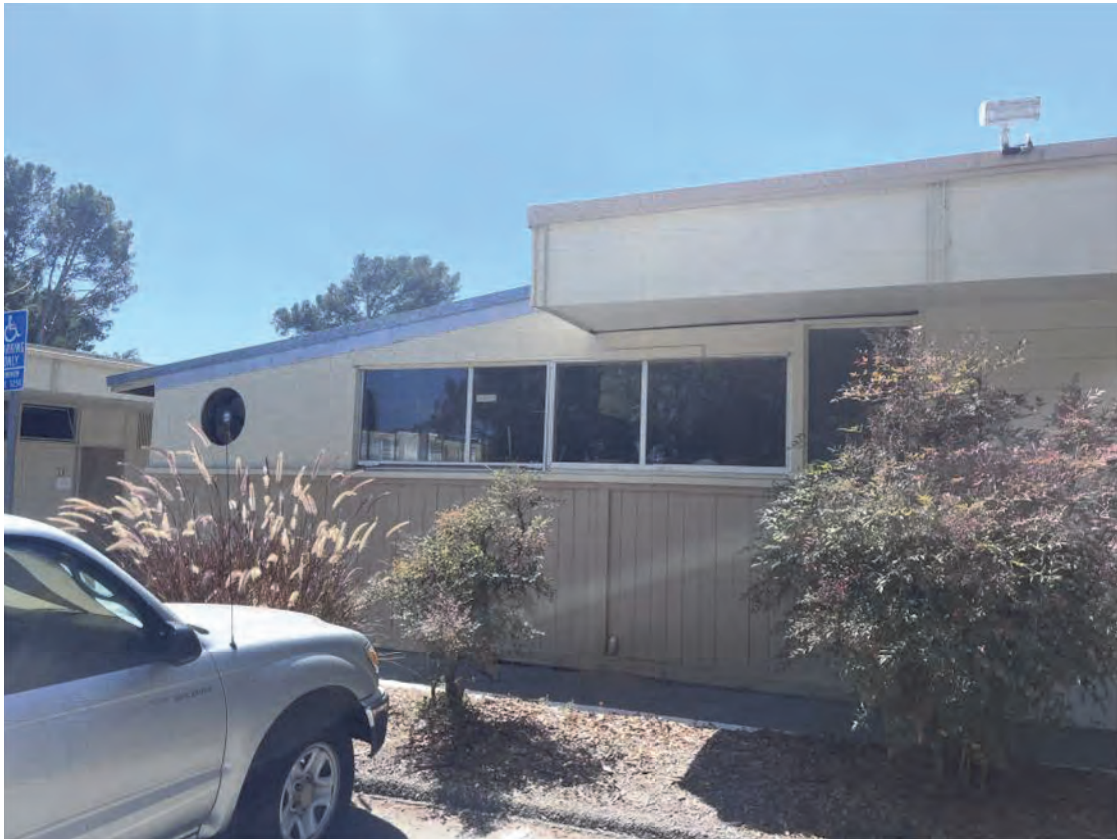
Addition @ South-East Corner - Exterior

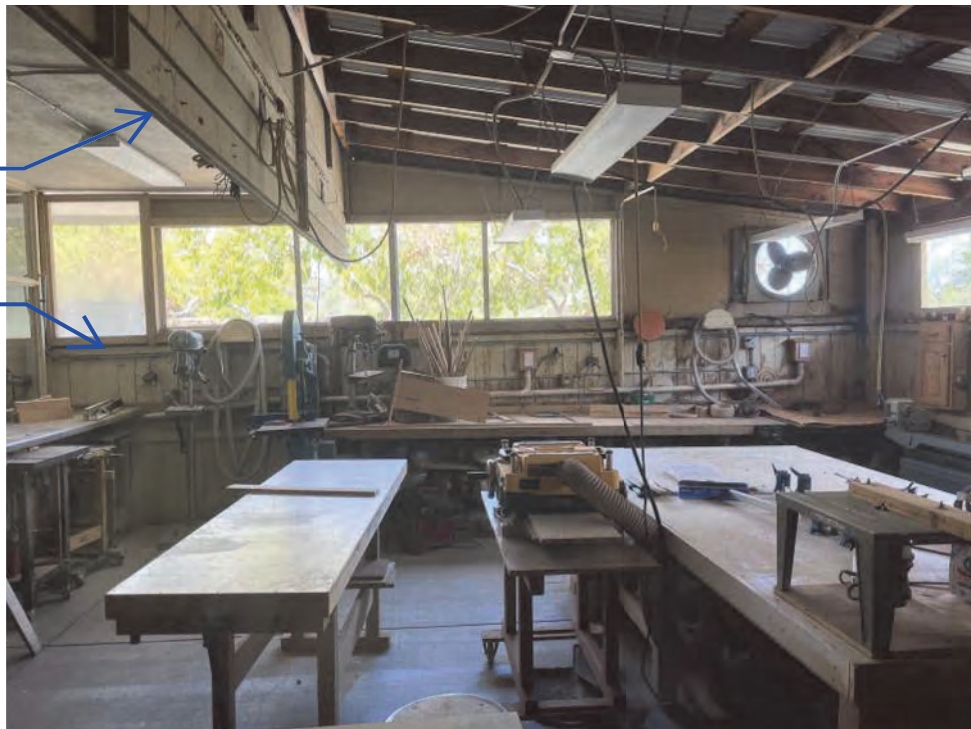
Addition @ South-East Corner - Interior

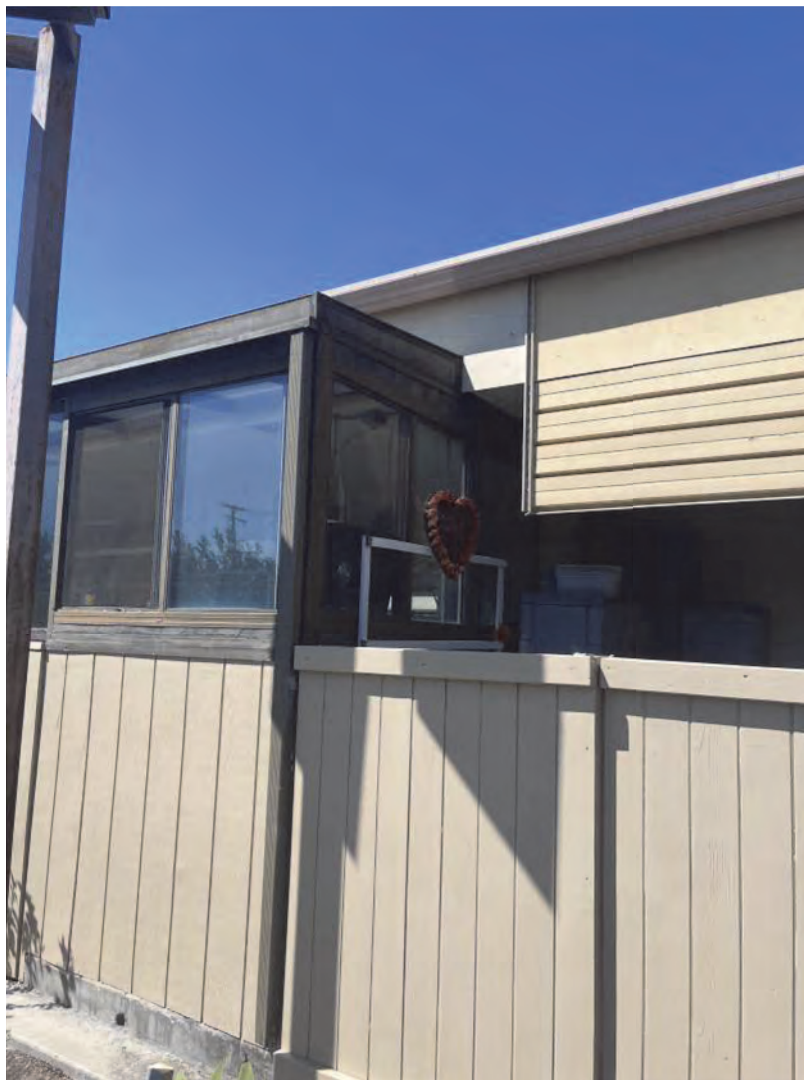
Addition @ South-West Corner - Exterior

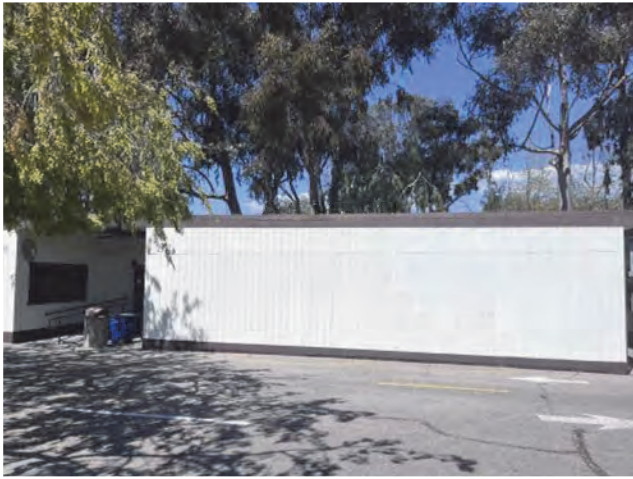
Site Conditions Observed:
Slight deterioration of cold-formed steel floor joists sitting on concrete footings and inadequate anchorage of floor system to strip footings.

Slight Deterioration of Floor System on Footing

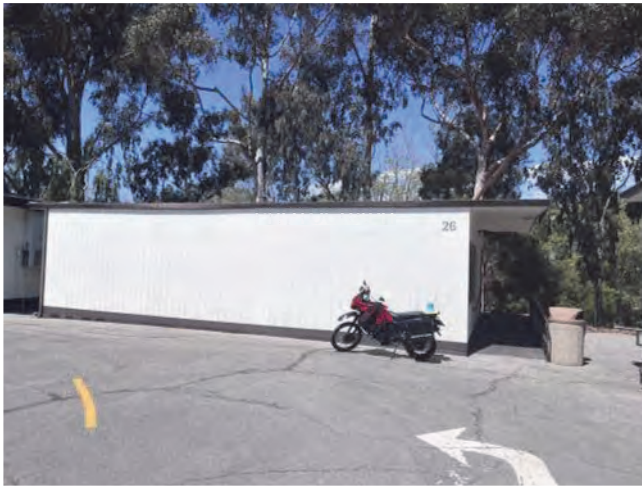
Site Conditions Observed:
Slight deterioration of wood sill-on-ground and cripple wall sheathing.

*Slight Deterioration of Wood Sill-On-Ground
and Cripple Wall Sheathing*

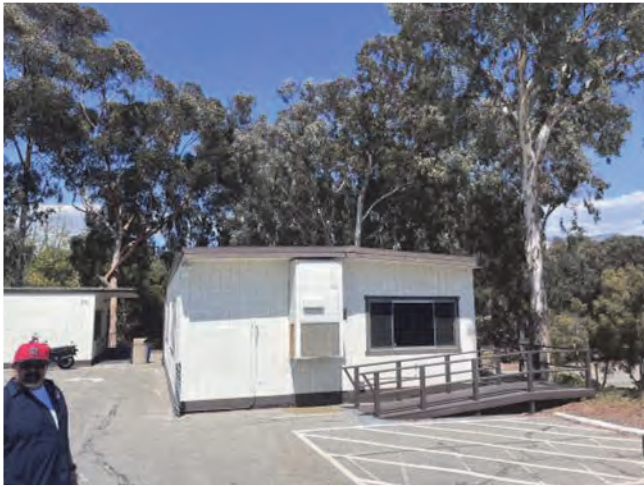
Site Conditions Observed:
 Slight deterioration of cripple wall sheathing.

Slight Deterioration Cripple Wall Sheathing

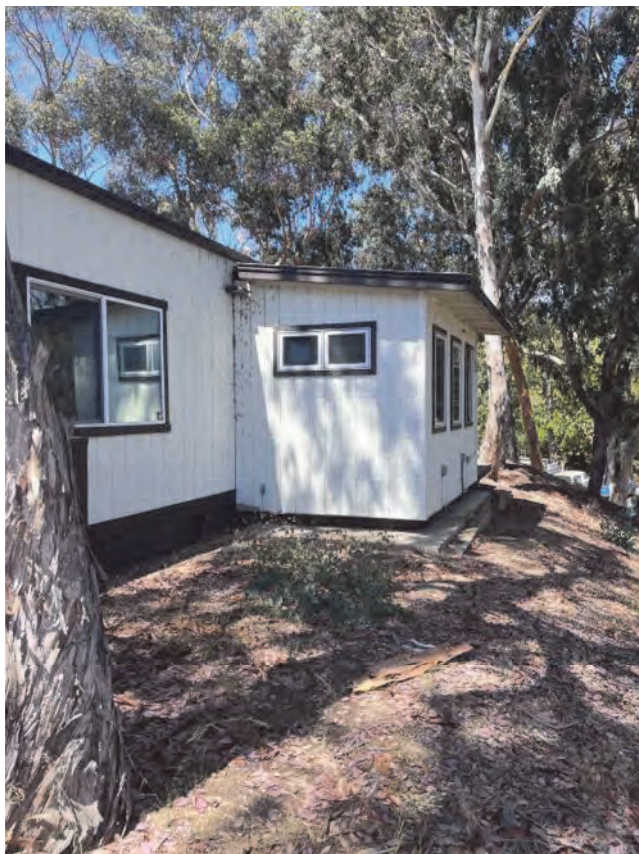
Single Room Addition to East Side

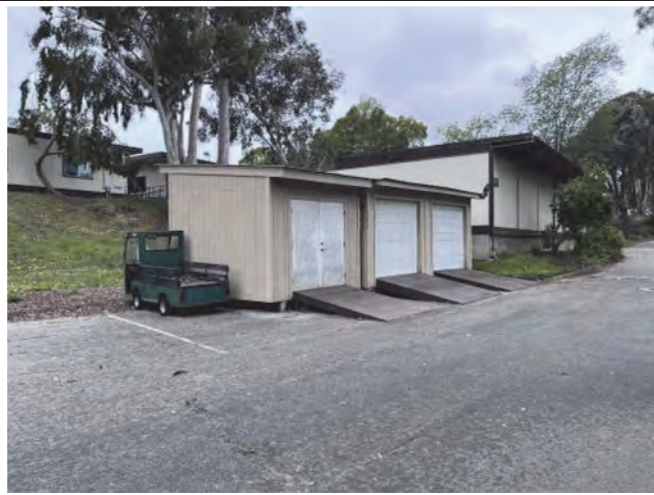
Site Conditions Observed:
Slight deterioration to the cripple wall sheathing

*Slight Deterioration to Cripple
Wall Sheathing*

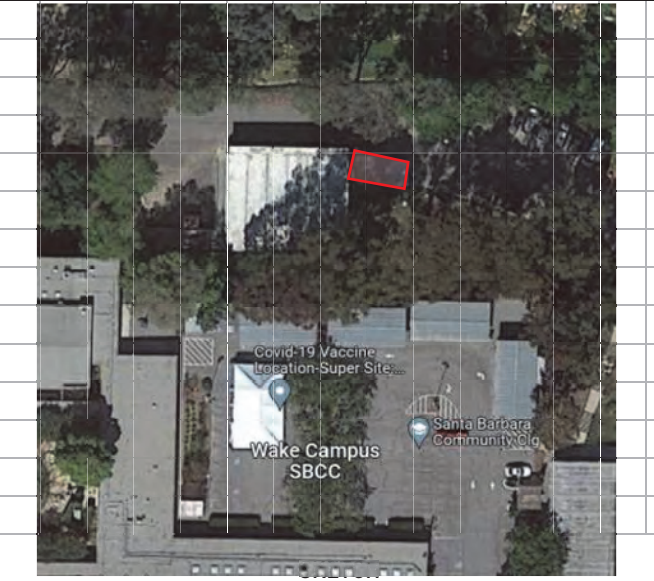
COMMENTS:
Multiple single-story structure with wood framed roof, floor, and walls supported on pressure treated lumber plates. Wood stud with plywood shearwall seismic system. Plywood sheathing for roof diaphragm.
Site Conditions Observed:
The structures are intermittently supported by pressure treated plates, with very limited lateral resistance towards the front face.
 Additional sketches or comments on separate page

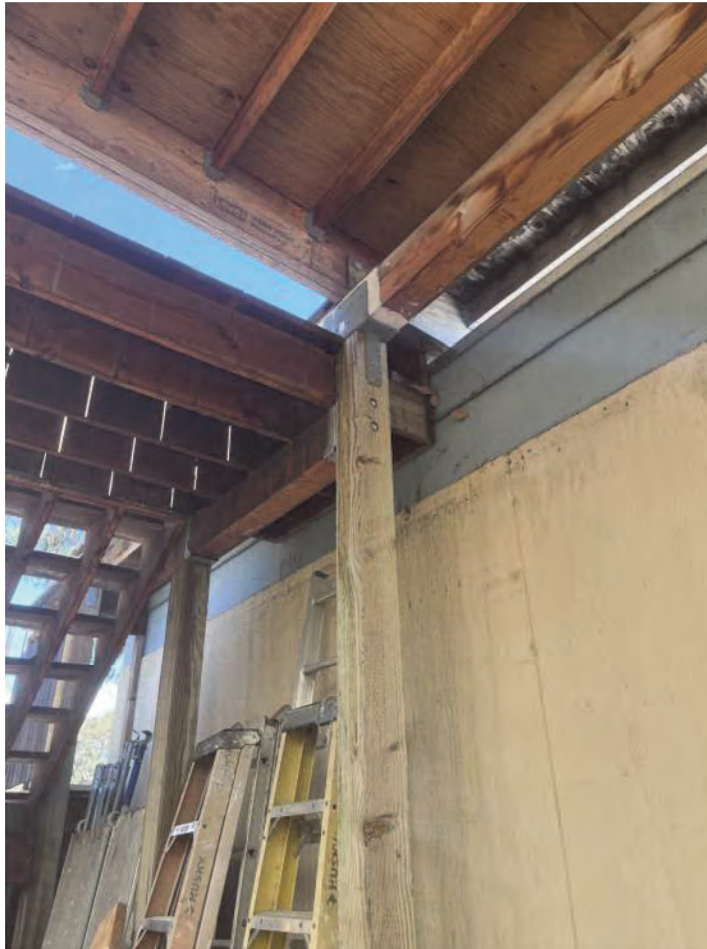
Site Conditions Observed:
Exterior stair, landing, and high roof addition west courtyard with no physical plans or permits for review.

*Stair, Landing, & High Roof Addition
@ West Courtyard*

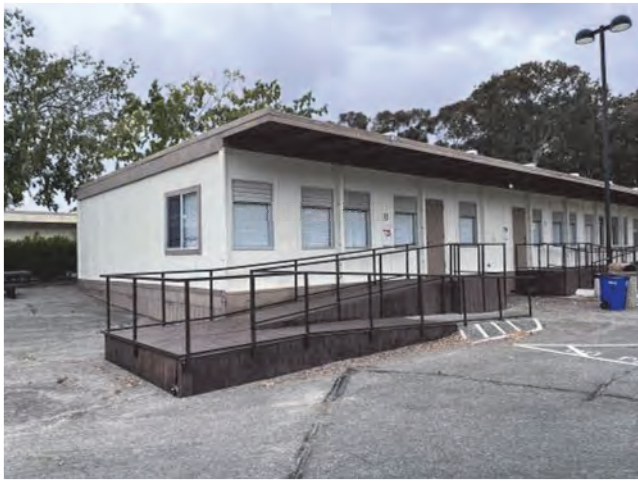
COMMENTS:
 Single-story structure with light gage steel framed roof, floor, and walls supported on pressure treated lumber plates Light gage steel with plywood shearwall seismic system. Corrugated steel sheathing for roof diaphragm. DSA approval was found on as-built plans from original location (Carpinteria) but no approved plans occur for current location.
 Site Conditions Observed:
 Slight deterioration of cripple wall sheathing.
 Additional sketches or comments on separate page

*Slight Deterioration of Cripple Wall
Sheathing*

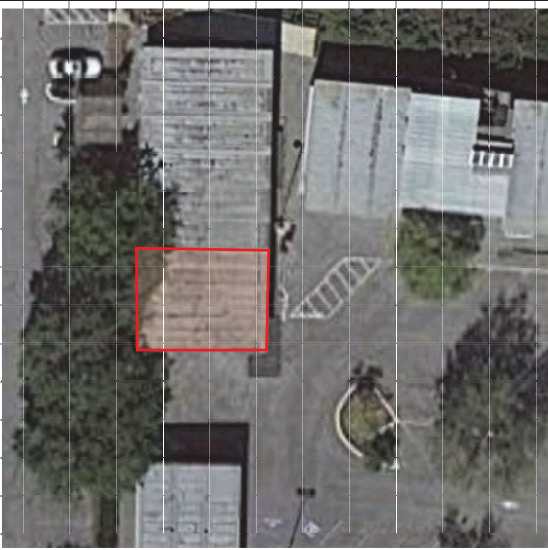
COMMENTS:
Single-story structure with light gage steel framed roof, floor, and walls supported on pressure treated lumber plates Light gage steel with plywood shearwall seismic system. Corrugated steel sheathing for roof diaphragm. DSA approval was found on as-built plans from original location (Carpinteria) but no approved plans occur for current location.
Site Conditions Observed:
The lack of space between the adjacent modular building, and the building being located at the end of the block, justify a pounding potential.
 Additional sketches or comments on separate page

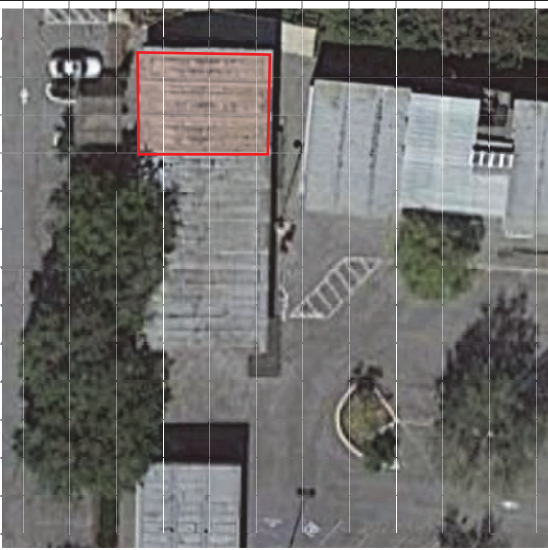
COMMENTS:
 Single-story structure with light gage steel framed roof, floor, and walls supported on pressure treated lumber plates Light gage steel with plywood shearwall seismic system. Corrugated steel sheathing for roof diaphragm. DSA approval was found on as-built plans from original location (Carpinteria) but no approved plans occur for current location.
 Site Conditions Observed:
 The lack of space between the adjacent modular building, and the building being located at the end of the block, justify a pounding potential.
