Santa Barbara City College

SBCC Campus & Building Assessments Report

April 2016

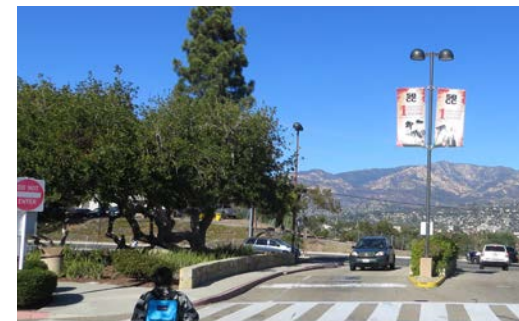
East Campus main entrance

- This entrance is heavily used by vehicles, pedestrians, bikes, and buses.
- Many modes of transit overlap haphazardly in this area, in particular pedestrians crossing through the vehicular lanes, to get to the bus stop.

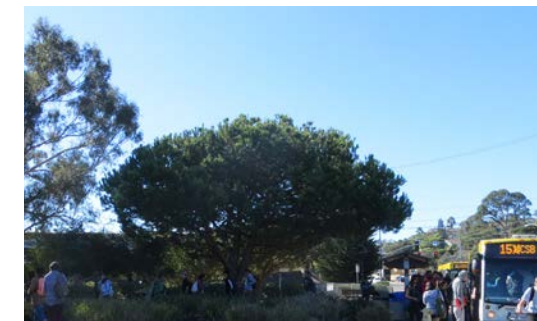
Bus stop at East Campus main entrance

- The bus stop is heavily used, and not large enough to accommodate the number of people waiting in and moving through the space.
- Pathways to the bus stop are not direct and students frequently utilize roads to get to the stop.

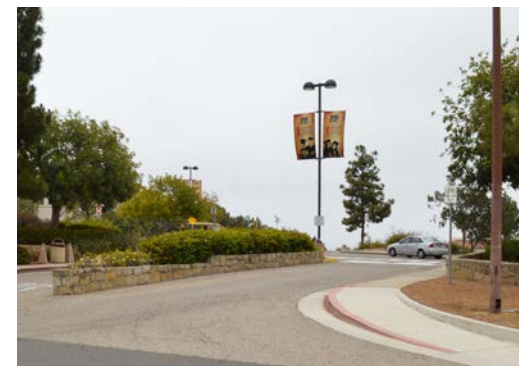
East Campus main entrance

- A raised planter separates traffic at the East Campus entrance, blocking site lines.

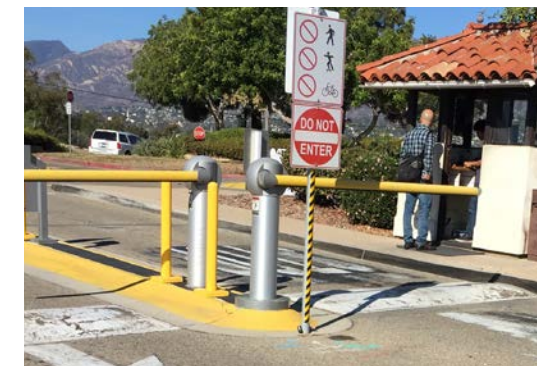
East Campus main entrance kiosk

- Upon arriving at East Campus, wayfinding is unclear, especially for pedestrians.
- Cars back up at kiosk, causing congestion.

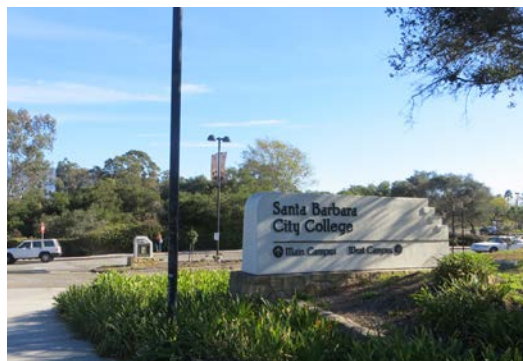
West Campus main entrance

- This entrance is primarily used by vehicles, though pedestrians and bikes have designated space.
- The entry sign is visible from Cliff Drive, however, site lines to this sign are poor.

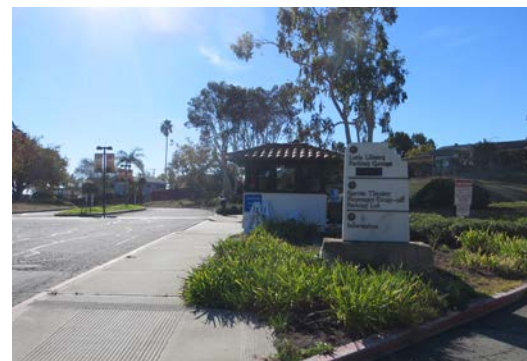
West Campus main entrance, kiosk

- This kiosk greets visitors as they arrive on west campus, however, there is little else to provide a sense of arrival or direction at this entrance.

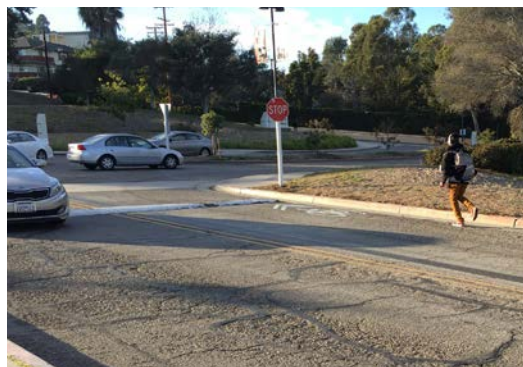
West Campus main entrance

- Students walk in the road, trying to find the most direct route.

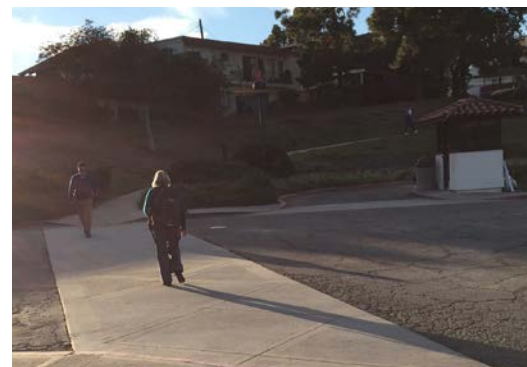
West Campus main entrance

- Traffic does not have a stop sign at this intersection or at the kiosk.

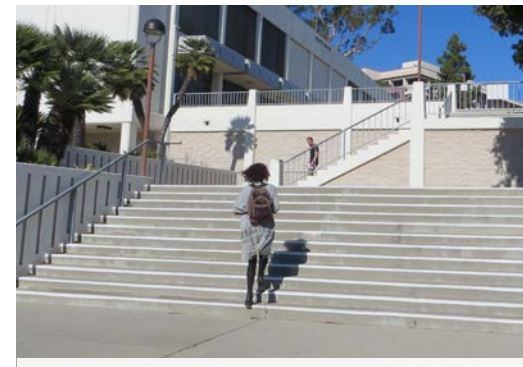
Sports Pavilion pedestrian entrance from Lot 2B

- Pedestrian access to East Campus from the lower parking lots is particularly indirect. Due to the terrain, mazes of stairs and ramps lead into the campus.

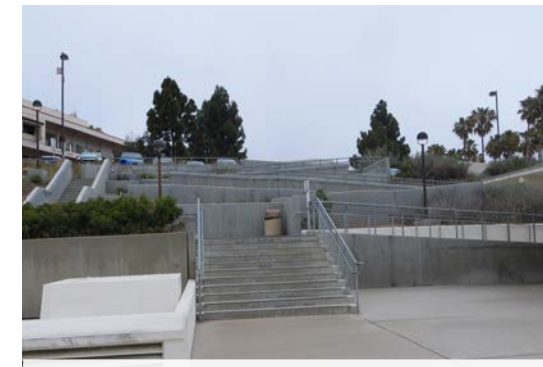
Sports Pavilion pedestrian entrance from Lot 2B

- Stairs and ramps continue past the Sports Pavilion. These must be traversed in order to reach the core of East Campus from the lower parking lots.

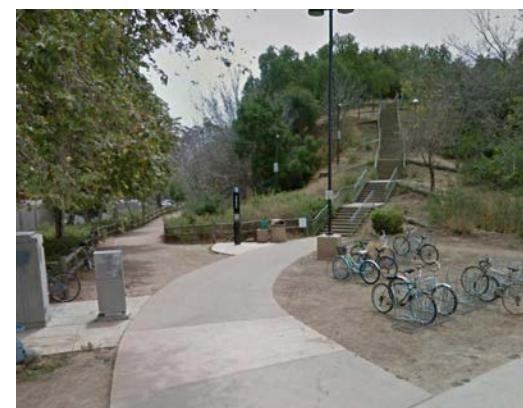
Cliff Drive Pedestrian Entrance

- Topographic change visually separates the Cliff Drive entrance from the campus.

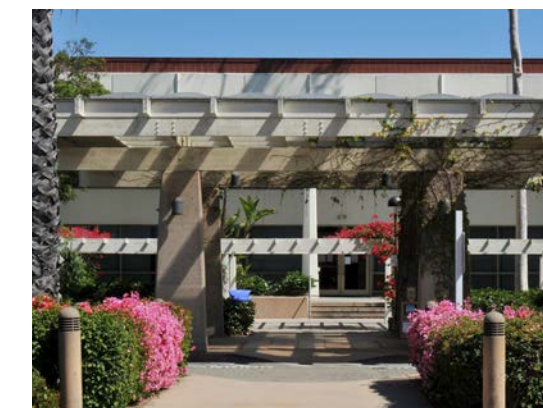
Passenger drop off area by student services

- There is little signage or other wayfinding devices to orient visitors at this drop off.

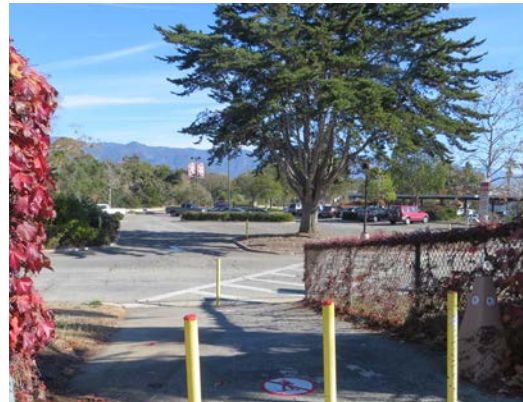
Del Sol West Campus Pedestrian Entrance

- Pedestrian and bike entrances at Del Mar and Del Sol Avenues are poorly framed, but heavily used by the community.

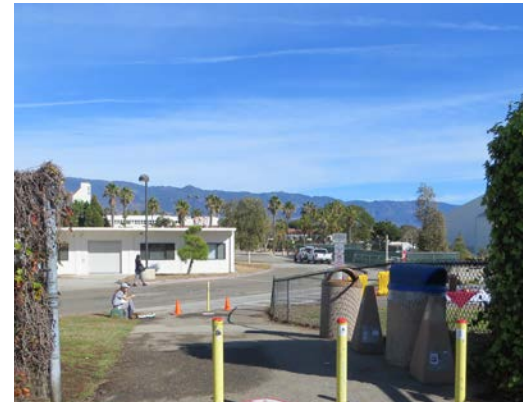
Del Mar West Campus Pedestrian Entrance

- The entrances themselves poorly announce transition into the campus causing regulatory issues such as littering.

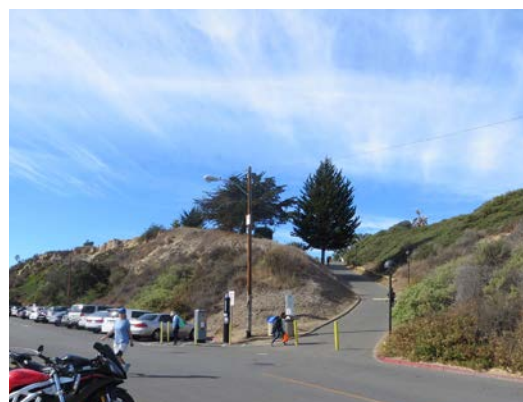
Lot 3 Pedestrian Entrance

- There is little wayfinding or sense of arrival at the thresholds between the parking lots and the campus paths. Due to the terrain, accessibility is an issue.

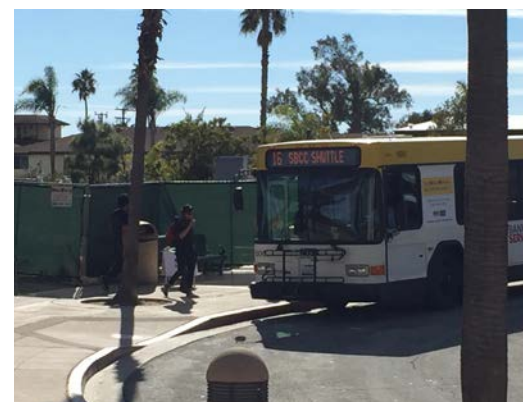
Bus stop at West Campus drop off circle

- This bus stop lacks seating and shelter and competes for space with passenger loading.
- There is little sense of arrival at this entry.

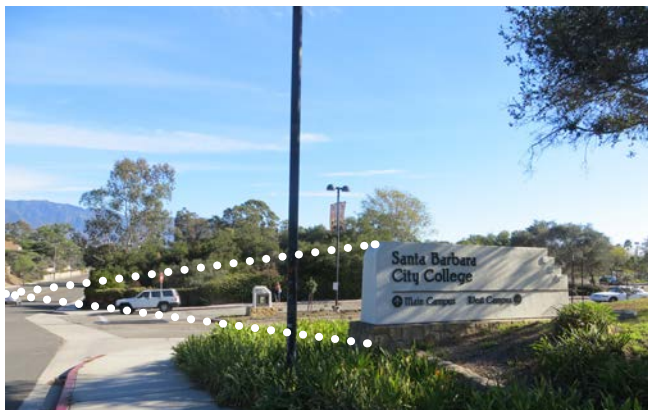
West Campus Entrance signage
 • Signage is not easily seen from Cliff Drive.

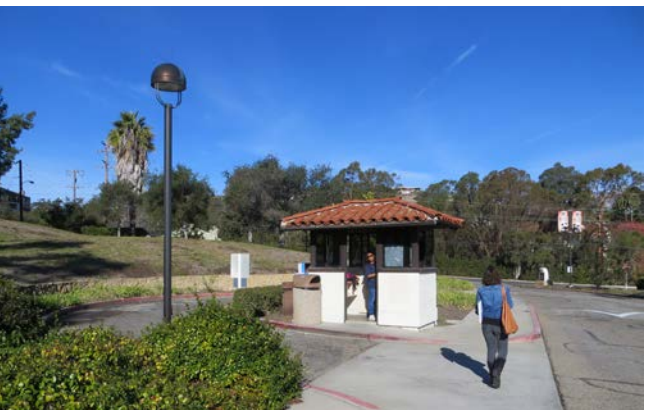
West Campus Entrance kiosk
 • Traffic exiting kiosk crosses pedestrian pathway and enters roadway without a stop sign.

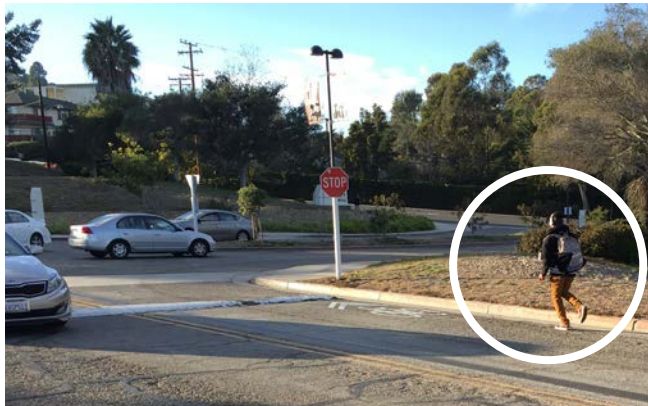
West Campus Entrance, desire line
 • Students walk dangerously in roadway.

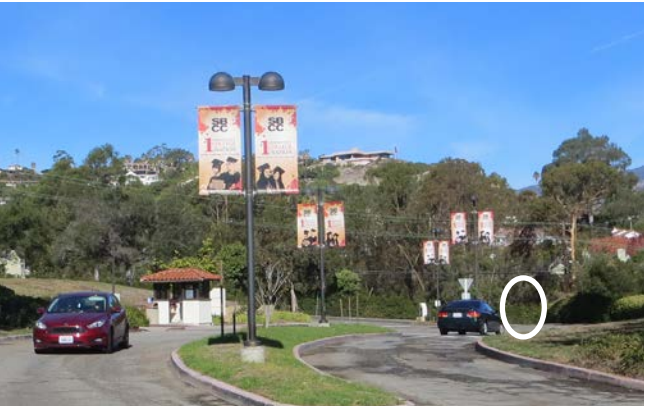
West Campus Entrance intersection
 • No stop sign at intersection

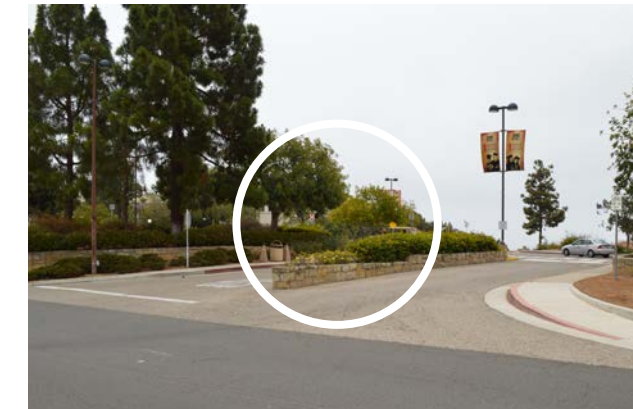
East Campus entrance
 • No signage announces the main East Campus entrance.

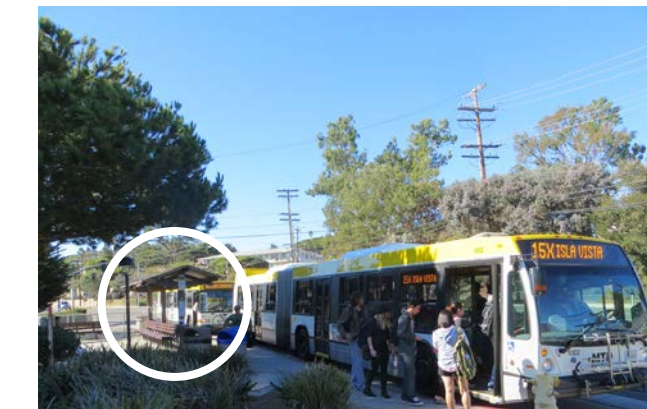
East Campus bus stop
 • The bus shelter and connecting pathways are poorly located in relation to embarking and disembarking.

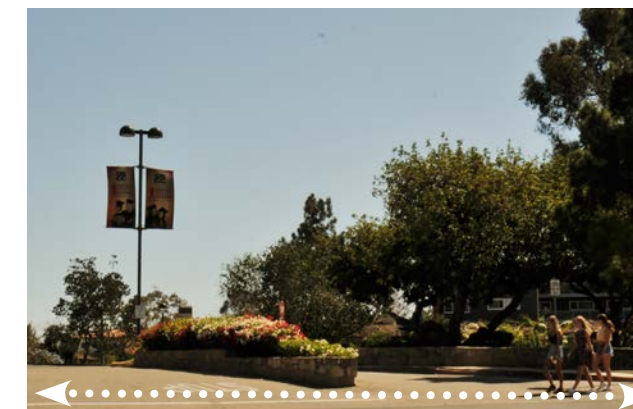
East Campus entrance
 • No crosswalk connects the sidewalk along Cliff Drive.

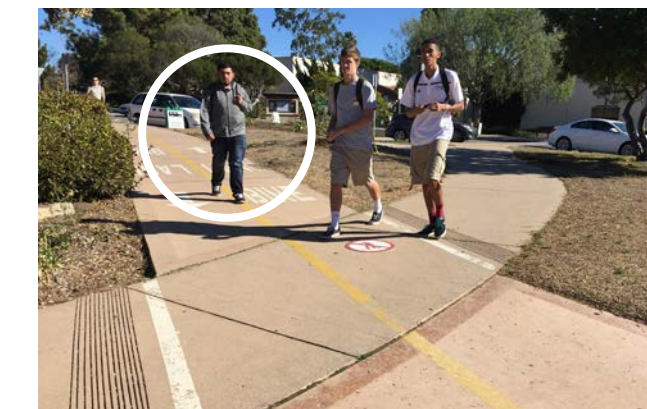
Bike lane at East Campus entrance
 • Bikes and pedestrians conflict along the only path dedicated to bikes on campus.

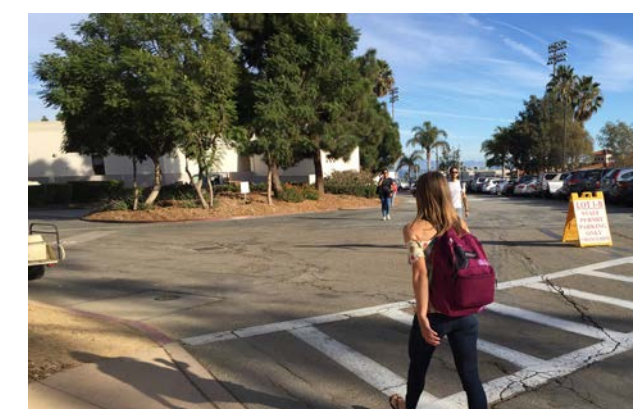
East Campus Entrance, roadway + crosswalk
 • Students walk dangerously in the road as crosswalks and sidewalks do not provide a direct route.

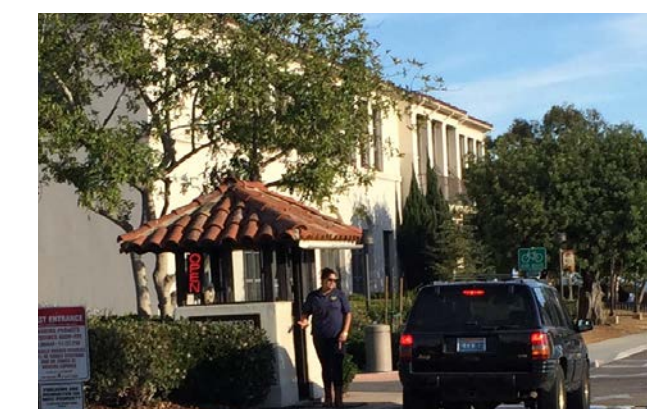
East Campus Entrance kiosk
 • Vehicles stack as some wait to stop at kiosk and others try to access parking.

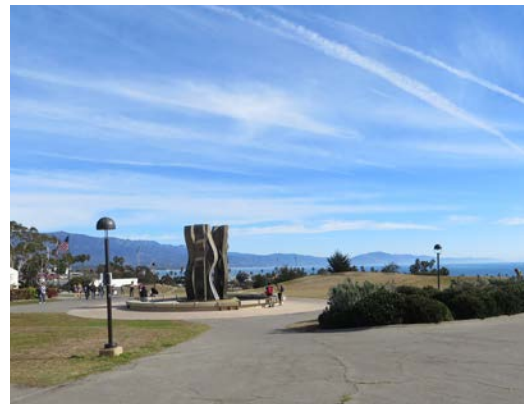
Primary pedestrian path, West Campus

- The primary path through campus lacks a clear sense of direction.

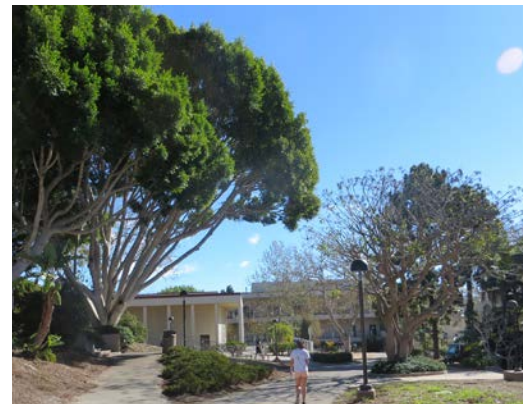
Secondary pedestrian path, East Campus

- Secondary paths are often circuitous, and due to slope and materials, are noncompliant.

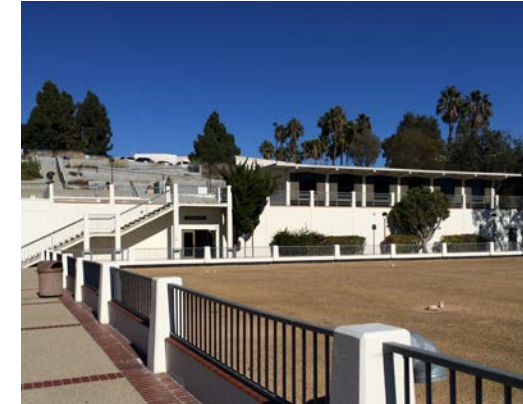
Accessible route near Sports Pavilion, East Campus

- Accessible routes are often indirect and confusing to navigate.

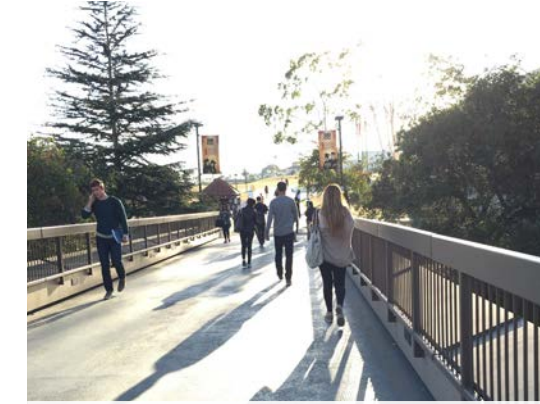
Primary pedestrian path, Loma Alta Bridge

- Loma Alta Bridge is the only pedestrian connection between East and West Campus.

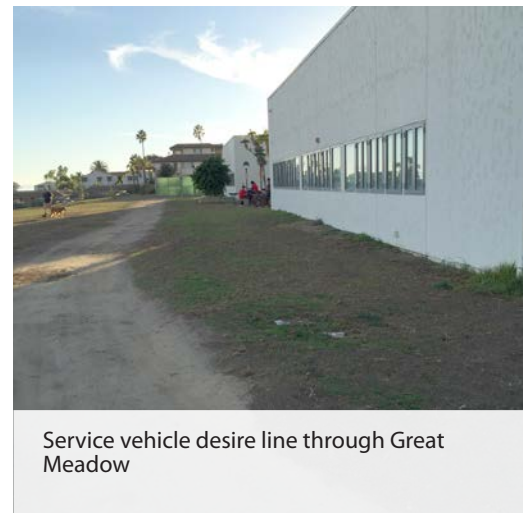
Service vehicle desire line through Great Meadow

- Campus service vehicles also use desire lines when a direct connection is not available.

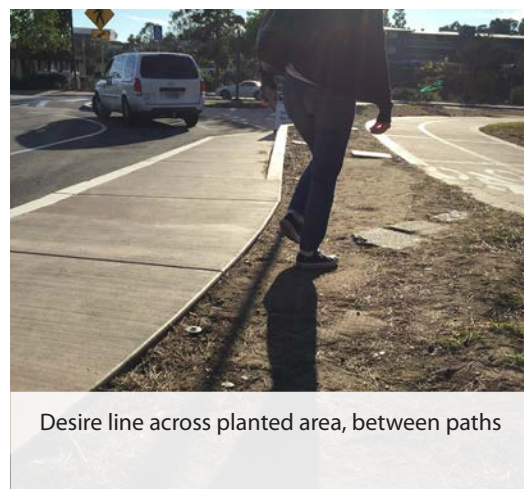
Desire line across planted area, between paths

- Students cut across planted areas between paths, damaging vegetation.

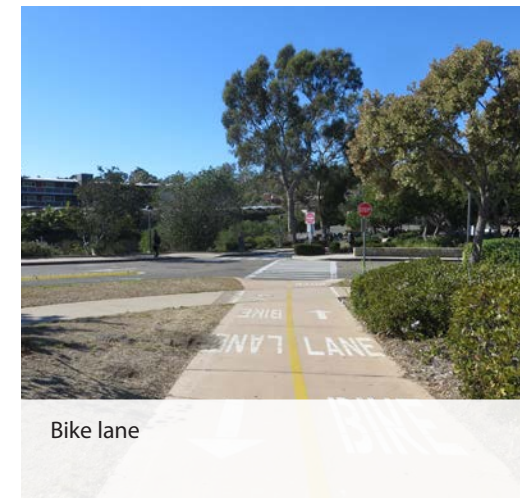
Bike lane

- The campus only has one pathway just for bikes, which parallels Cliff Drive on East Campus.

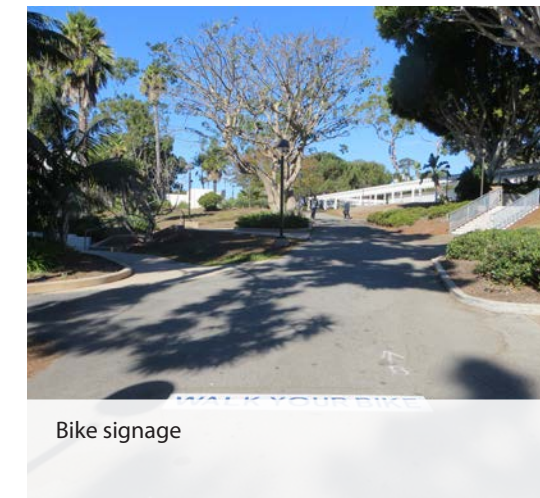
Bike signage

- Through most of campus, bikes are meant to be walked, not ridden.

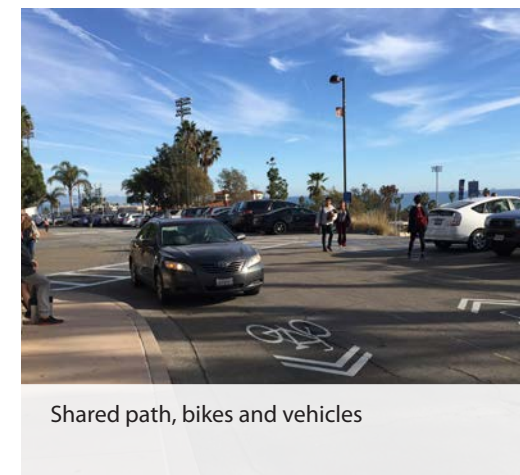
Shared path, bikes and vehicles

- Bikes typically share space with vehicles on campus.

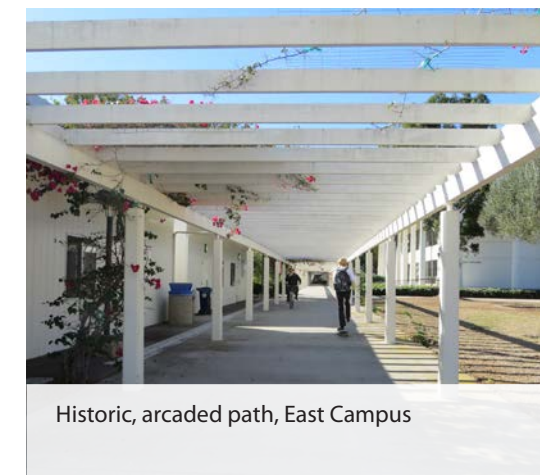
Historic, arched path, East Campus

- Bikes and skateboards often share pedestrian paths.

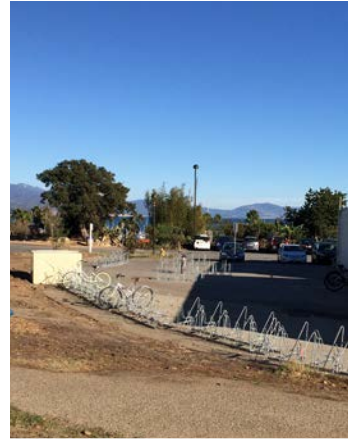
Over-abundant bike parking on East Campus

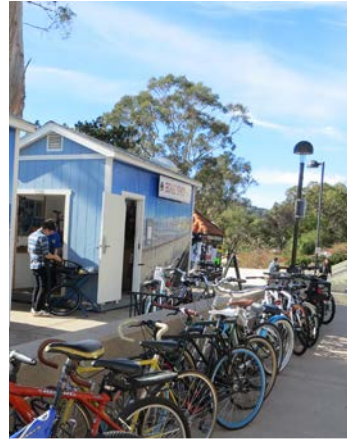
Bike parking and service on East Campus

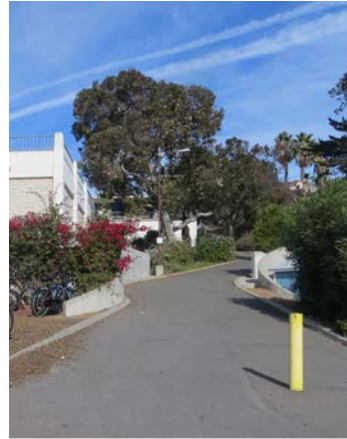
Over-crowded bike parking at Lot 2C entrance

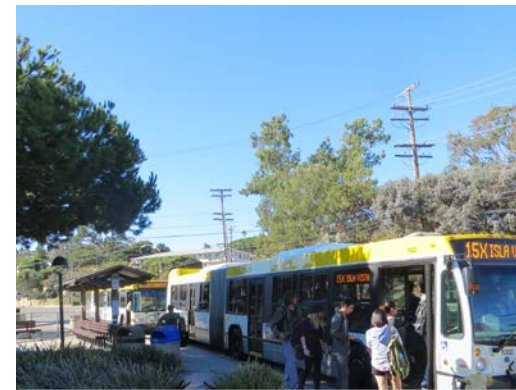
bus stop, East Campus

- This bus stop lacks adequate space to accommodate arriving and departing passengers comfortably and safely.
- People embark and disembark far from the path that leads to the stop, causing students to use the adjacent roads to access the stop.

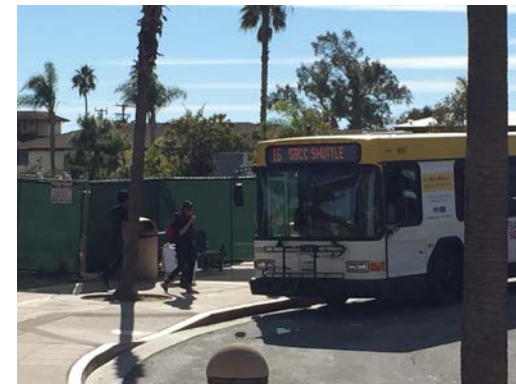
bus stop, west Campus

- This bus stop lacks shelter or seating and competes with passenger loading at the same location.

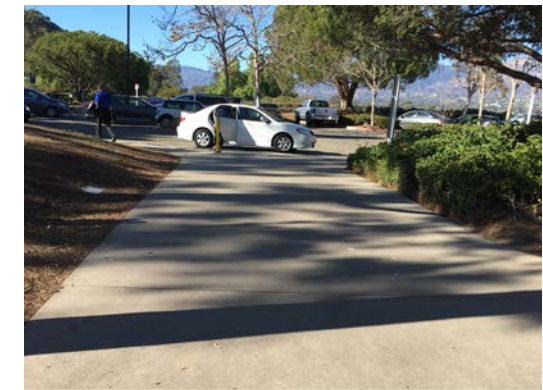
passenger loading by Student Services, East Campus

- Passenger loading areas tend to lack sufficient campus orientation or wayfinding.
- These areas are scattered across campus, as opposed to being centralized.

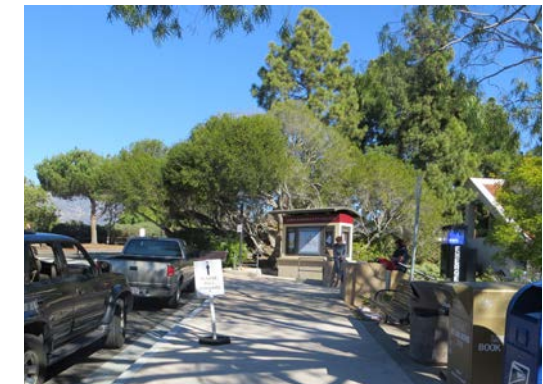
passenger loading by Administration, East Campus

- Passenger loading zones are often overcrowded with vehicles.

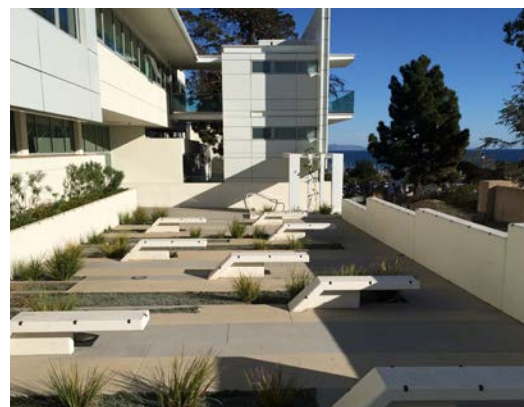
Humanities Building Courtyard

- This courtyard is not easily visible or accessible from the building or adjacent path.
- The seating is inflexible and uncomfortable and there is no relief from direct sun.

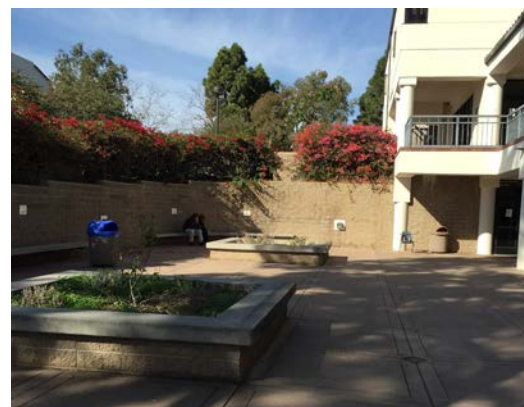
Interdisciplinary Center Courtyard

- This courtyard is hidden, underutilized and lacks any notable landscape features.
- The tall walls are forboding and make the space feel sunken.

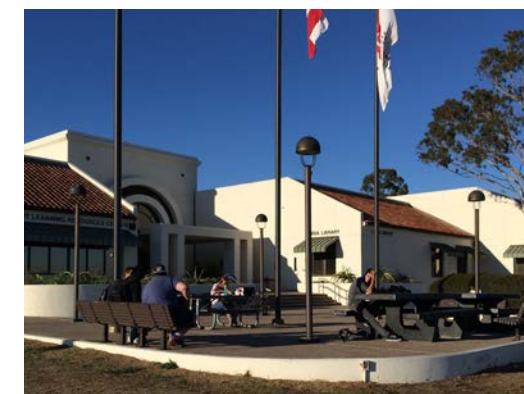
Luria Library Entrance Plaza

- This plaza is highly visible and has ocean views, however, there is little shade and furnishings do not support a range of activity.

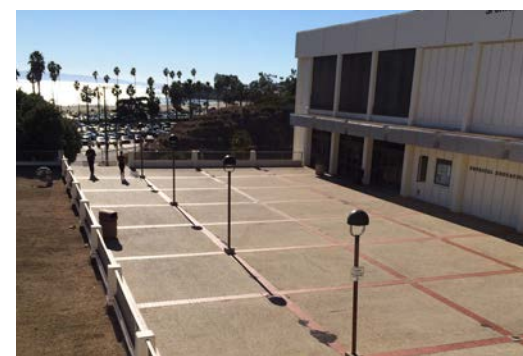
Sports Pavilion Plaza

- This plaza is vast and empty lacking furnishings or shade.
- People move through this space without lingering.

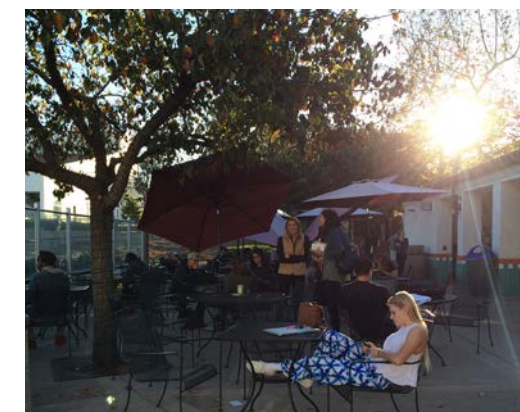
West Snack Shop

- Located by the only dining facility on the East Campus, this dining plaza is often crowded.
- Wind screens define the space and restrict flexible expansion during busy times.

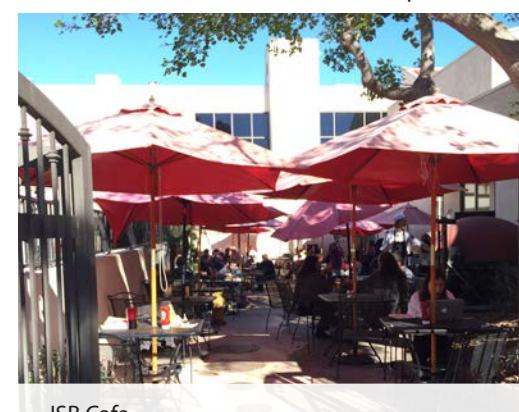
JSB Cafe

- This dining area is very popular and typically crowded.
- Walls and gates define and constrict space, there is limited ability to even circulate.

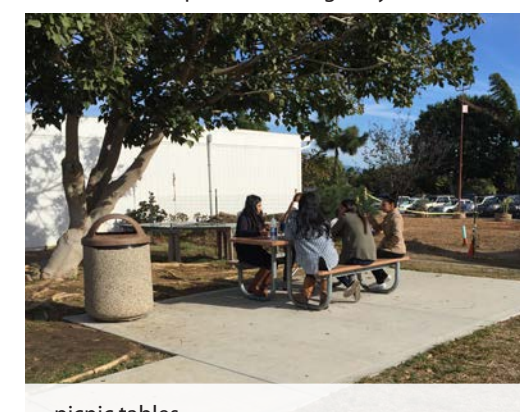
- Sporadically placed across campus, picnic tables offer a quieter, more intimate outdoor dining experience.
- Many are randomly sited and offer little sense of place.

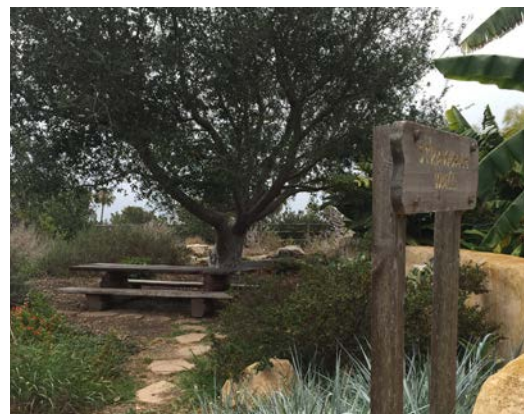
Lifescape Gardens

- Seating is tucked away throughout the gardens, offering a quiet space, however, additional seating that is more visible and accessible could be beneficial.

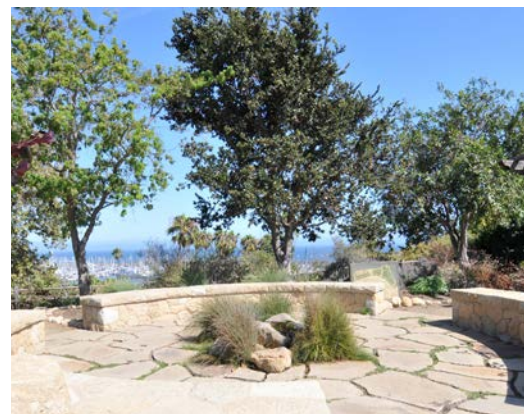
Courtyard in Lifescape Gardens

- While the scale of this space provides an intimate setting, there is little shade.

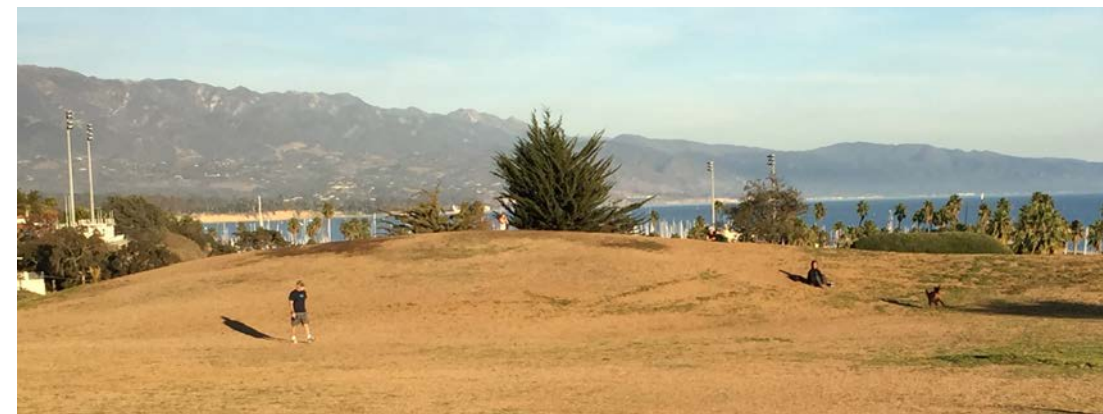
Great Meadow

- The Meadow is often used by the community as a dog park.
- Due to the drought, irrigation has been turned off and the dry turf grass is perhaps less inviting for gathering than it once was.

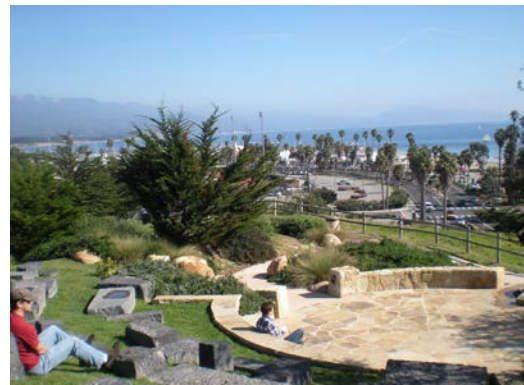
- Bagish Overlook is well-used due to attractive views.
- The materials of the site are incohesive and busy, distracting from the view beyond, and accessibility is a concern.

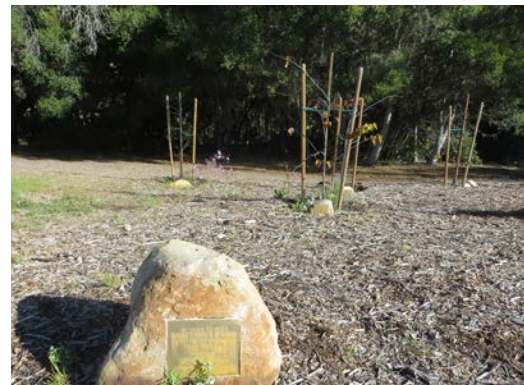
memorial monuments at West Campus entrance

- These memorials stand alone in a low-traffic area, are unrelated to other memorials on campus, and are not connected to any defined pathway.

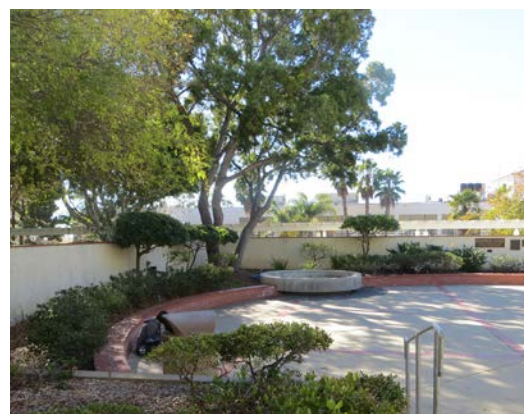
memorial plaza by Student Services

- This walled space is large and underutilized with seat walls that do not promote socializing or lingering.

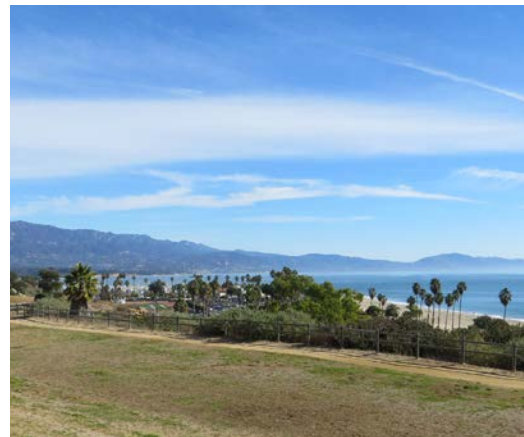
- Open space and expansive views support gathering and activity.
- The Great Meadow has some patches of dry, brown turf due to the drought and subsequent irrigation shut-off.

The current condition of the Great Meadow is fair. With the historic drought, irrigation has been turned off and the majority of the grass appears dry and brown. Overlooks and the more complex planting arrangements that accompany them bite into the overall strength of the feature. With limited accommodations for service vehicles, dirt paths have developed that also break up this landscape. In addition to the Great Meadow, the campus contains other swaths of lawn. Like the meadow, these areas are not currently receiving irrigation and have become dry and brown. The use of non-native turf grass is superfluous. There is an opportunity to transition a portion of the areas currently covered with turf to native coastal meadow.

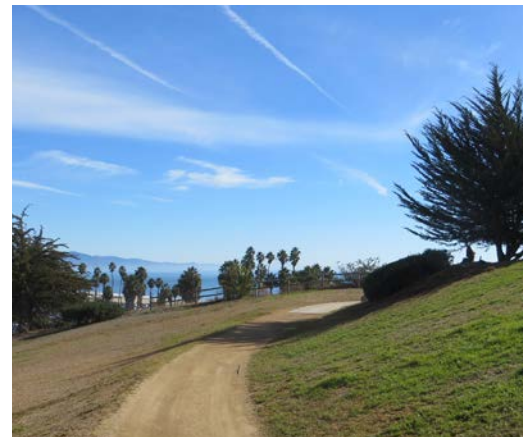
Great Meadow, pedestrian path

- Dirt paths for pedestrians and small service vehicles connect overlooks while cutting through the landscape.

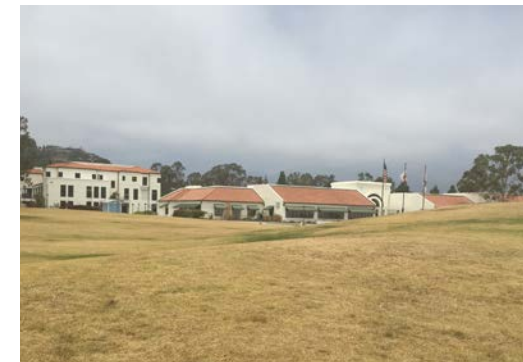
- The Meadow's gently rolling topography supports gathering and activity.
- The Great Meadow has areas of dry, brown turf due to the drought and subsequent irrigation shut-off.

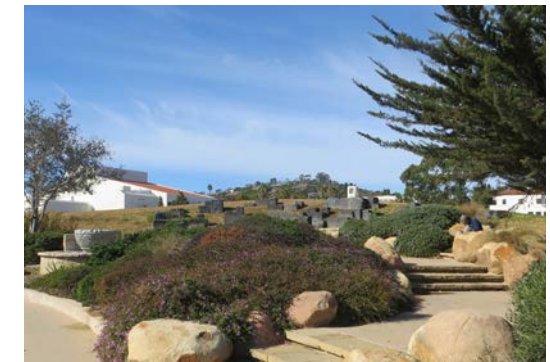
Great Meadow

- Overlooks carve into the meadow.

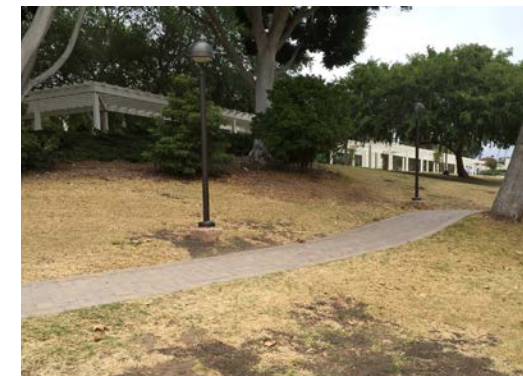
open lawn with some mixed planting

- Additional areas of lawn also have dry, brown turf due to the drought and subsequent irrigation shut-off.

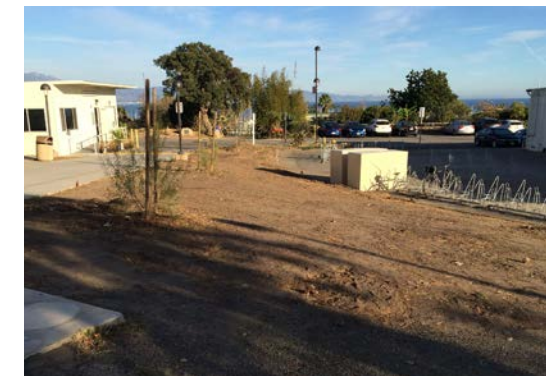
bare earth

- Areas previously covered with lawn have become unsightly, patchy areas of dry turf and bare earth.
- These spaces are subject to weeds and soil erosion.

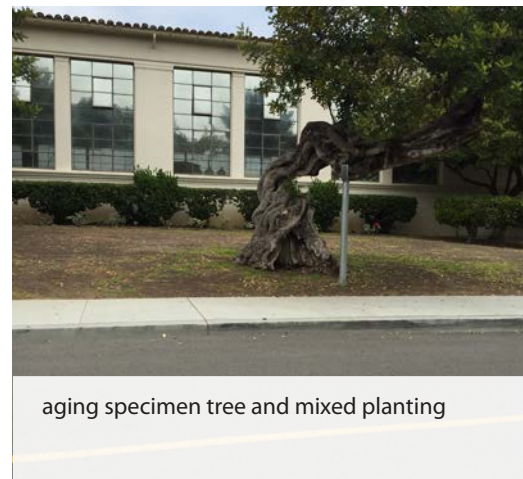
aging specimen tree and mixed planting

- The carob trees by the Administration Building are aging, structurally unsound, and in need of maintenance and eventual removal.

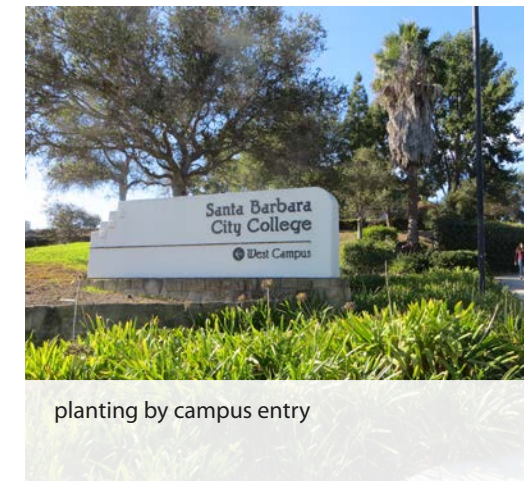
planting by campus entry

- The West Campus entry is defined by large swath of Agapanthus.
- Many older plantings do not comply with current campus sustainability goals.

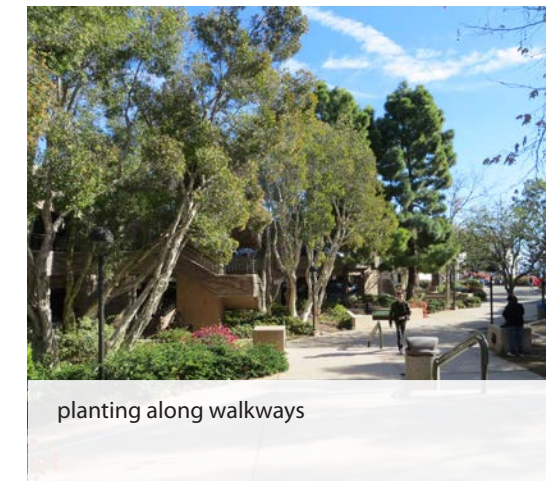
planting along walkways

- Many mixed planting areas appear eclectic, unplanned, and irregular.

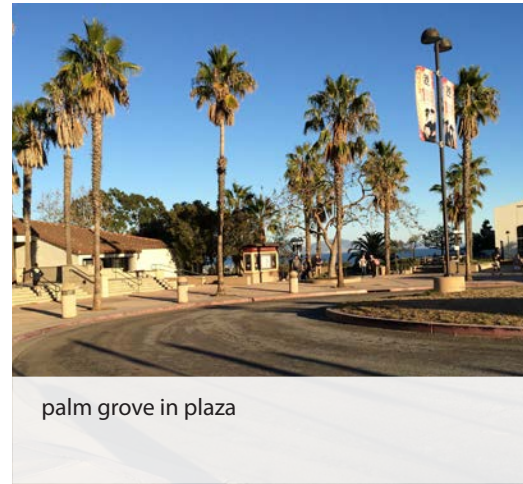
palm grove in plaza

- Palms add identity and spatial structure to an entry plaza and drop off area in west campus.
- Throughout campus, many palm fronds need removal.

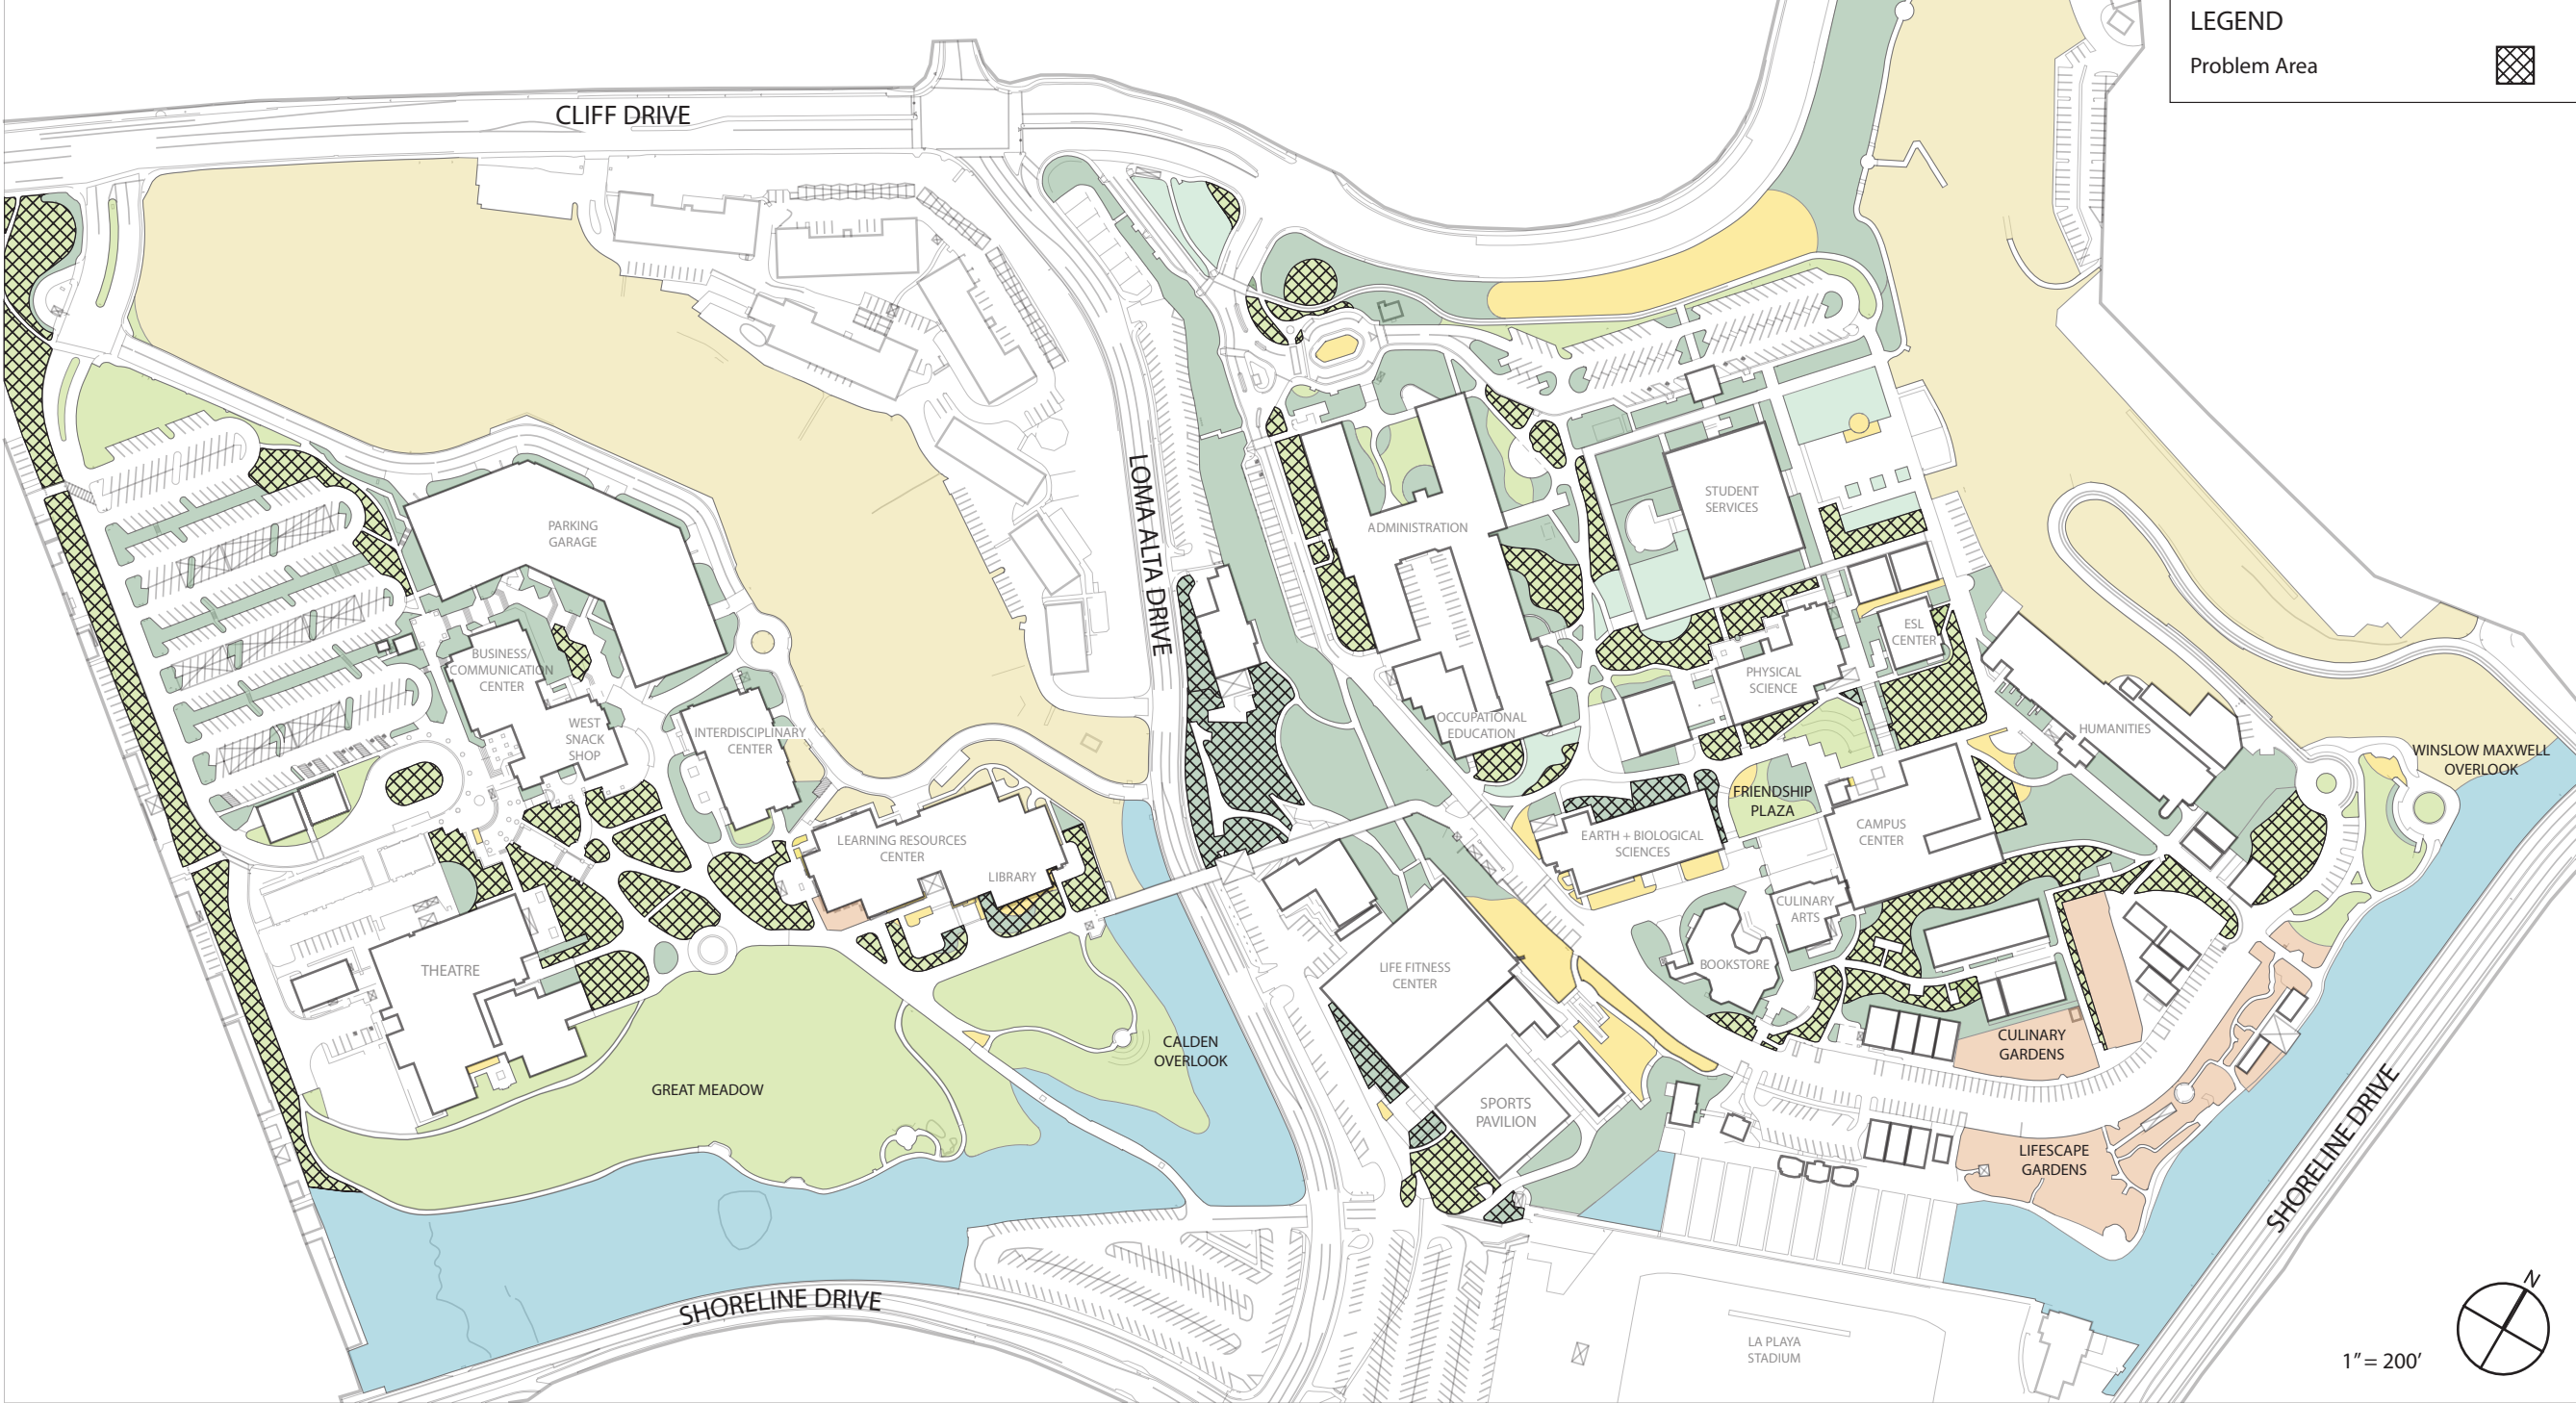
LANDSCAPE PROBLEMS ASSESSMENT SITE PLAN

- The campus lacks current irrigation technologies including a master valve and pump regulator.
- There are fluctuations in water pressure and a lack of smart controllers with linked weather stations.

- Replacement of high water use plants with permaculture gardens is proceeding without a larger master plan in place.
- With exception to Great Lawn, Oak Woodland, and Coastal Bluff, the campus lacks a strong, compositional execution of plants that could strengthen a sense of place and streamline maintenance practices.

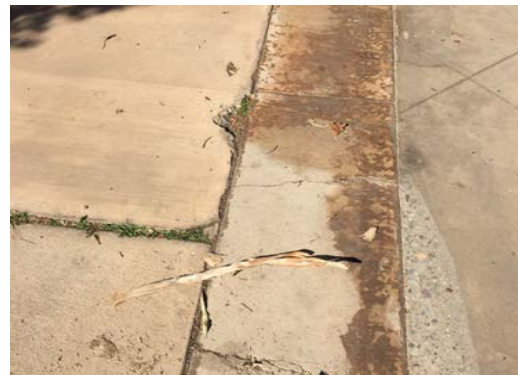
concrete with integral color

- Many joints are larger than 1/4", often uneven, and have minor to moderate cracking.
- Vertical uplifting at joints creates a tripping hazard and numerous areas around campus have been ground down.

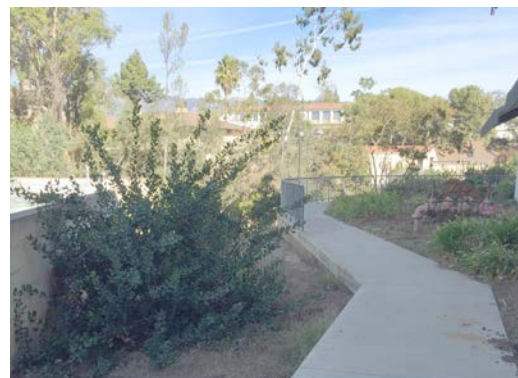
concrete walkway

- A few walkways and surfaces have a more than a 4" drop from pavement edge to the adjacent grade.

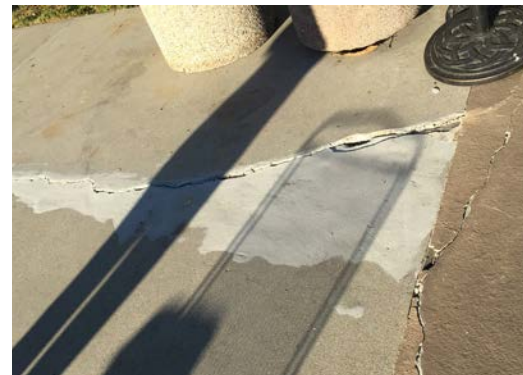
concrete with and without integral color

- Patching often does not match the surrounding paving and is poorly executed.
- While "Sombbrero Buff" with broom finish is the standard for integral color concrete, colors and finishes vary greatly depending on age and location. This variation reduces overall pavement cohesiveness.

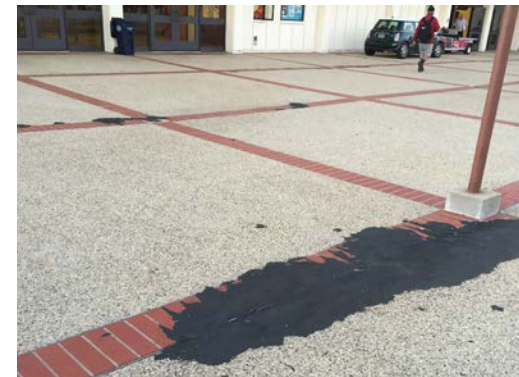
concrete with exposed aggregate and brick accents, patching

- Patching is often poorly executed and does not match the surrounding paving.
- Multiple paving types used on one surface increase maintenance demands.

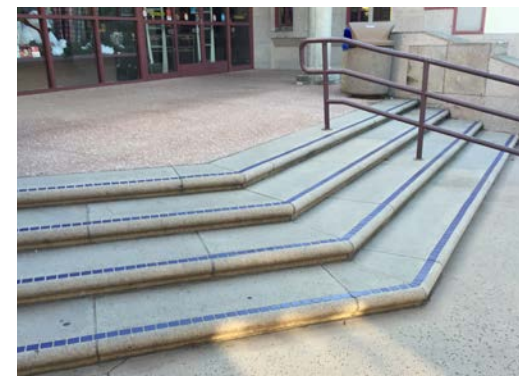
concrete stairs with tile accents on treads

- Tile accents on stair treads do not meet code. A grooved edge on tread nose is required.
- Paving in building entry plazas is typically in fair condition.

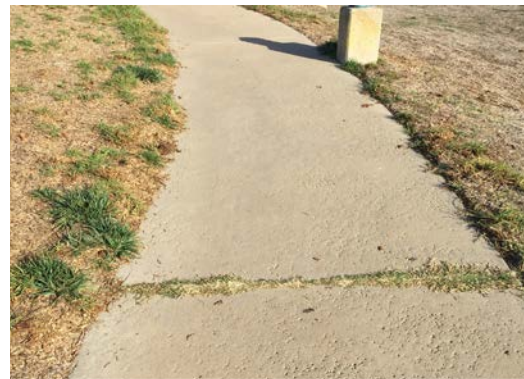
concrete with integral color

- A few pathways have exceptionally wide joints, with weeds emerging.
- Inconsistent finish of concrete contributes to lack of visual cohesion and is more difficult to maintain.
