Santa Barbara City College

SBCC Campus & Building Assessments Report

April 2016

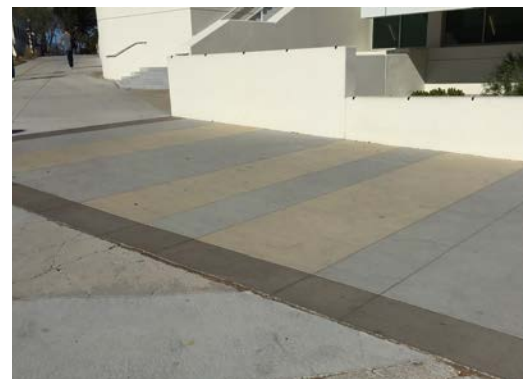
concrete with and without integral color

- Some areas have high degree of variation in concrete color and finish.
- Patching does not match the surrounding paving.
- Many construction joints are wider than 1/4".

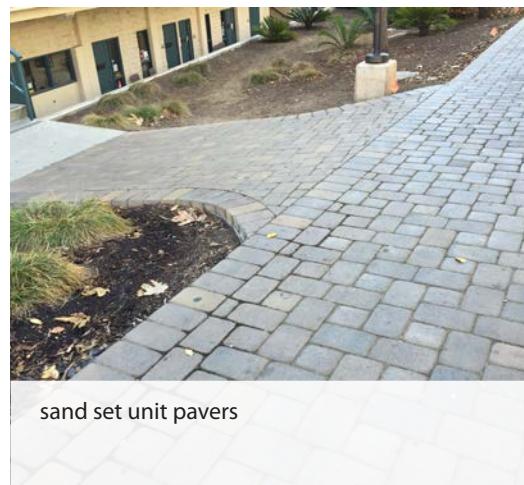
sand set unit pavers

- Pathways with unit pavers have more than 4" drop to adjacent grade in several locations.
- Sand set unit pavers require additional maintenance for removal of weeds and debris.

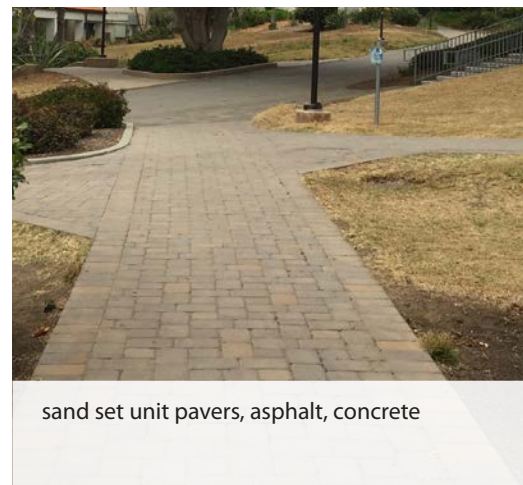
sand set unit pavers, asphalt, concrete

- Many areas of campus have an erratic use of paving materials.
- Changes in paving material make wayfinding confusing.

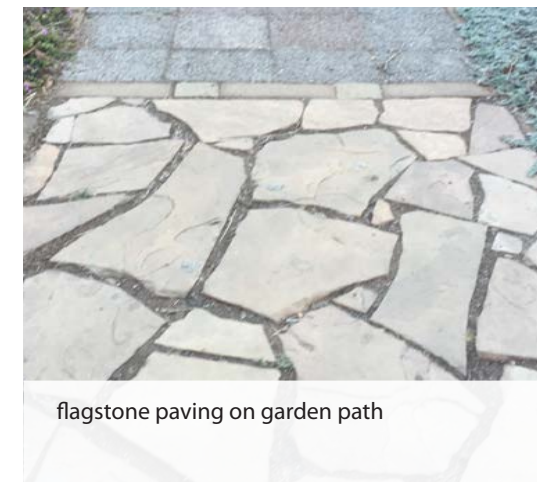
flagstone paving on garden path

- Joints between stone pieces are typically wider than 1/4" and are non-compliant.

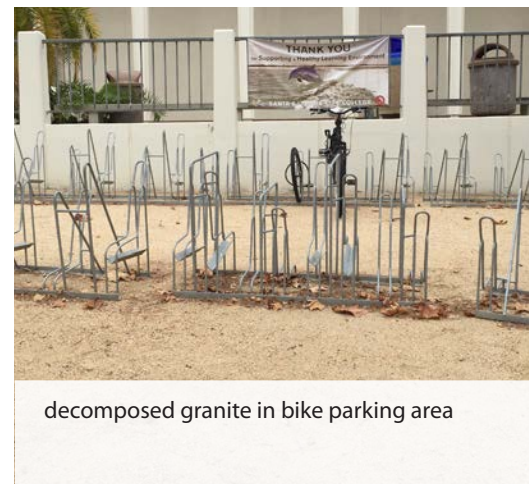
decomposed granite in bike parking area

- Transitions from DG to other surfaces are often uneven.
- DG is typically difficult to maintain.
- DG accumulates debris and can be tracked into buildings when wet.

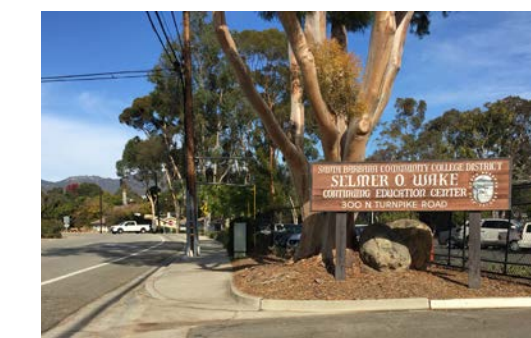
Wake Campus entry

- This sign is the main visible feature at the campus entry.
- Campus entries do not include direct pedestrian access.

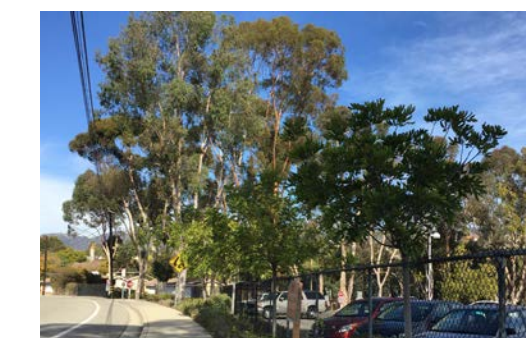
sidewalk along North Turnpike Road

- The campus is separated from the adjacent sidewalk and street by a chain link fence.

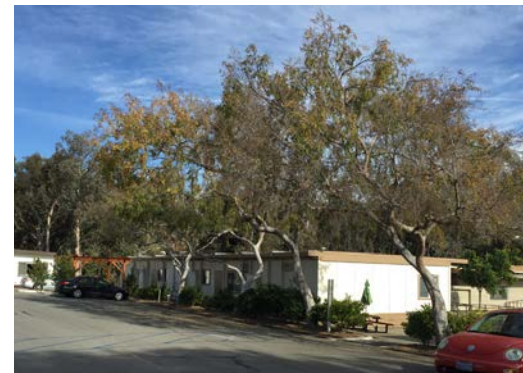
parking lot planting

- Trees in the core of campus are typically small and appear somewhat unhealthy.

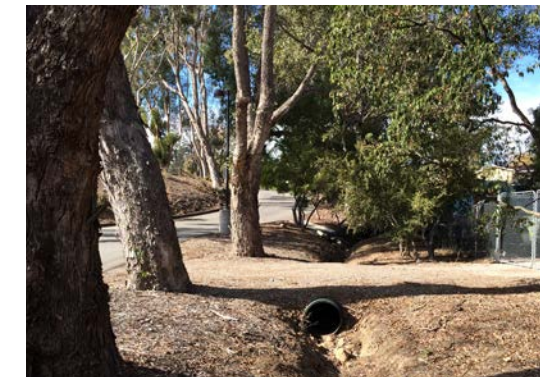
drainage ditch along northern edge of campus

- Drainage ditches line the northern and eastern edges of the site.

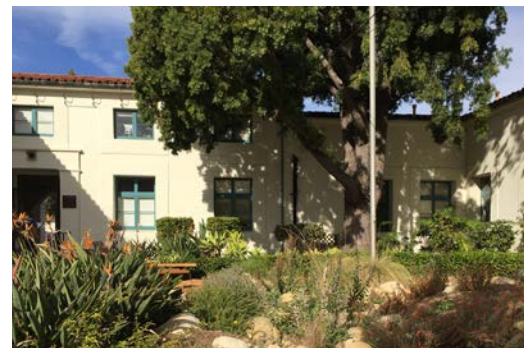
bioretention area

- The bioretention area was designed and built to handle stormwater, however, it is not an engineered installation.
- This installation is an aesthetic evolution of the historic quality of the landscape.

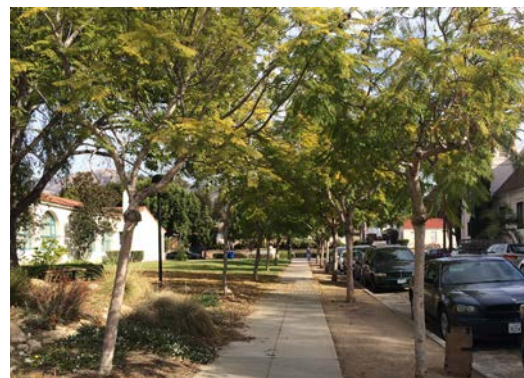
streetscape with street tree allee

- The surrounding streetscapes include an allee of Jacaranda trees lining the sidewalk along Padre Street.
- The curbside planting strip is mostly dirt.

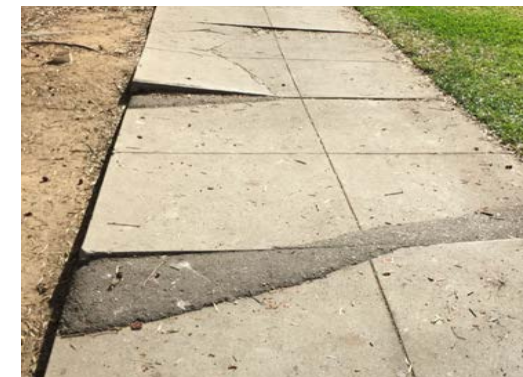
concrete sidewalk

- Portions of the sidewalk have uneven surfaces with minor to moderate cracking and some patching.
- Construction joints, especially those between asphalt and concrete, are typically wider than 1/4".

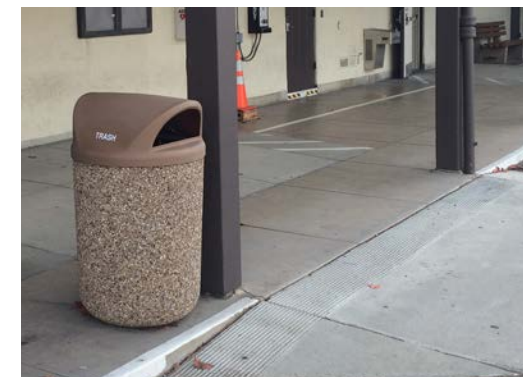
concrete ramps

- The transition from the parking lot to the pedestrian arcade lacks tactile warning pavers.
- Much of the walkway is raised 2-3" above the parking lot.

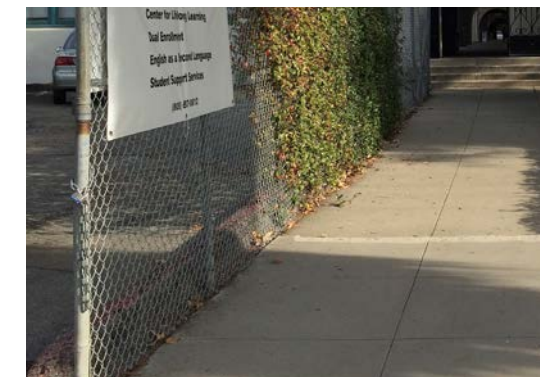
concrete entry

- Walkways connecting building entries to the surrounding sidewalk have uplifting at joints.
- Most of these have been ground down.

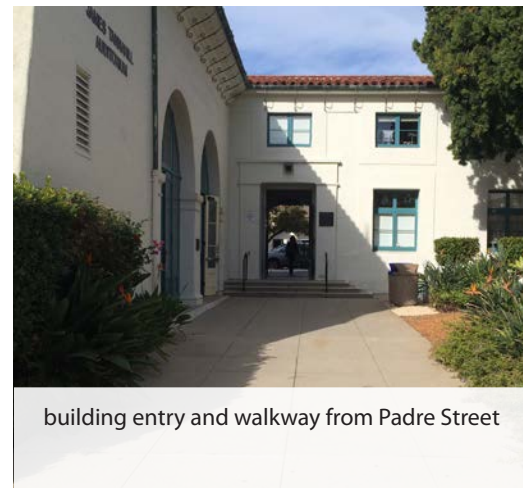
building entry and walkway from Padre Street

- The main entry from Padre Street is only accessible by stairs.

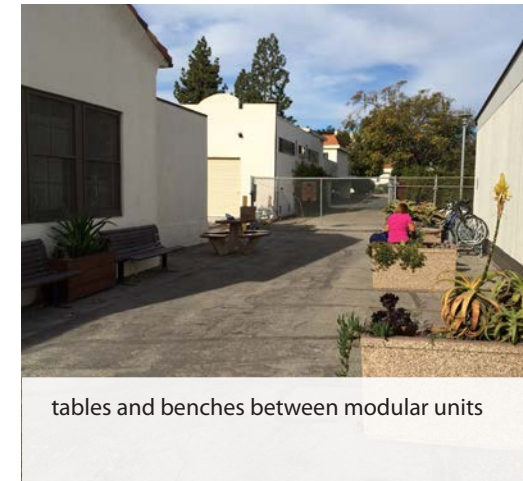
tables and benches between modular units

- Outdoor seating appears arbitrary and unplanned.
- Connectivity between the the historic building and modular units is poor.

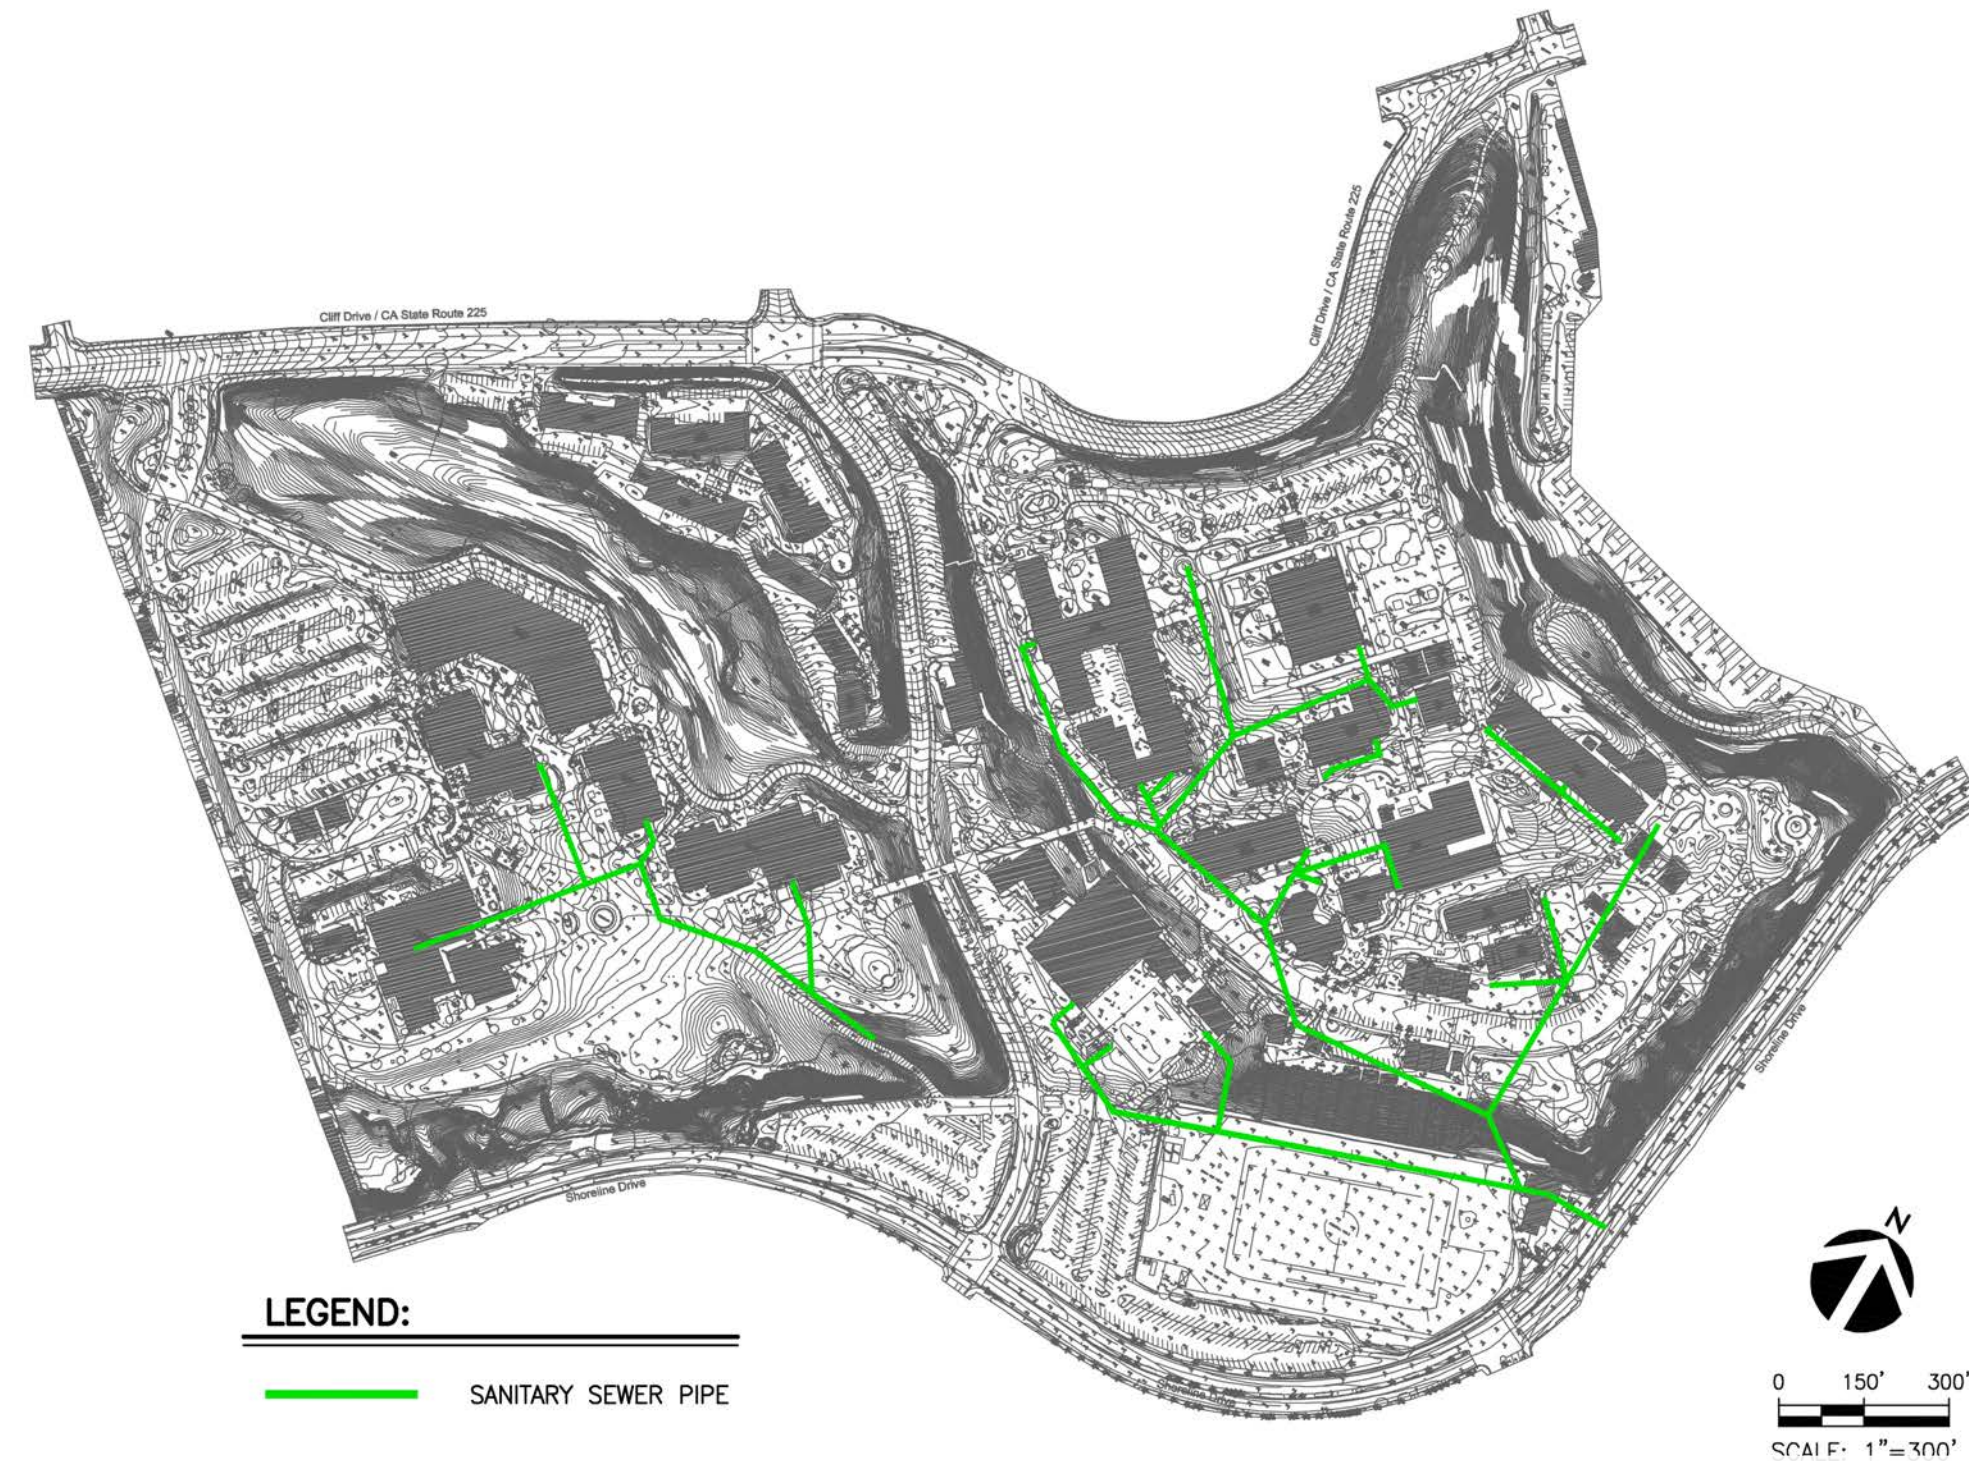
Figure 3.1.11 Existing Sanitary Sewer System

It is our understanding that the campus sewer system is aged and constructed mostly of clay pipes, which have a tendency to deteriorate over time. Additionally, the campus has experienced blockages caused by tree roots damaging, displacing, and/or clogging the pipes. Lastly, a few incidents of vandalism have required repairs to building sewer systems.

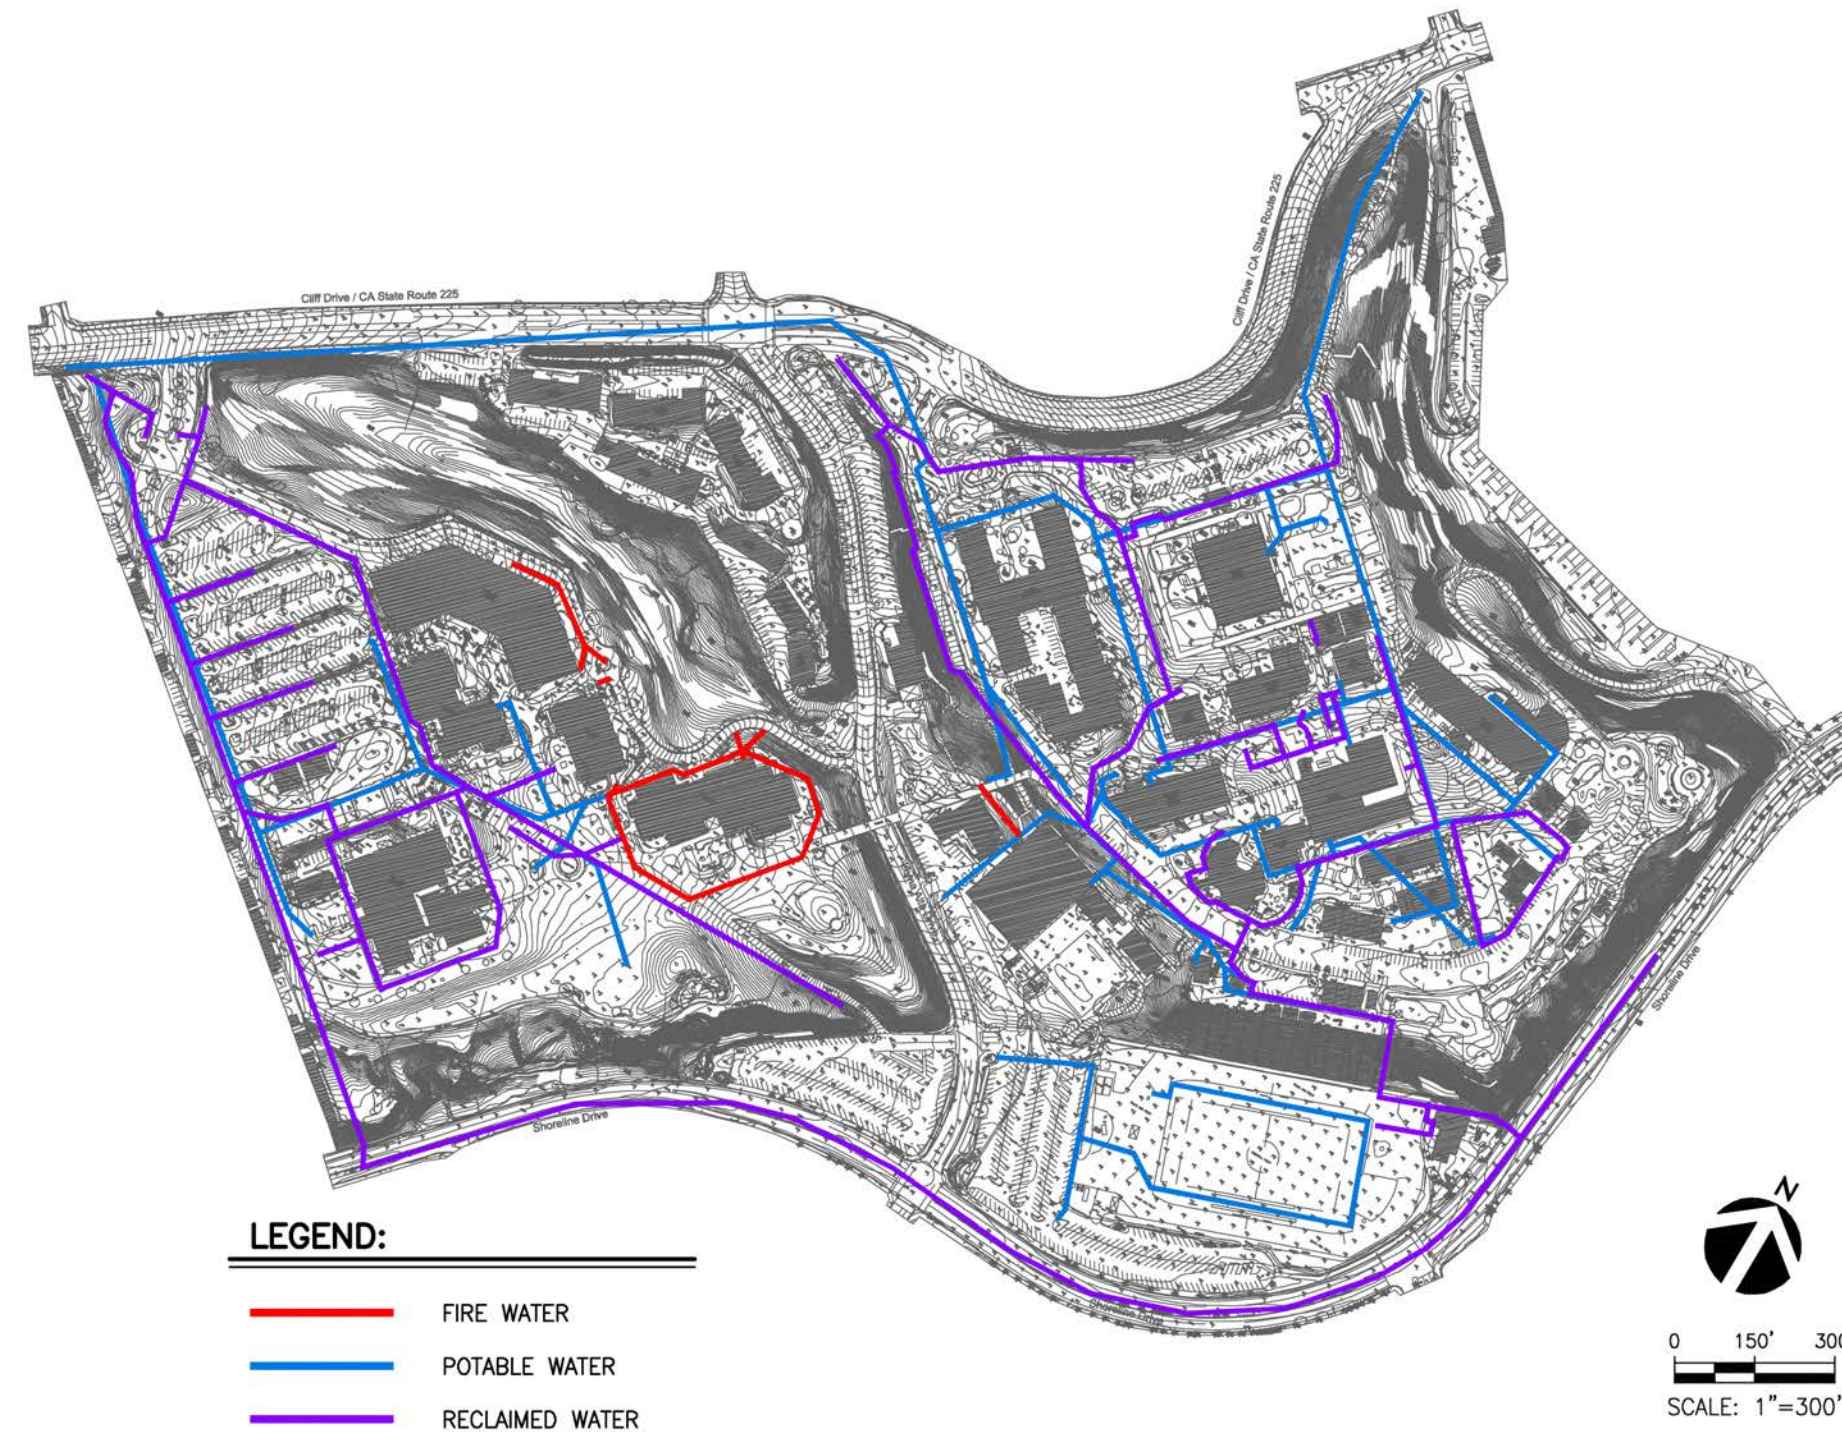
Figure 3.1.11 Existing Water System

It is our understanding that the existing water system is aged and that leaks are common on campus. Additionally, many of the pipes are highly corroded which has required repairs at multiple buildings.

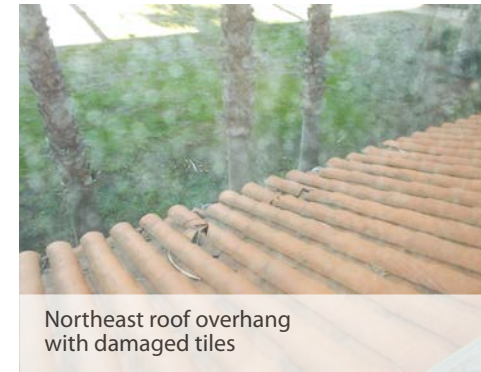
sheet with areas of built up roofing over wood decking. There are various locations where the Spanish tile is broken and damaged.

Northeast roof overhang with damaged tiles

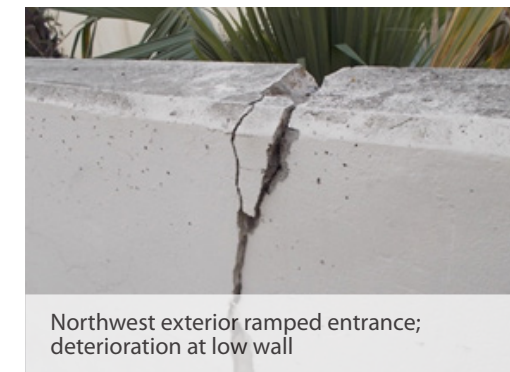
Northwest exterior ramped entrance; deterioration at low wall

- The ramped approach to the northeast building entrance is excessively long, and requires a landing mid-way up and handrails to meet current ADA codes. This concrete ramp shows significant cracks and spalling, and the adjacent exterior half wall is also cracked.
- Several entry egress door thresholds exceed the 1/2" maximum height, without being beveled at a 2:1 slope. Minimum maneuvering clearances are not met at all exterior first floor office doors, and numerous doors do not have ADA compliant entry signage.
- An ADA compliant path of travel from the main public transit location does not exist.

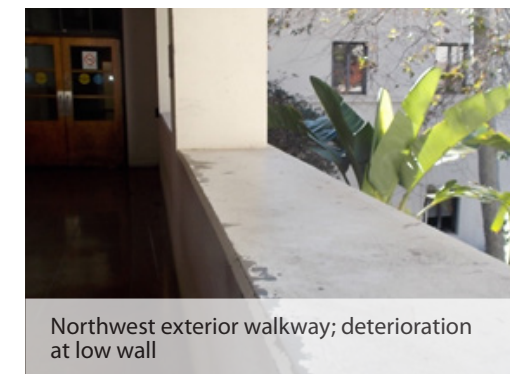
Northwest exterior walkway; deterioration at low wall

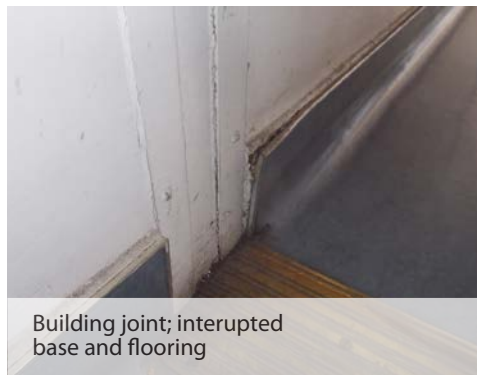
Building joint; interrupted base and flooring

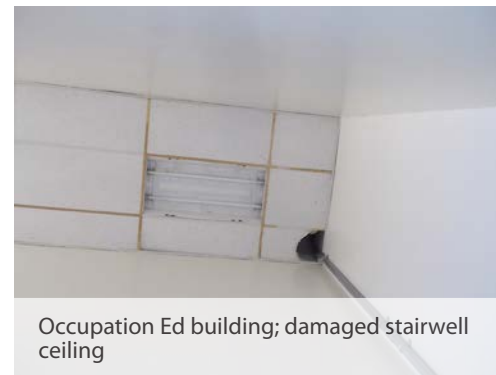
Occupation Ed building; damaged stairwell ceiling

INTERIOR FINISHES: Although some wall and floor finishes have been refurbished during various renovation projects, numerous walls, wall corners and floor finishes throughout the buildings are damaged, outdated, and are in general need of repair.

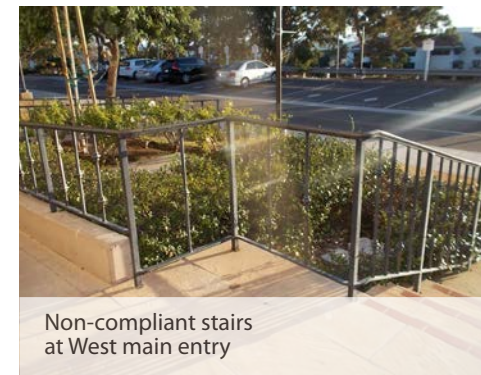
Non-compliant stairs at West main entry

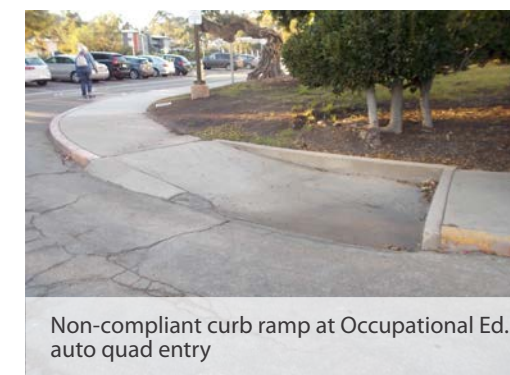
Non-compliant curb ramp at Occupational Ed. auto quad entry

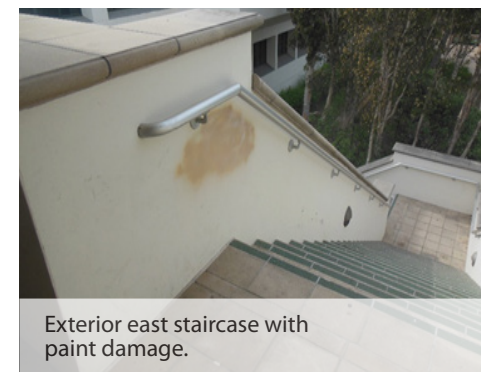
- The exterior wall finish is painted plaster over both concrete and steel stud construction, and at numerous locations, is in very poor condition. The finish is bubbled, peeling, has below surface plaster deterioration, and is in need of repair.

Exterior east staircase with paint damage.

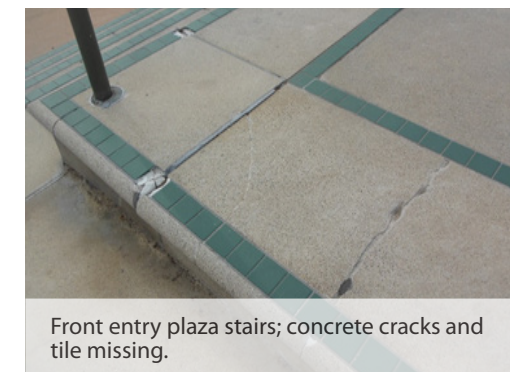
Front entry plaza stairs; concrete cracks and tile missing.

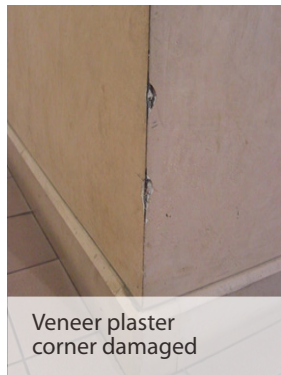
Veneer plaster corner damaged

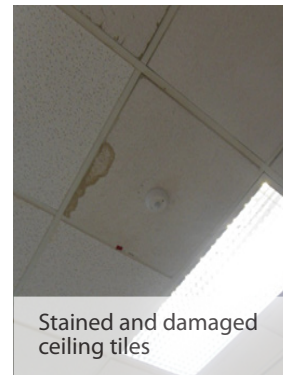
Stained and damaged ceiling tiles

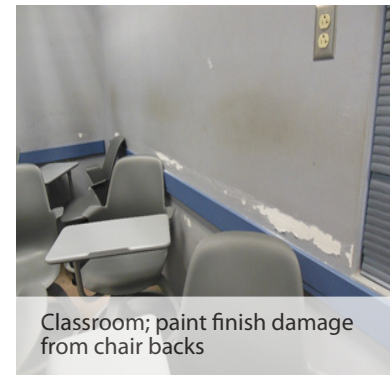
Classroom; paint finish damage from chair backs

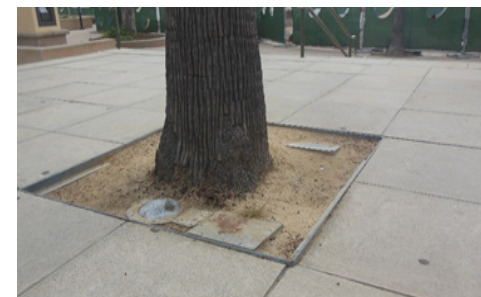
West entry plaza tree well; hazardous surface feature along path of travel.

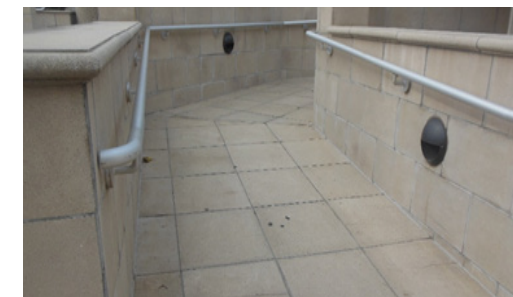
Ramp to building entry; intermediate landing exceeds 2% allowed maximum cross slope

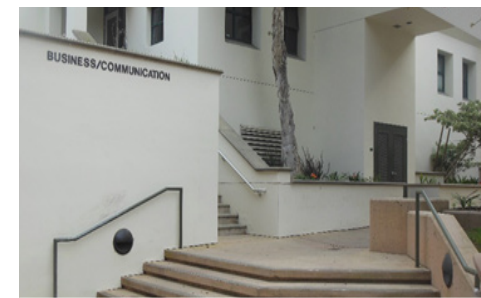
Non-accessible entry lacks wayfinding signs directing user to ramped entry location

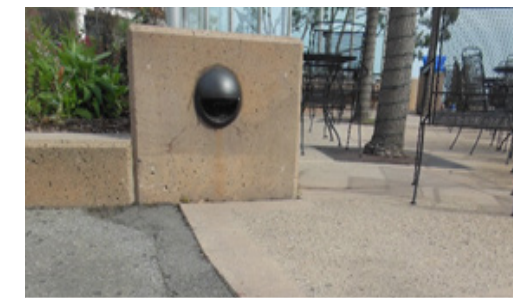
Pathway material transition; abrupt change in level and hazardous surface features

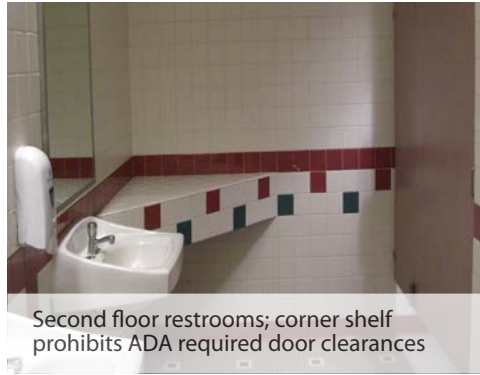
Second floor restrooms; corner shelf prohibits ADA required door clearances

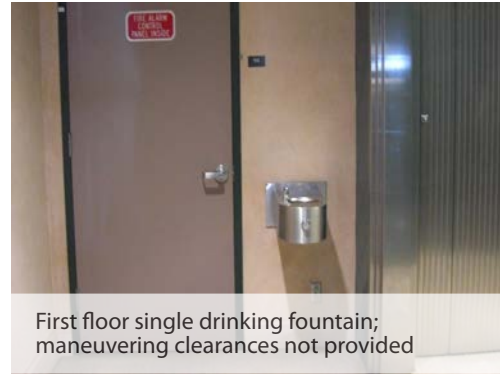
First floor single drinking fountain; maneuvering clearances not provided

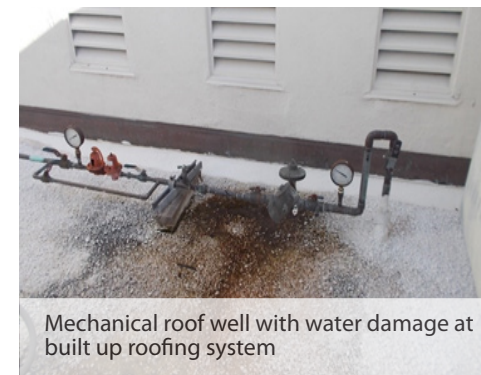
ROOF: While the clay tile roof remains, generally, in good condition, failure of the built-up roof in some locations requires further investigation and repair.

- Built up roofing at the mechanical roof wells have standing water, poor roof drainage, and potential underlying damage possibly caused by the old, poorly maintained mechanical equipment in the same location.

Mechanical roof well with water damage at built up roofing system

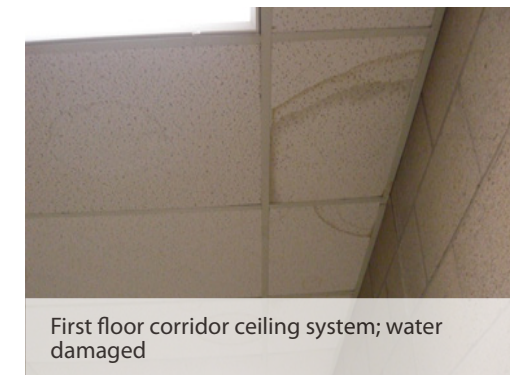
First floor corridor ceiling system; water damaged

- Not included as part of any of the upgrades completed between 2013 and 2015, the suspended ceiling system is original and many of the acoustical ceiling tiles are damaged, stained, and in need of replacement. The ceiling suspension grid system is bent or damaged in some locations and requires repair. Additionally, the suspended ceiling system components likely no longer meet current ASTM ratings, the CBC, or Department of the State Architect (DSA) requirements.

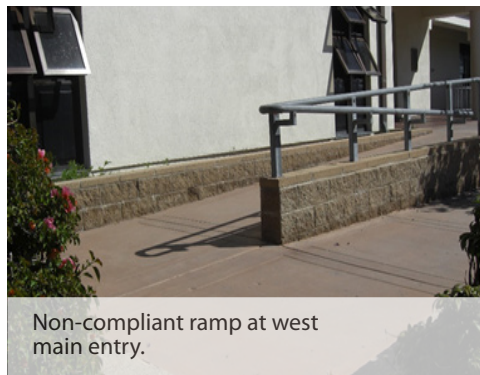
Non-compliant ramp at west main entry.

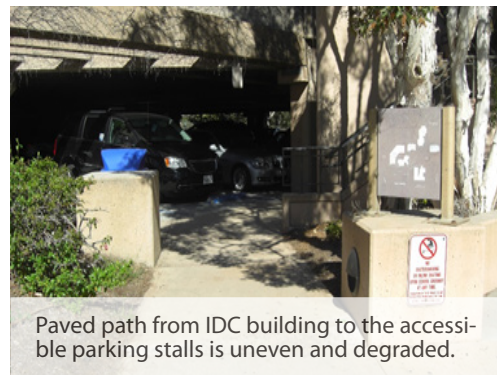
Paved path from IDC building to the accessible parking stalls is uneven and degraded.

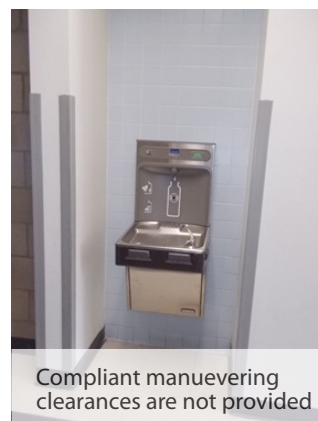
Compliant maneuvering clearances are not provided

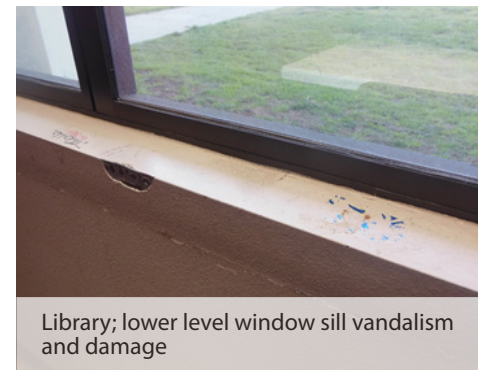
Library; lower level window sill vandalism and damage

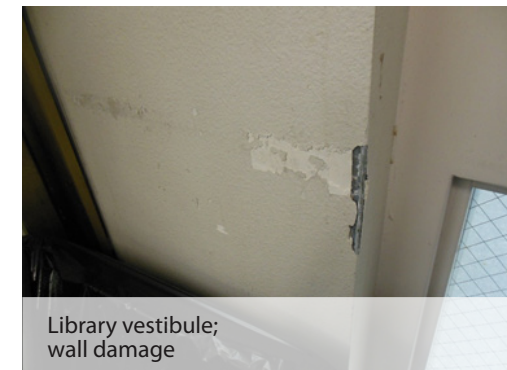
Library vestibule; wall damage

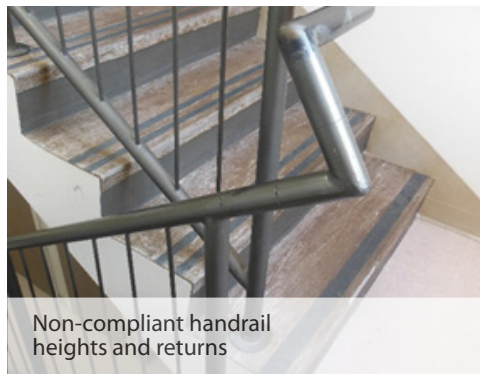
Non-compliant handrail heights and returns

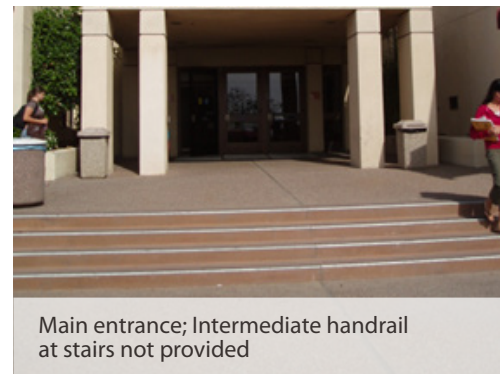
Main entrance; Intermediate handrail at stairs not provided

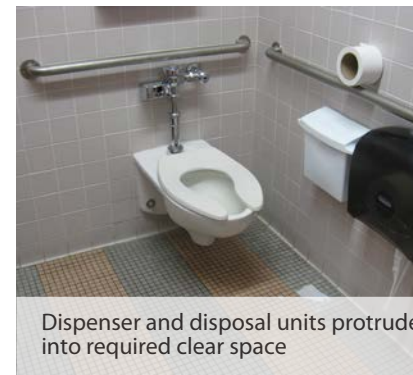
Dispenser and disposal units protrude into required clear space

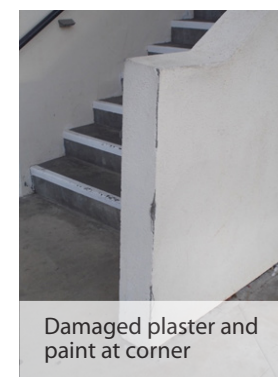
- The exterior painted plaster wall finish is in overall fair condition, with various locations of peeling paint and hairline cracks that require repair and repainting.

Damaged plaster and paint at corner

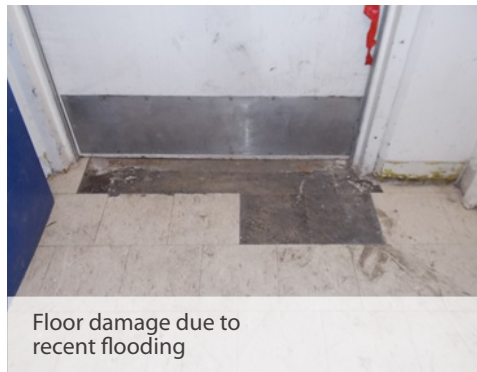
HAZARDOUS MATERIAL REMEDIATION: Due to recent flooding in the basement, there may be the need for remediation of hazardous materials from the damaged walls and floors.

Floor damage due to recent flooding

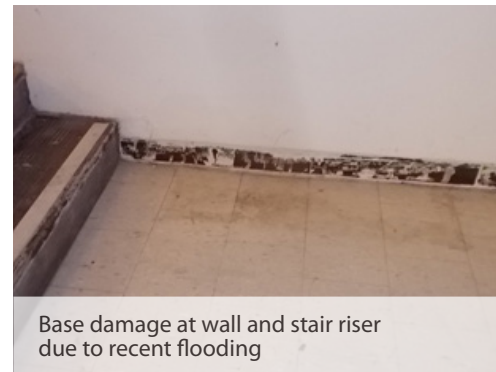
Base damage at wall and stair riser due to recent flooding

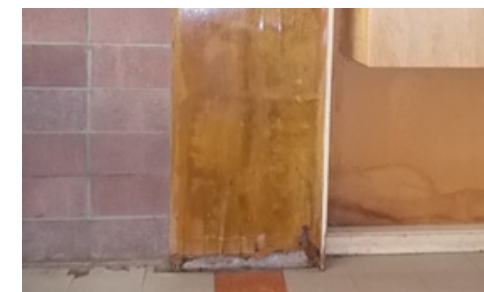
Auditorium walls; water damaged exposed CMU and wood finishes

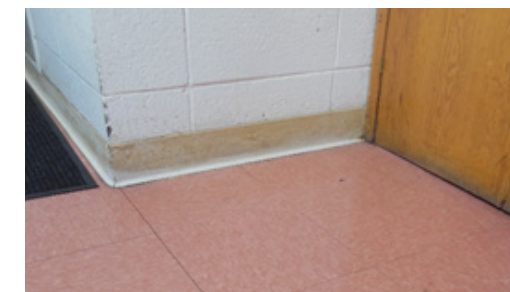
VCT in classrooms; worn and in need of replacement

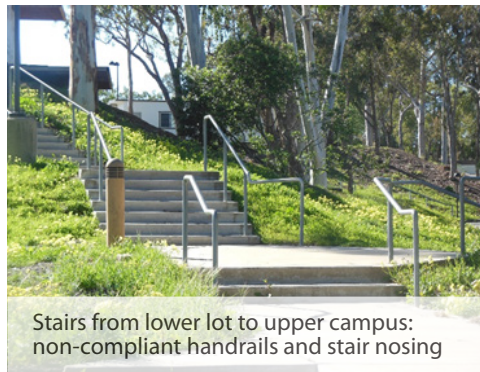
Stairs from lower lot to upper campus: non-compliant handrails and stair nosing

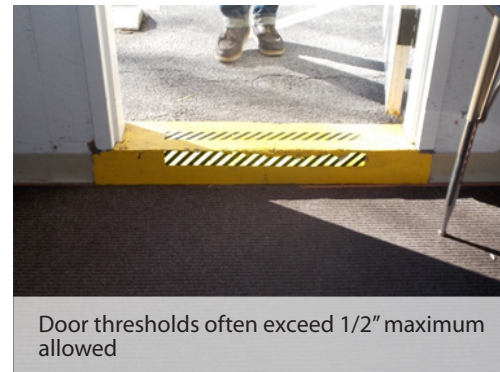
Door thresholds often exceed 1/2" maximum allowed

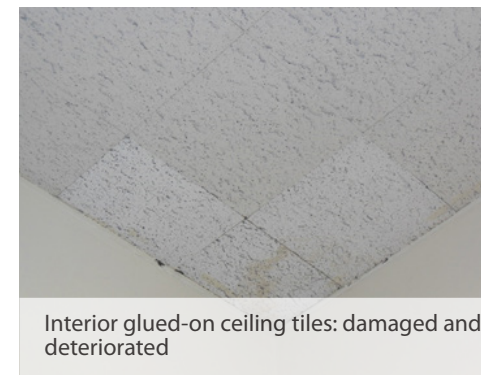
Interior glued-on ceiling tiles: damaged and deteriorated

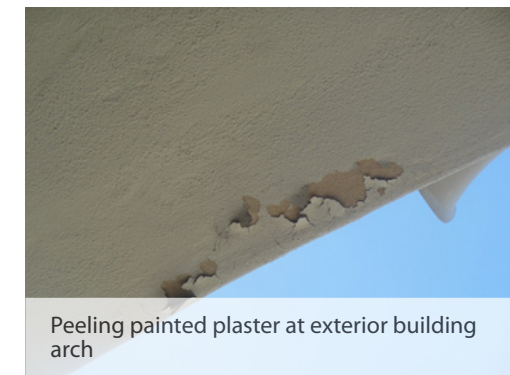
- The exterior plaster paint is in fair condition and, at times, does not correctly match the adjacent surface color.
- The exterior concrete walkways are in poor condition, with deep cracks and uneven surfaces and deteriorated materials

Peeling painted plaster at exterior building arch

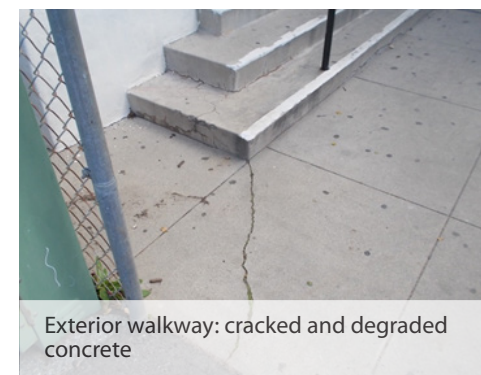
Exterior walkway: cracked and degraded concrete

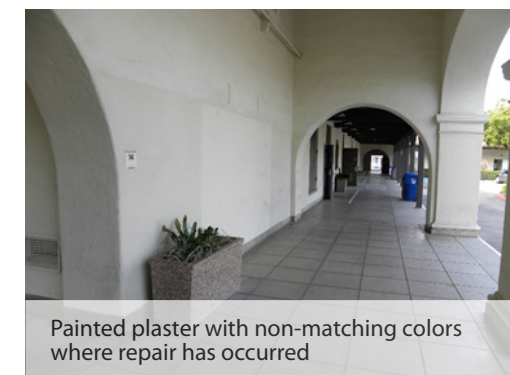
Painted plaster with non-matching colors where repair has occurred

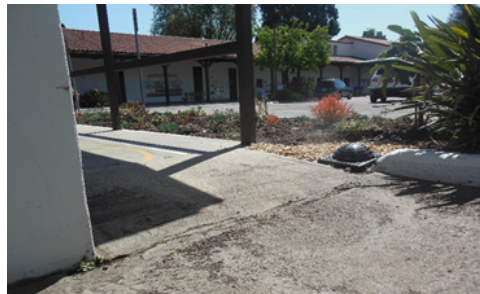
Path of travel with hazardous surface feature and no level landing at bottom of ramp

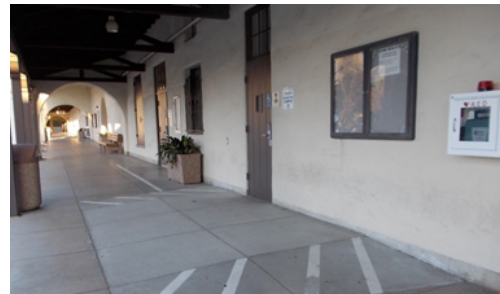
Path of travel interrupted by ramp

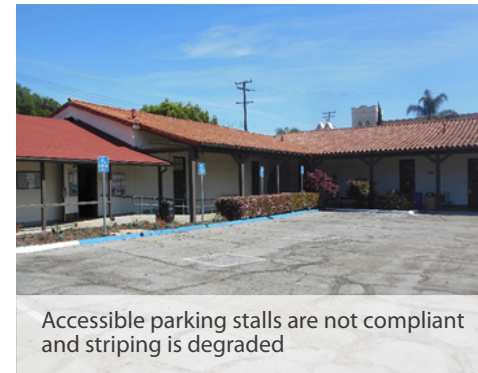
Accessible parking stalls are not compliant and striping is degraded

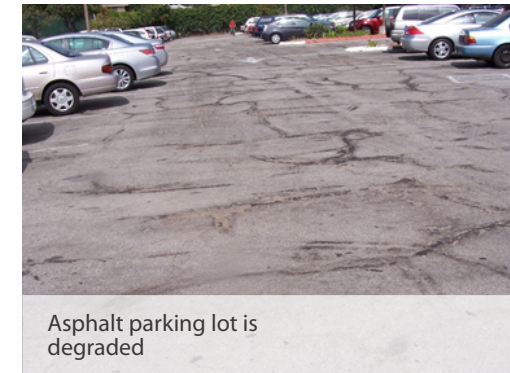
Asphalt parking lot is degraded

- Both the center and west parking lot asphalt is in very poor and deteriorated condition and requires restoration.
- The asphalt surface at both parking lots is in very poor condition, and the striping is faded. The asphalt surface has raveling, alligator cracks, upheaval, and depressions. Cracks have been filled with slurry, but the surfaces would benefit from a full restoration and restriping.
- Additionally, the main lot slopes toward a poor draining catch basin in the southwest corner by Rooms 17 and 20. During periods of heavy rain, this area floods up to the doors, due to excessive storm water retention.
